**I-5 – SR 161/SR 18 Triangle Improvements Project  
(Corrington) Mitigation Site**

**USACE NWP (23) NWS-2009-181**

**2015 MONITORING REPORT**

**Washington State  
Department of Transportation**

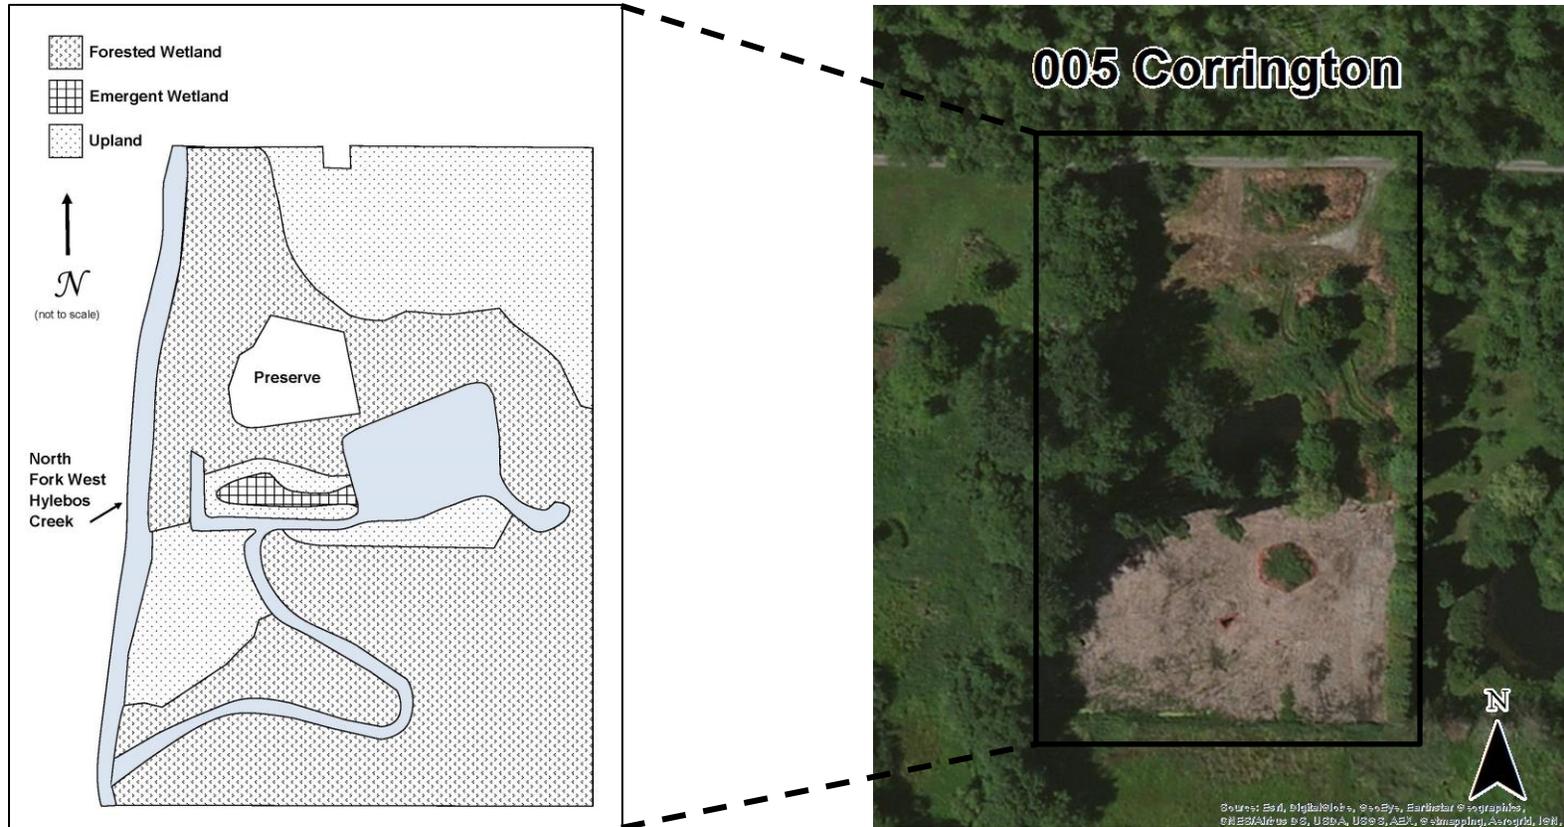
**Figure 1 Site Sketch**

The I-5 Corrington Mitigation Site contains a forested and emergent wetland with several upland areas. A new channel connects the existing pond to the North Fork of West Hylebos creek. Appendix 2 includes site directions.

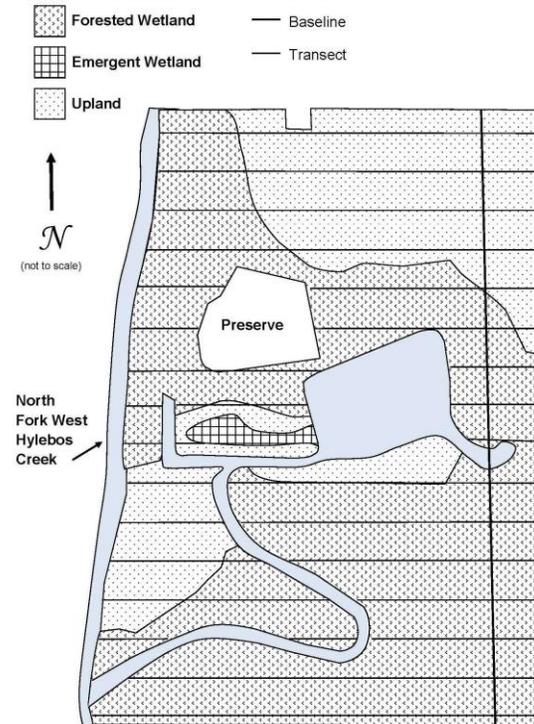
**Figure 2 Site Sampling Design (2015)**

**Placement of Baseline:** Along the eastern edge of the site boundary. Length 141m  
**Transects 1-14**

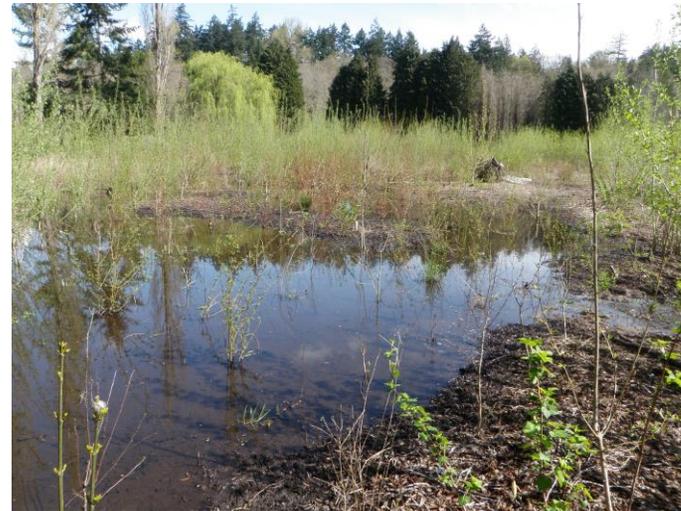
This site is generally developing as intended, and contains robust herbaceous and woody vegetation communities. The southwest corner has been inundated for a prolonged period of time due to an active beaver dam located just off the site. This inundation has caused significant mortality in that area, which is relatively small. Cover of invasive species is low. Chorus frogs, bird nests, and birds were observed at the time of monitoring.

**Photo 1**  
**Inundation in the shrub-shrub wetland**  
**(March 2015)**

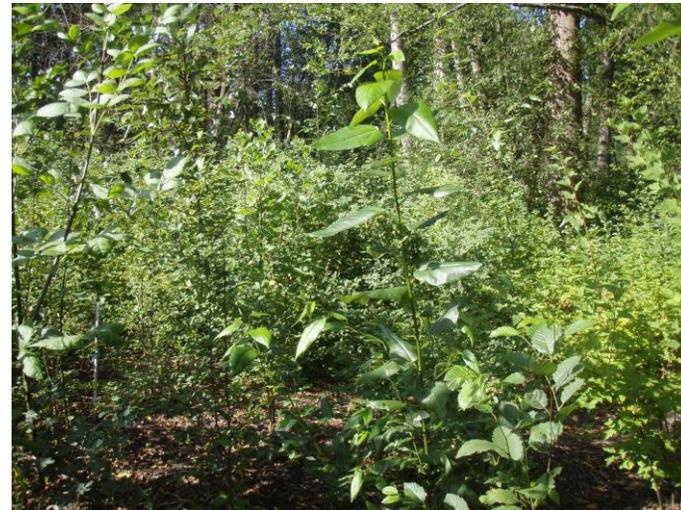
Density of native, facultative or wetter woody species in the scrub-shrub and forested wetlands and buffer and riparian areas combined is estimated at 12 plants/100ft<sup>2</sup> (CI<sub>80%</sub>= 10.4-13.7). This value exceeds the performance standard target. Dominant species include Nootka rose (*Rosa nutkana*), salmonberry (*Rubus spectabilis*), red alder (*Alnus rubra*), and black cottonwood (*Populus balsamifera*). (Photo 2)

**Photo 2**  
**Density in the buffer (July 2015)**

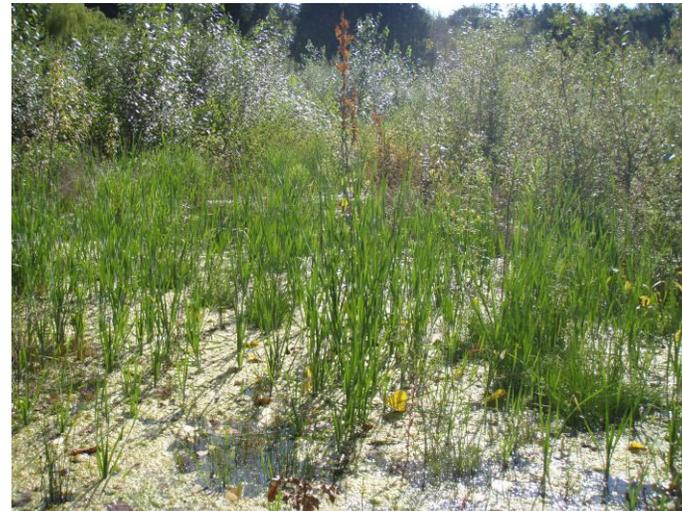
Cover of native, facultative or wetter herbaceous species in the emergent wetland is estimated at 51 percent (CI<sub>80%</sub> = 40-61%). This value exceeds the performance standard target. Dominant species include hardstem bulrush (*Schoenoplectus acutus*) and fringed willowherb (*Epilobium ciliatum*). (Photo 3)

**Photo 3  
Herbaceous cover in the emergent wetland  
(July 2015)**

Routine weed control will continue in 2016.
