**SR 532 Corridor Improvements Project (MP 00.0 to 9.89)  
(Estuarine) Wetland Mitigation Site and Stream 8E Riparian  
Mitigation Site  
WIN # A53210G**

**USACE NWP (14) NWS-2008-1081**

**2015 MONITORING REPORT**

# SR 532 Corridor Improvements Project (MP 0.00 to 9.89) (Estuarine) Wetland Mitigation Site and Stream 8E Riparian Mitigation Site

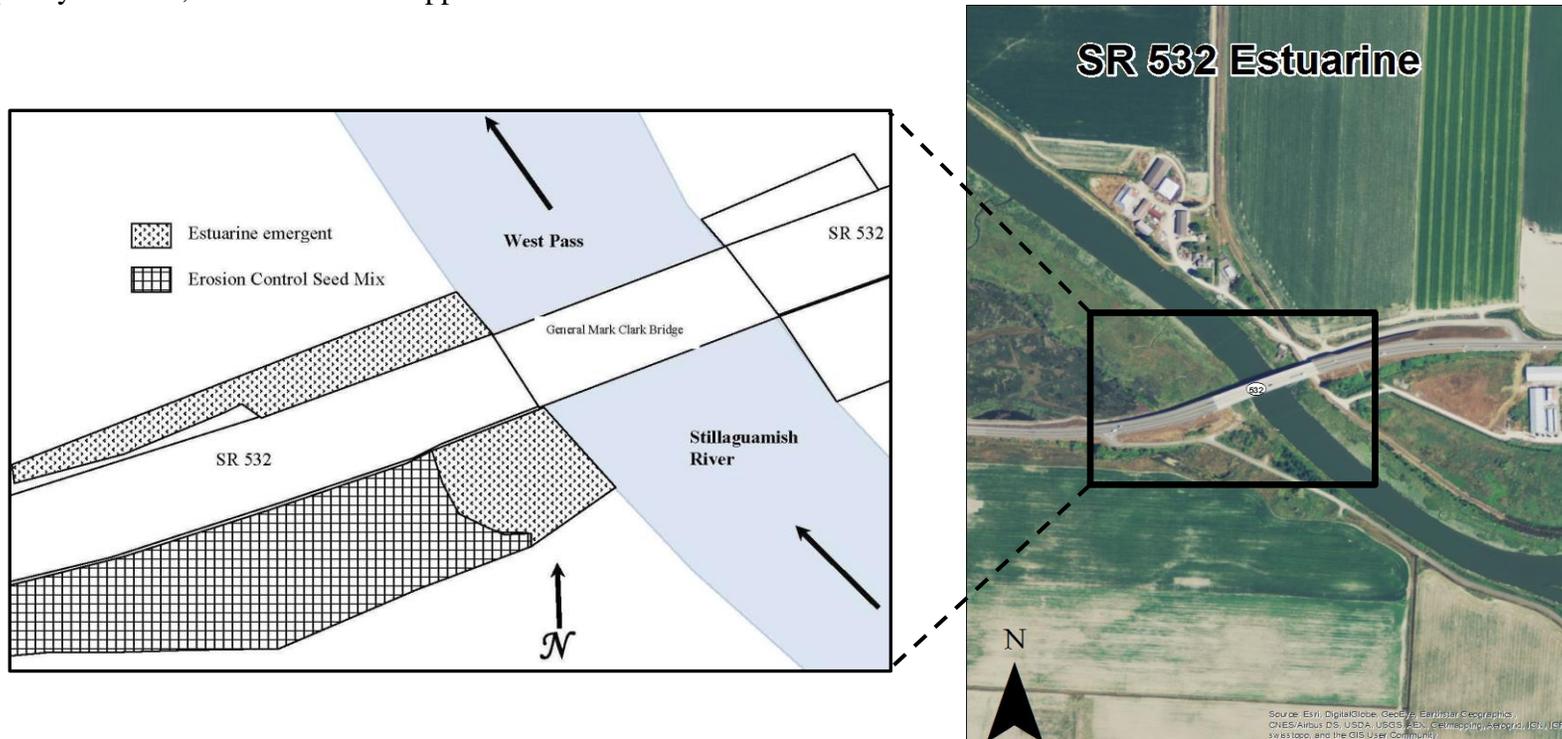
**Figure 1 Site Sketch**

This mitigation site (Figure 1) is re-established wetland under the Gary Clark Bridge along the West Pass of the Stillaguamish River. This site was created to compensate for the loss of 0.01 acre of estuarine wetlands due to the replacement of the Gary Clark Bridge. The site is designed to restore a portion of the historic estuary at this location. The intent is to have a self-sustaining, functional wetland system with intertidal salt marsh habitat that provides habitat for a variety of fish and wildlife species, water quality benefits, and food-chain support functions.

The SR 532 Estuarine Mitigation Site contains an emergent community of native salt tolerant species commonly found in high salt marsh communities. Appendix 1 includes site directions.

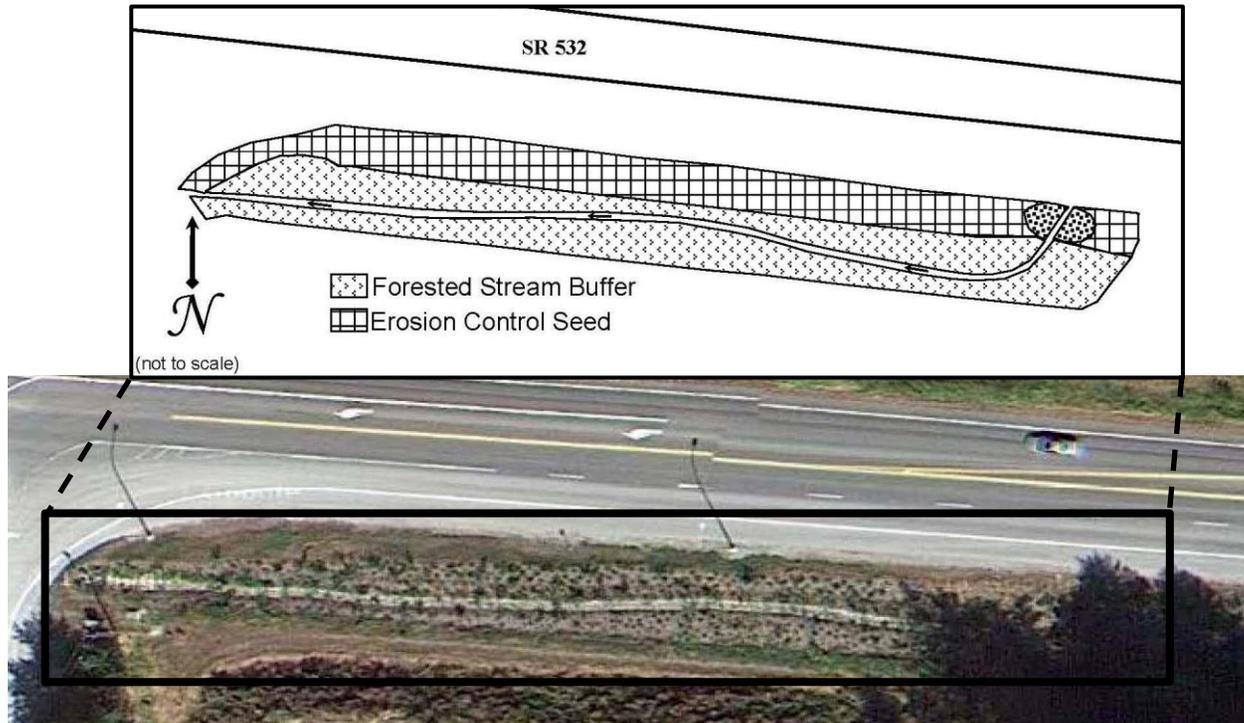
**Figure 1 Site Sketch**

This 0.22-acre mitigation site (Figure 2) was created to compensate for the loss of 370 linear feet of stream channel due to the widening of SR 532. The site will provide increased wildlife habitat by improving the quality of the riparian buffer, as well as increasing the area and food resources available for aquatic invertebrates and amphibians.

The SR 532 Stream 8E Mitigation Site consists of 388 linear feet of stream enhancement and 0.22 acre of riparian buffer enhancement along Stream 8E. Appendix 1 includes site directions.

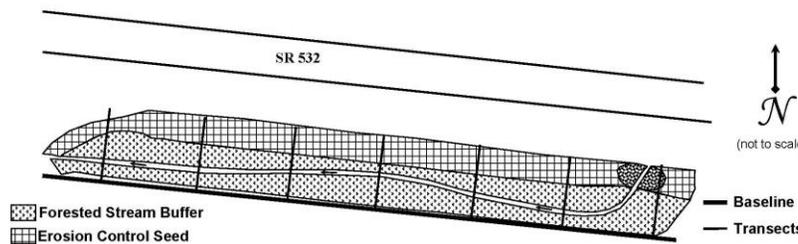
**Figure 2 Site Sampling Design (2015)**

**Placement of Baseline:** The 104 meter baseline was placed parallel to SR 532 on the south side of the riparian area. The interval between transects was seven meters.

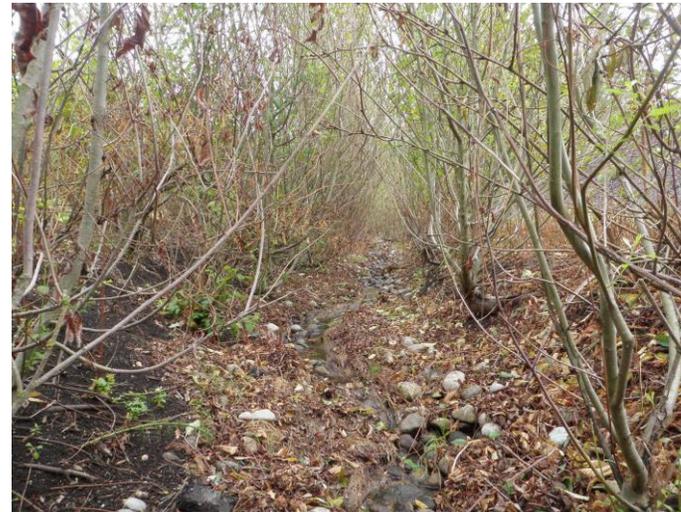
**Photo 1**  
**Stream 8E woody cover (Sept 2015)**

The site has developed into a diverse riparian habitat. Survival of the planted native woody species is high across the site and invasive species cover is low.

Due to the development of the woody riparian community it appears that the site is contributing to the screening, shading, organic debris and in time, large woody debris recruitment to the stream (Photo 1). The site has met the final year (Year-5 for the stream) standards.

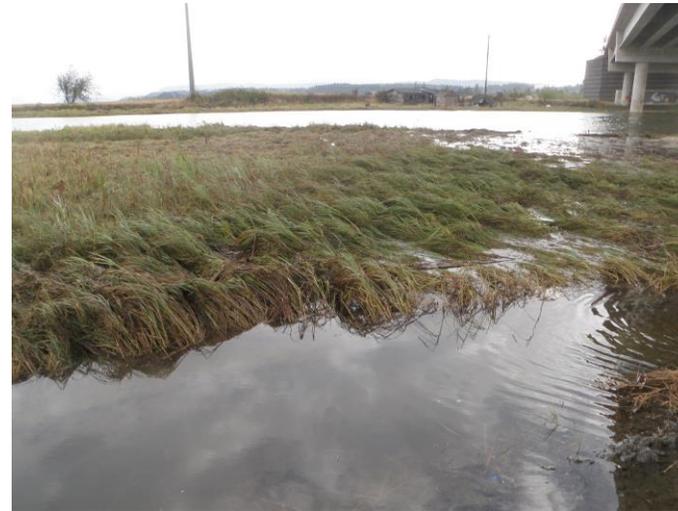
**Photo 2**  
**Wetland at high tide (Sept 2015)**

Salinity measurements were taken at 8:30 am during high tide (Photo 2). Two measurements were taken, one on each side of the bridge. Point 1 was on the south side of the bridge and the result was 15 ppt. Point 2 was on the north side of the bridge and the result was 18 ppt.

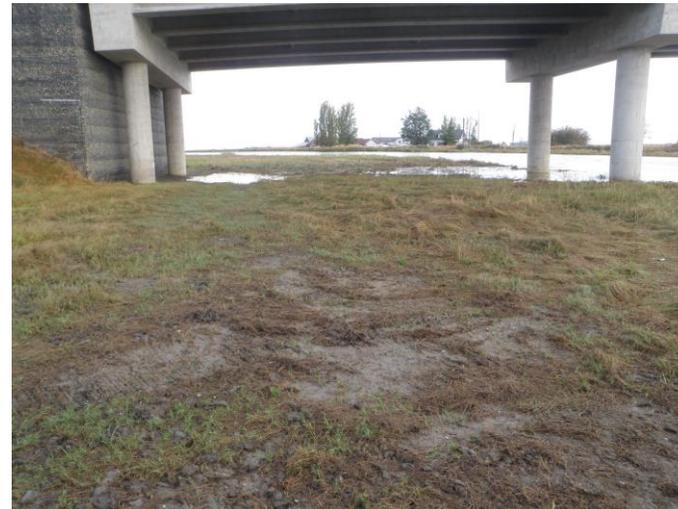
**Photo 3**  
**Emergent cover in the wetland (Sept 2015)**

Native herbaceous cover is estimated at 80 percent in the wetland community (Photo 3). Dominant species include inland saltgrass (*Distichlis spicata*), Lyngbye's sedge (*Carex lyngbyei*), and seacoast bulrush (*Schoenoplectus maritimus*).

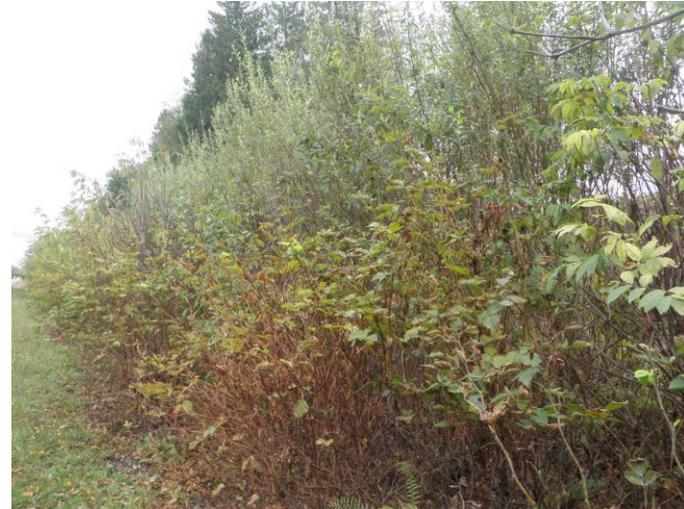
**Photo 4**  
**Woody cover in the riparian buffer (Sept 2015)**

Cover of trees and shrubs in the riparian area is 87% ( $CI_{80\%} = 78-97\%$ ) (Photo 4). Dominant species present include red elderberry (*Sambucus racemosa*), salmonberry (*Rubus spectabilis*), and Indian plum (*Oemleria cerasiformis*). The planted species have become well established, providing shade and bank stabilization for the stream channel.

No noxious or listed species observed on site at the time of monitoring. Reed canarygrass was present within the stream buffer and channel but made up less than five percent cover.

The region has plans to continue weed control as needed.

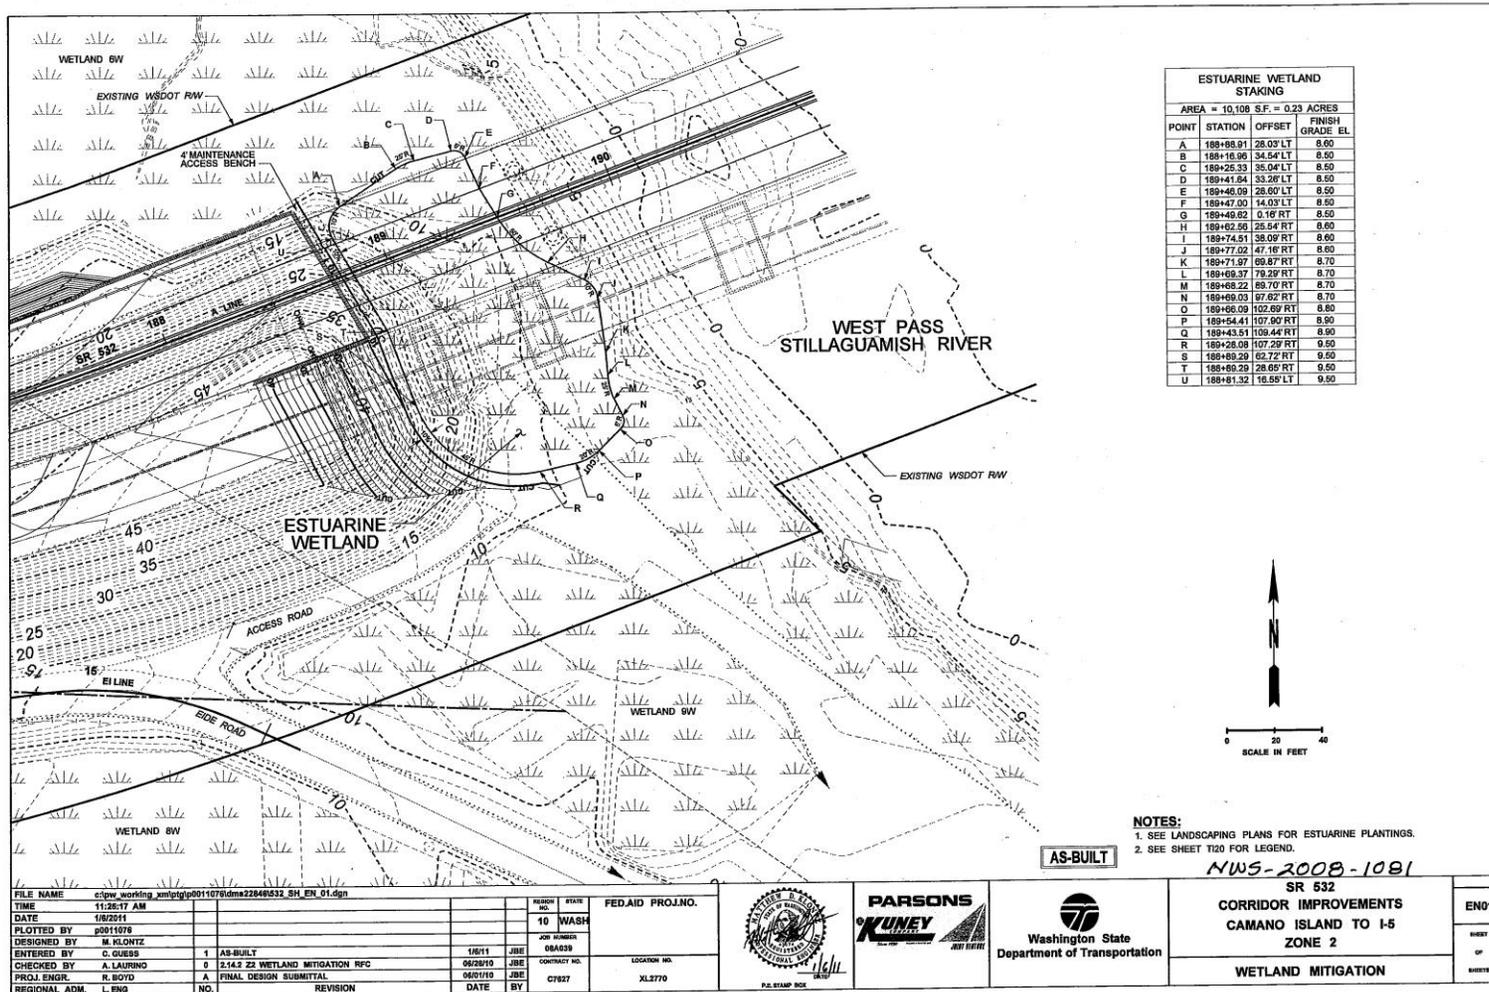
# Appendix 1 – As-Built

Appendix 1 shows the mitigation site as-built and the stream planting plan (WSDOT 2009, 2011).

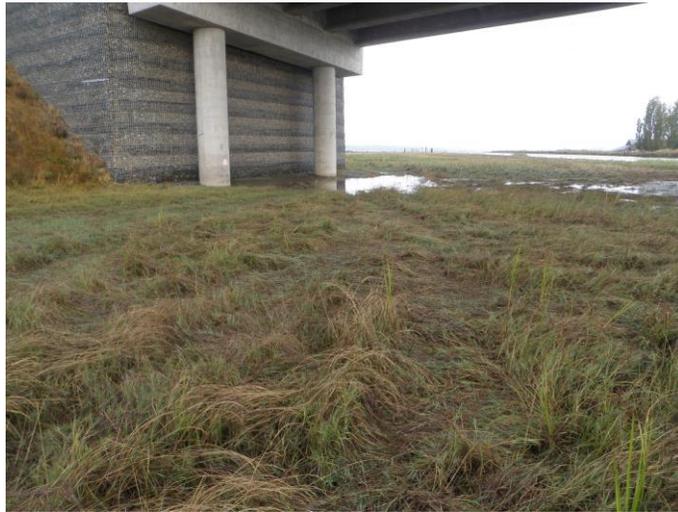
Photo Point 1a

The photographs below were taken from permanent photo-points on September 1, 2015 and document current site development.

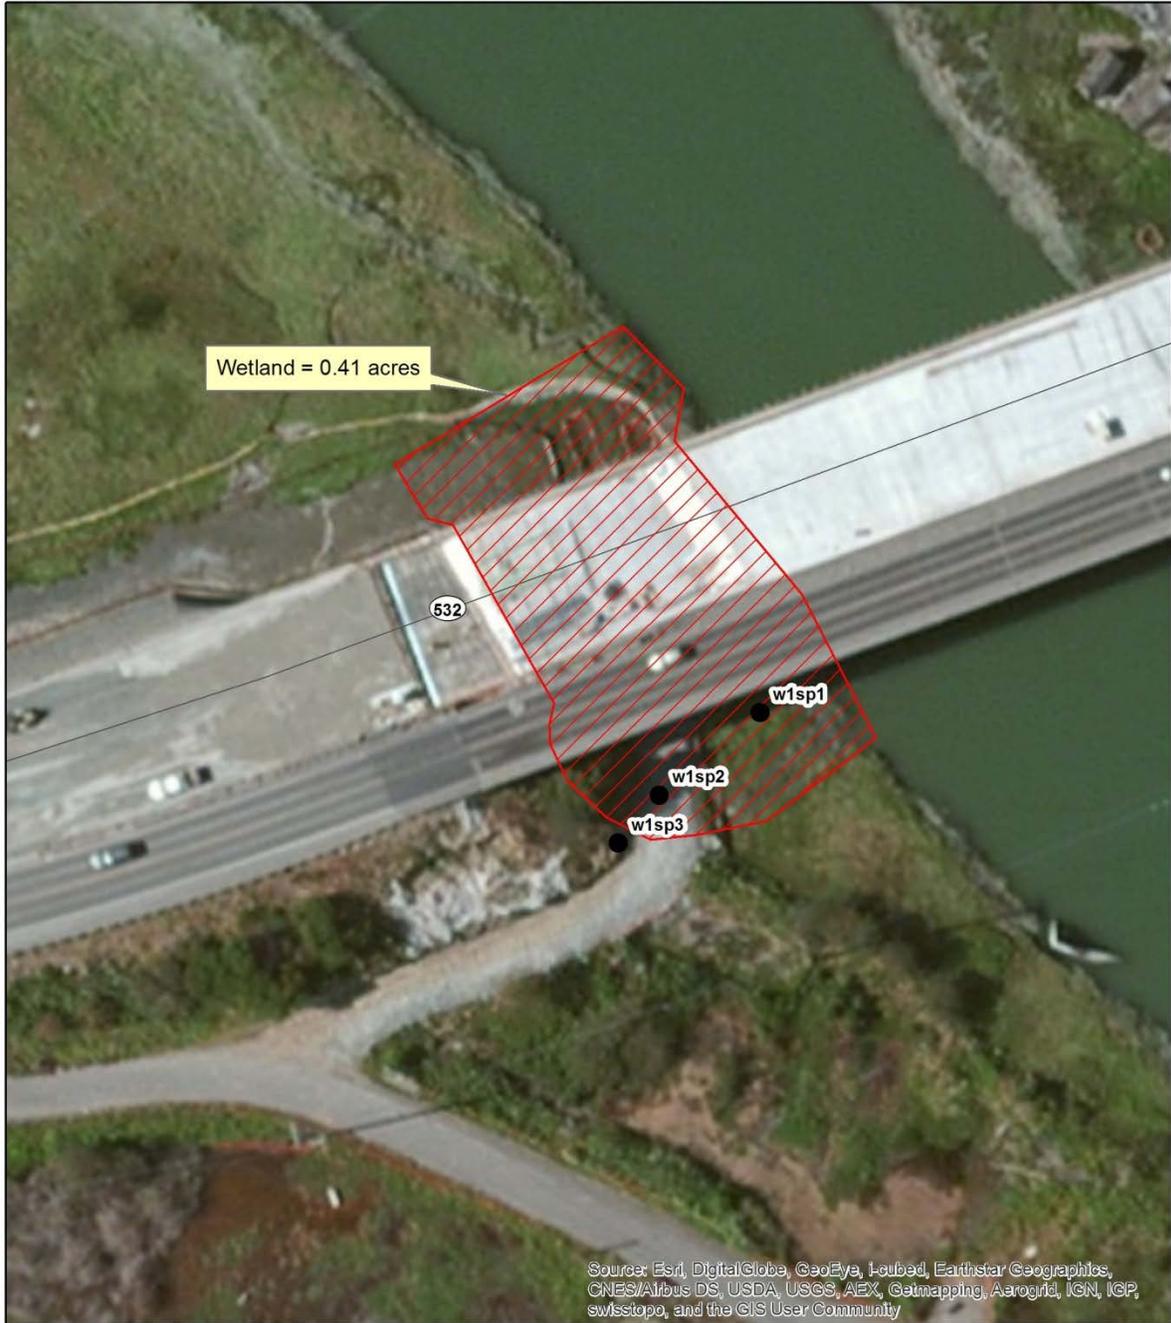
**Figure 2. Wetland boundary in red and sampling point locations in black. Study area is synonymous with the wetland boundary.**

A Global Positioning System (GPS) Trimble GeoXT mapping grade unit was used to record the wetland boundaries and sampling point locations (Figure 2). Wetland boundary points were recorded at regular intervals and at any change in direction along the boundary.

Wetlands described in this report were assessed only within the wetland mitigation site boundary (Figure 2). The entire mitigation site meets wetland criteria; therefore the study area, mitigation site boundary, and wetland boundary are synonymous. The wetland mitigation area is contiguous with off-site estuarine wetlands. Wetland areas beyond the mitigation site boundary are not included in this report.

The delineation determined 0.41 acre of wetland were present within the SR 532 Estuarine Mitigation Site. Delineation data were collected at three sampling points and recorded on wetland determination data forms (Appendix A). Paired wetland and upland sample points were used to define the wetland edge. Additional wetland sample points characterize various wetland vegetation communities. Data recorded on wetland determination data forms characterize typical wetland and upland conditions observed on site. Vegetation, soils, and hydrology were examined in many additional sampling locations to determine the wetland boundary.
