**SR 14 Marble Rd Vic. To Belle Center Rd Vic. Safety
Improvements (Cleveland Oak) Mitigation Site**

USACE NWP (23) NWS-2011-544

2015 MONITORING REPORT

Issued March 2016

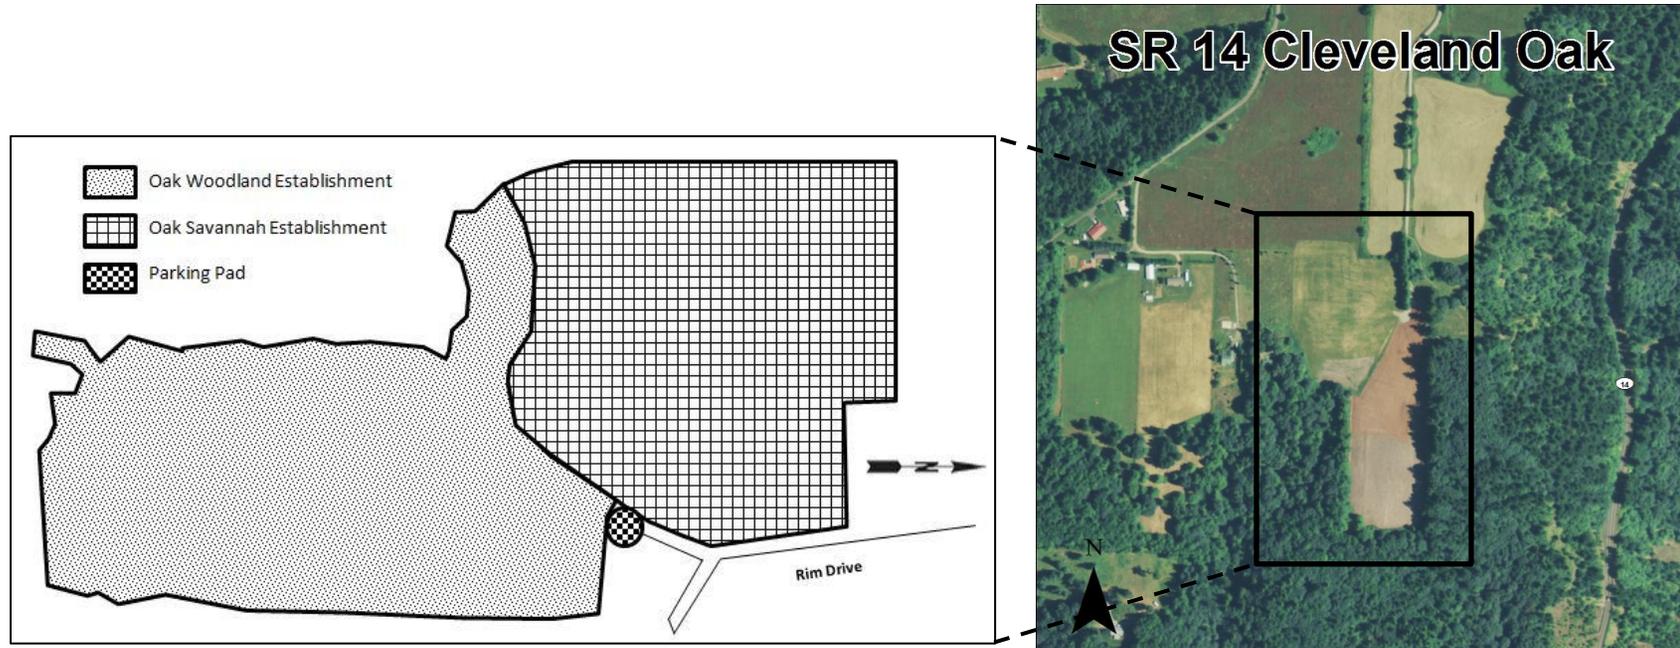
Figure 1 Site Sketch

This 12-acre mitigation site (Figure 1) consists of Oregon white oak woodland establishment on a former hayfield west of Skamania, WA. This site was created as partial compensation for the loss of 2.25 acre of Oregon white oak woodlands due to safety improvements on SR 14 from the Marble Road vicinity to the Belle Center Road vicinity.

The SR 14 Cleveland Oak Mitigation Site contains 6.4 acres of oak woodland establishment, designed to eventually have a closed tree canopy and dense woody understory, and 5.7 acres of oak savannah establishment, designed with clumps of oak plantings interspersed with an understory of native grasses and forbs. Appendix 2 includes site directions.

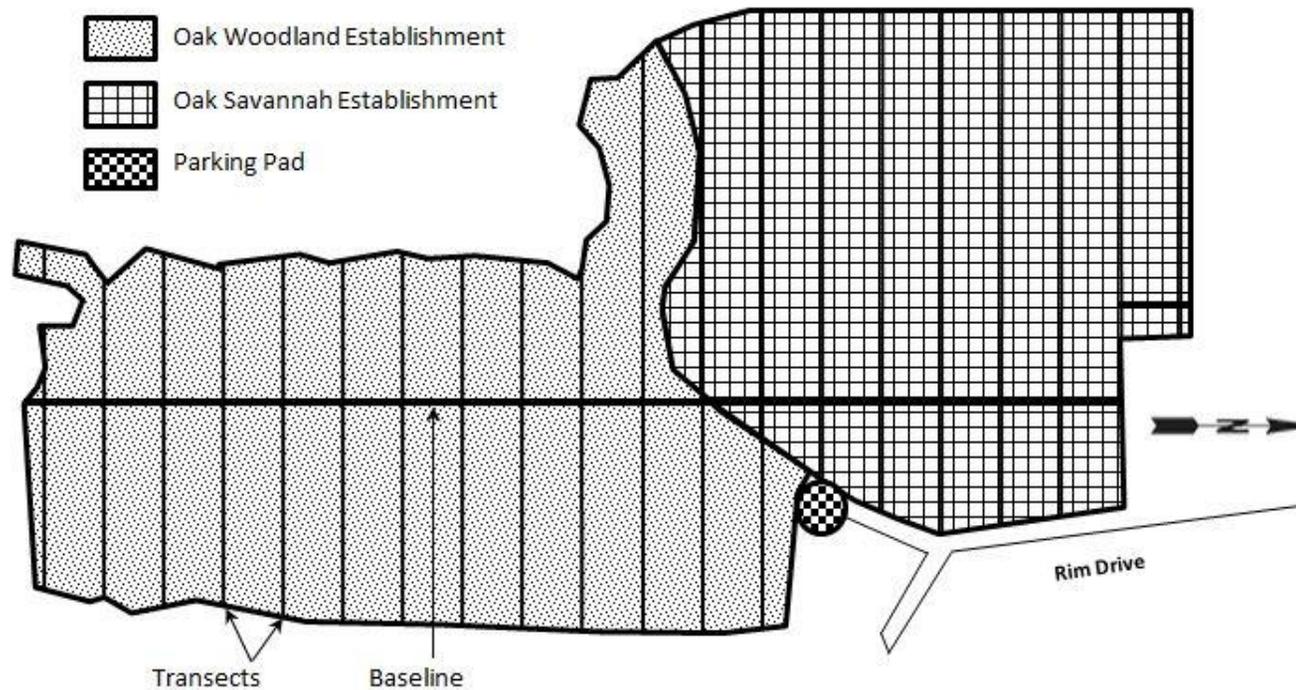
Figure 2 Site Sampling Design (2015)

Placement of Baseline: Through the center of the site, oriented north-south with a short segment offset at the north end.

PS 1	PS 1	PS 2, 3, 4	PS 5
Attribute	Survival	Survival	Cover/Presence	Cover
Target pop.	Native Woody	Native Woody	Noxious Weeds	Herbs
Zone	Oak Woodland	Oak Savannah	Entire Site	Oak Savannah
Sample method	UBT	UBT	Visual Estimate	Point Line
SU length				20 m
SU width	1 m	1 m		
Points per SU				20
Total # of SU	20	10		23

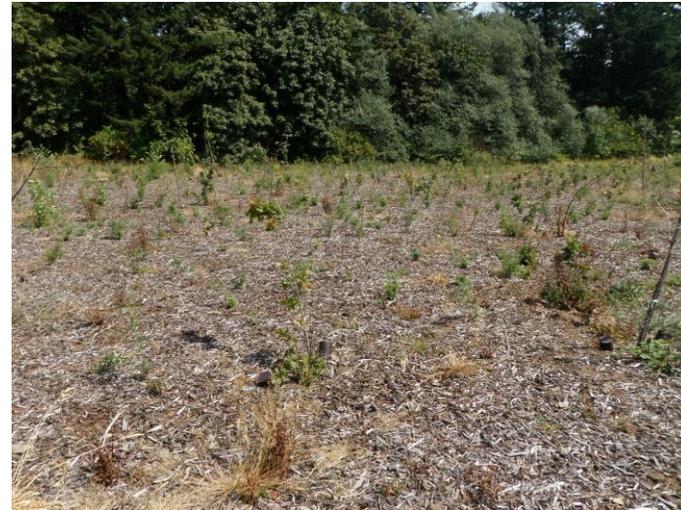
The survival rate of woody plantings across the entire site is estimated at 89% (CI_{80%} = 87-91%). In the Oak Woodland area alone (Photo 1), survival is estimated at 90% (CI_{80%} = 88-92%). The most abundant species in this area is snowberry (*Symphoricarpos albus*), followed by dull oregongrape (*Mahonia nervosa*), western serviceberry (*Amelanchier alnifolia*), Oregon white oak (*Quercus garryana*), and Indian plum (*Oemleria cerasiformis*). The survival rate of woody plantings in the Oak Savannah area alone (Photo 2) is estimated at 70% (CI_{80%} = 63-76%). The only woody species planted in this area is Oregon white oak (*Quercus garryana*).

Photo 1
Woody survival in the oak woodland (August 2015)

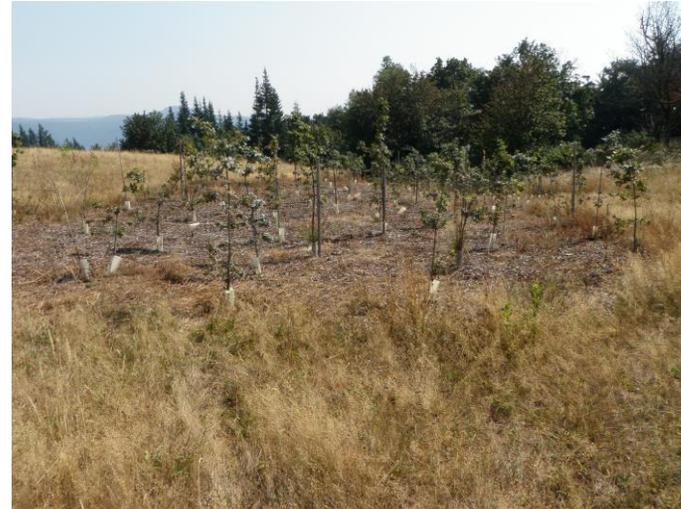
Photo 2
Woody survival in the oak savannah (August 2015)

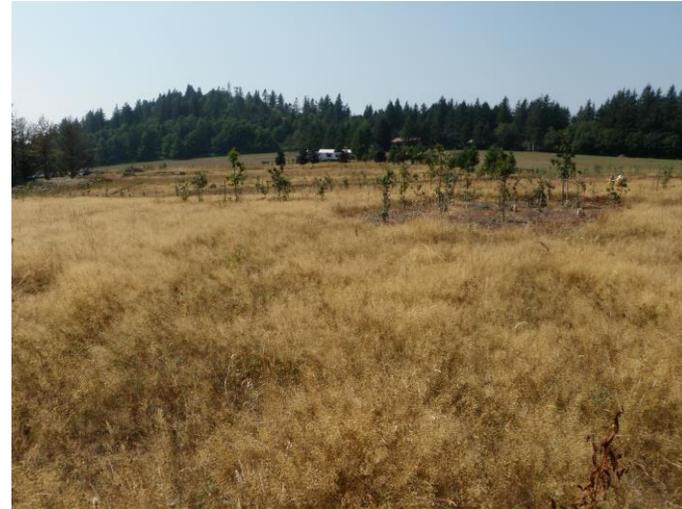
The results for total cover of non-native grasses and forbs in the herbaceous portions of the oak savannah (Photo 3) were inconclusive due to the timing of the monitoring visit. The site was visited late in the summer of a very dry year and many of the grasses no longer had useful flowering parts for identification. Despite the inconclusive results, in terms of a specific cover estimate for non-native species, it was clear from the incomplete sampling results and visual observations that the cover of non-native species is greater than five percent. In order to obtain more definitive results, monitoring for this site will be scheduled for earlier in the summer in the coming years when better and more abundant specimens are available for identification.

Photo 3
Herbaceous cover in the oak savannah
(August 2015)

Non-native herbaceous species that were present in this area include narrowleaf plantain (*Plantago lanceolata*), oxeye daisy (*Leucanthemum vulgare*), common velvetgrass (*Holcus lanatus*), butter and eggs (*Linaria vulgaris*), sweet vernalgrass (*Anthoxanthum odoratum*), common sheep sorrel (*Rumex acetosella*), red clover (*Trifolium pratense*), and hairy cat's ear (*Hypochaeris radicata*). Native herbaceous species that were present in this area include blue wildrye (*Elymus glaucus*), nodding Trisetum (*Trisetum cernuum*), slender wheatgrass (*Elymus trachycaulus*), California brome (*Bromus carinatus*), and a lupine (*Lupinus* sp.).

Continued spot spraying will occur in the oak woodland and oak savannah bark mulch areas throughout the growing season followed by replanting in the 2016-2017 dormant season.

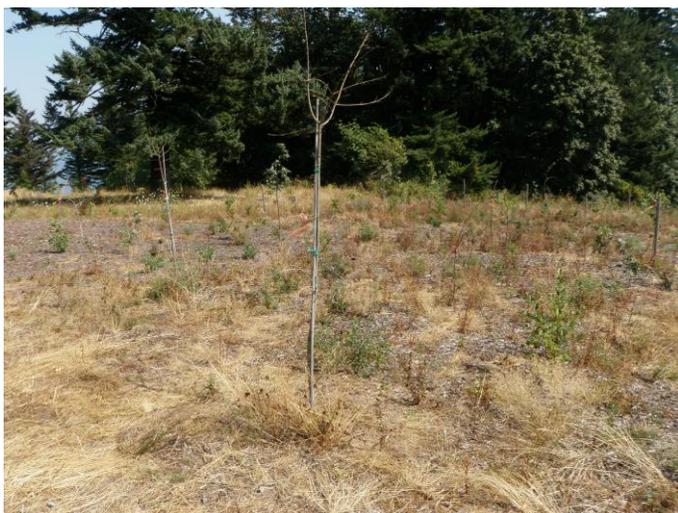
Photo Point 1a

The photographs below were taken from permanent photo-points on August 18, 2015 and document current site development.
