**Spring Valley Restoration Project Mitigation Site
USACE NWP (27) 200600839**

2015 MONITORING REPORT

**Washington State
Department of Transportation**

**Spring Valley Restoration Project Mitigation Site
 USACE NWP (27) 200600839
 Tacoma/Pierce County HOV Program; I-5: Port of Tacoma
 Road to King County Line-HOV USACE NWS-2008-1445**

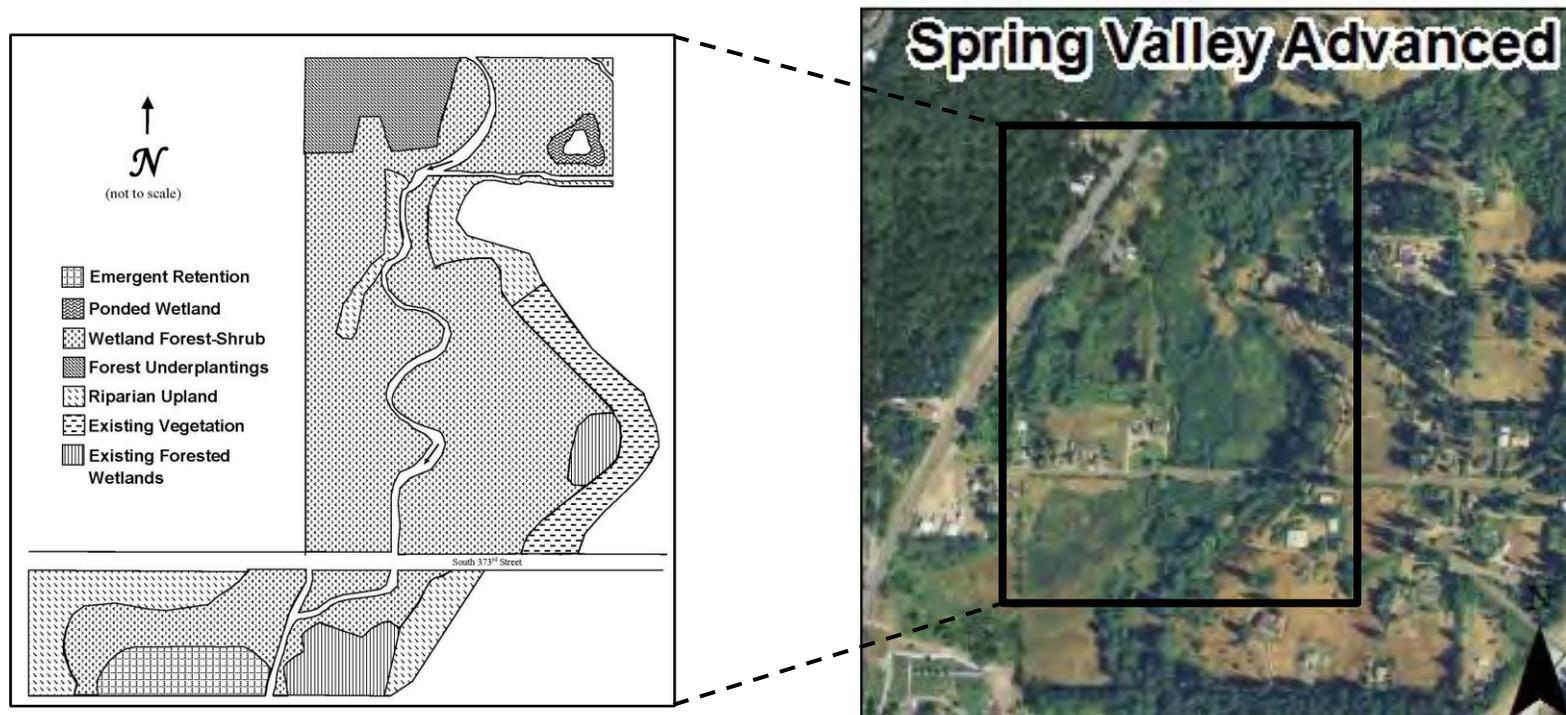
Figure 1 Site Sketch

I-5 Spring Valley Mitigation Site includes forest/shrub habitat, forest underplantings, and ponded wetlands. There are additional emergent areas not shown on this sketch. See As-built map in Appendix 1 for locations. Appendix 2 includes driving directions.

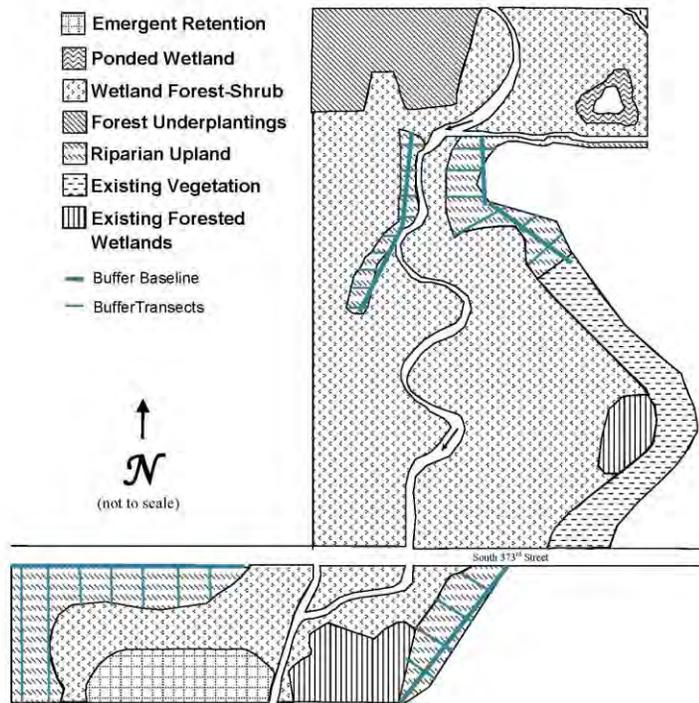
Figure 2 Site Sampling Design (2015)

Placement of Baseline: The baseline had six segments that spanned the buffer zone in each area. The total length was 468-meters.

Segmented Baseline: Length 64m Transects 1-4
 Length 75m Transects 5-9
 Length 82m Transects 10-14
 Length 31m Transects 15-16
 Length 77m Transects 17-21
 Length 139m Transects 22-29

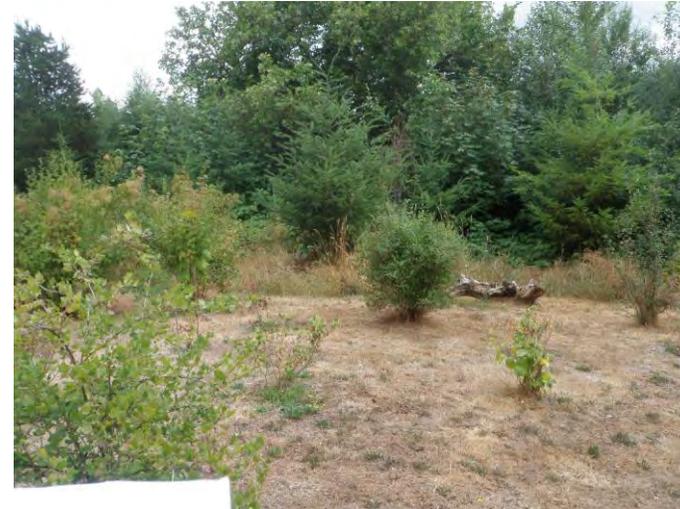
Photo 1
Woody cover in the Upland Buffer (July 2015)

Cover of woody species in the upland buffer is 32 percent (CI_{70%} = 25-38%) (Photo 1). Woody species establishment and growth in this zone has been slow. The result from quantitative monitoring in 2013 was 25 percent cover (CI_{53%} = 20-30%). This area was monitored again in 2015 because this standard was not met in 2013.

The current result of 32 percent shows improvement from previous years. The region restoration crew planted additional plants in February of 2015. The zone continues to develop and with continued maintenance, should meet the Year 10 standard of 50 percent cover.

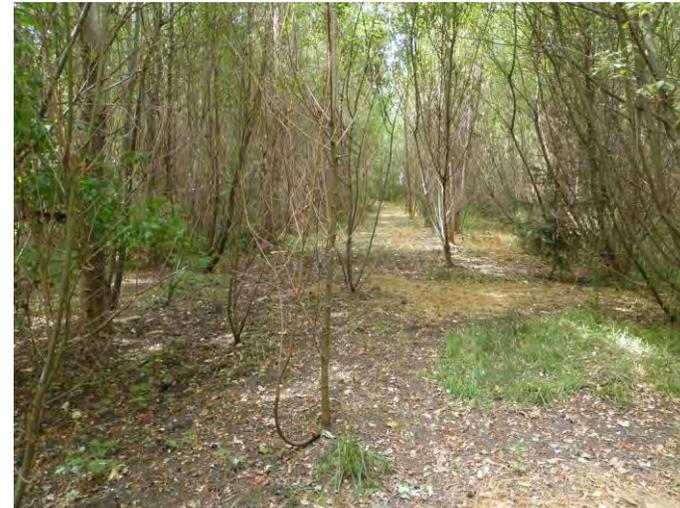
Photo 2
Woody Cover in the Wetland (July 2015)

Cover of woody species in the wetland is qualitatively estimated at 85 to 90 percent. The site has developed rapidly and has been meeting the Year 10 final year standard for wetland woody cover for two years. On June 24, 2015, a request to discontinue quantitative sampling for wetland woody cover was sent to USACE and the Department of Ecology, this request was accepted on July 14, 2015. The final year standards are still currently being met.

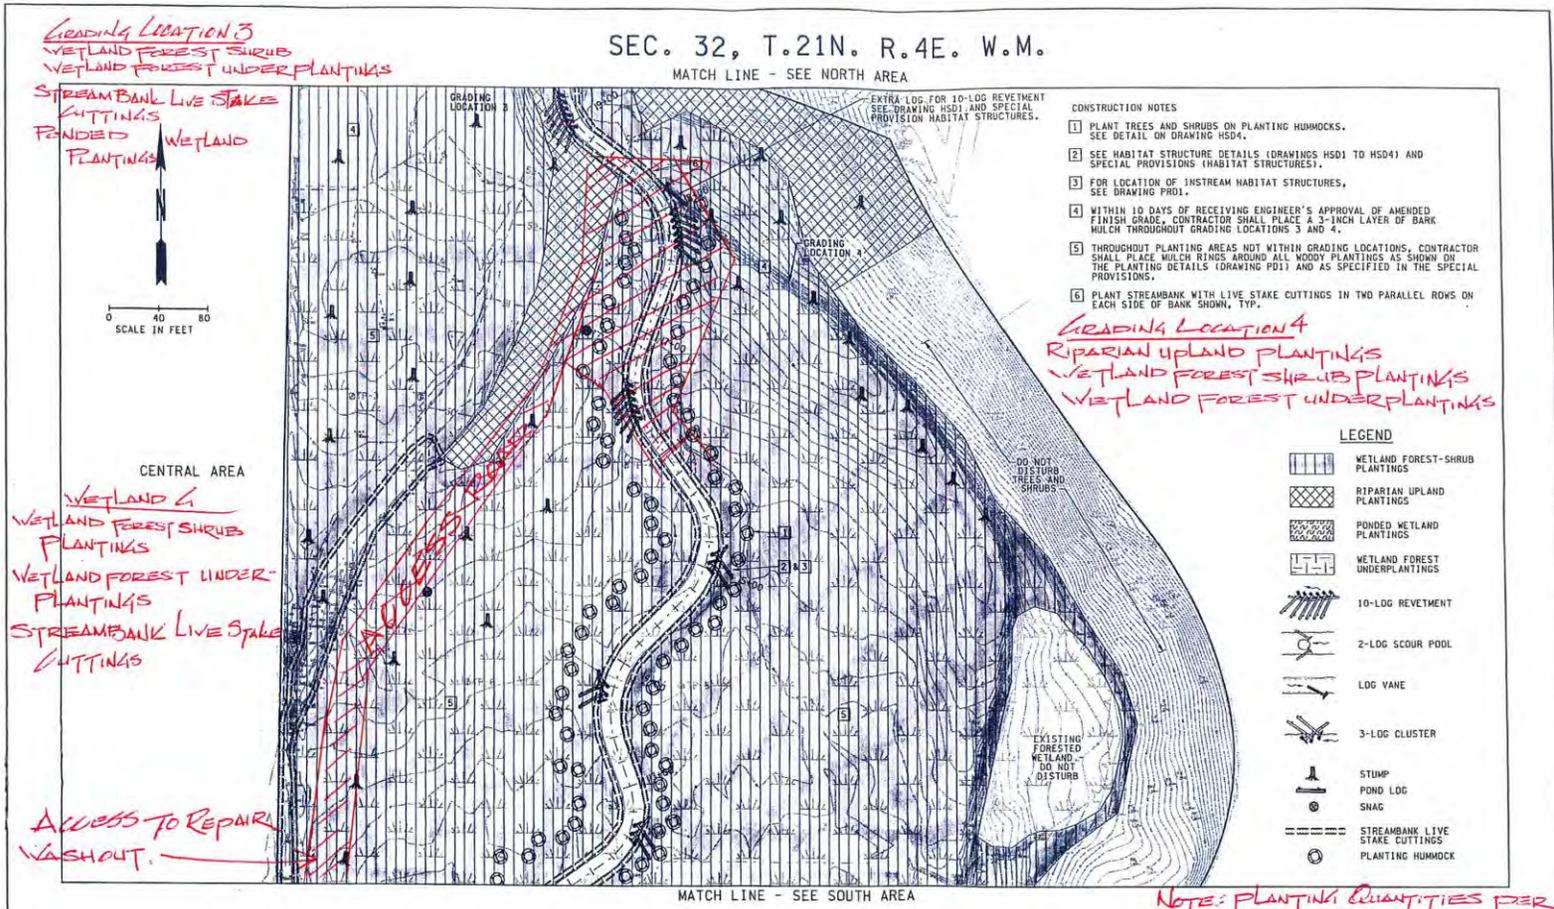
PLANTING PLAN - CENTRAL AREA

- CONSTRUCTION NOTES
- 1 PLANT TREES AND SHRUBS ON PLANTING HUMMOCKS. SEE DETAIL ON DRAWING HSD4.
 - 2 SEE HABITAT STRUCTURE DETAILS (DRAWINGS HSD1 TO HSD4) AND SPECIAL PROVISIONS (HABITAT STRUCTURES).
 - 3 FOR LOCATION OF INSTREAM HABITAT STRUCTURES, SEE DRAWING PDI1.
 - 4 WITHIN 10 DAYS OF RECEIVING ENGINEER'S APPROVAL OF AMENDED FINISH GRADE, CONTRACTOR SHALL PLACE A 3-INCH LAYER OF BARK MULCH THROUGHOUT GRADING LOCATIONS 3 AND 4.
 - 5 THROUGHOUT PLANTING AREAS NOT WITHIN GRADING LOCATIONS, CONTRACTOR SHALL PLACE MULCH RINGS AROUND ALL WOODY PLANTINGS AS SHOWN ON THE PLANTING DETAILS (DRAWING PDI1) AND AS SPECIFIED IN THE SPECIAL PROVISIONS.
 - 6 PLANT STREAMBANK WITH LIVE STAKE CUTTINGS IN TWO PARALLEL ROWS ON EACH SIDE OF BANK SHOWN, TYP.

Grading Location 4
 Riparian Upland Plantings
 Wetland Forest Shrub Plantings
 Wetland Forest Underplantings

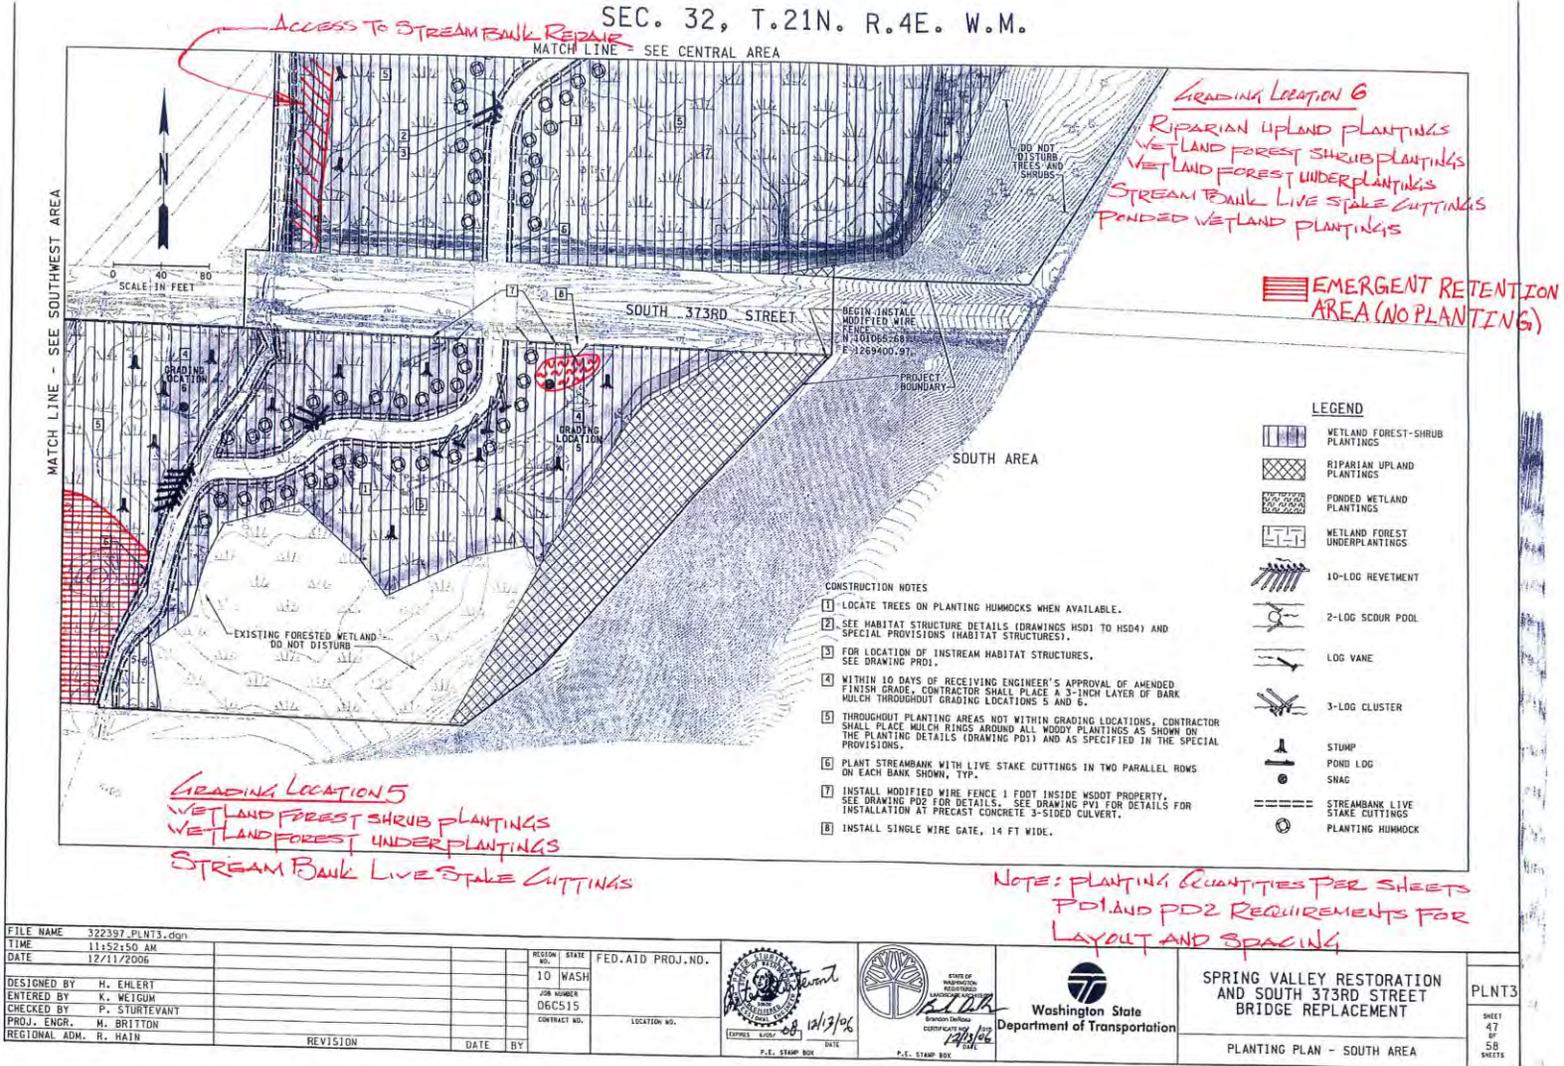
Grading Location 5
Wetland Forest Shrub Plantings
Wetland Forest Underplantings
Stream Bank Live Stake Cuttings

Grading Location 6
Riparian Upland Plantings
Wetland Forest Shrub Plantings
Wetland Forest Underplantings
Stream Bank Live Stake Cuttings
Pondered Wetland Plantings

- CONSTRUCTION NOTES**
1. LOCATE TREES ON PLANTING HUMMOCKS WHEN AVAILABLE.
 2. SEE HABITAT STRUCTURE DETAILS (DRAWINGS HSD1 TO HSD4) AND SPECIAL PROVISIONS (HABITAT STRUCTURES).

3. FOR LOCATION OF INSTREAM HABITAT STRUCTURES, SEE DRAWING PROJ1.
 4. WITHIN 10 DAYS OF RECEIVING ENGINEER'S APPROVAL OF AMENDED FINISH GRADE, CONTRACTOR SHALL PLACE A 3-INCH LAYER OF BARK MULCH THROUGHOUT GRADING LOCATIONS 5 AND 6.

5. THROUGHOUT PLANTING AREAS NOT WITHIN GRADING LOCATIONS, CONTRACTOR SHALL PLACE MULCH RINGS AROUND ALL WOODY PLANTINGS AS SHOWN ON THE PLANTING DETAILS (DRAWING PDI) AND AS SPECIFIED IN THE SPECIAL PROVISIONS.

6. PLANT STREAMBANK WITH LIVE STAKE CUTTINGS IN TWO PARALLEL ROWS ON EACH BANK SHOWN, TYP.
 7. INSTALL MODIFIED WIRE FENCE 1 FOOT INSIDE WSDOT PROPERTY. SEE DRAWING PD2 FOR DETAILS. SEE DRAWING PVI FOR DETAILS FOR INSTALLATION AT PRECAST CONCRETE 3-SIDED CULVERT.

8. INSTALL SINGLE WIRE GATE, 14 FT WIDE.

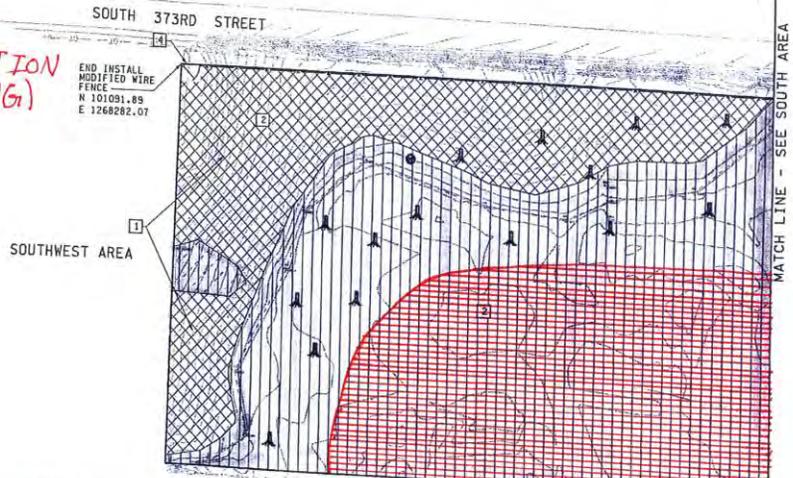
SPRING VALLEY RESTORATION AND SOUTH 373RD STREET BRIDGE REPLACEMENT
 PLNT4
 SHEET 48 OF 58 SHEETS
 PLANTING PLAN - SOUTHWEST AREA

- 1] SPECIAL TREE SETBACK FROM FENCE LINE REQUIRED WITHIN 50 FEET OF THE WESTERN PROPERTY LINE. SEE DETAIL ON DRAWING PDZ.
- 2] THROUGHOUT PLANTING AREAS NOT WITHIN GRADING LOCATIONS, CONTRACTOR SHALL PLACE MULCH RINGS AROUND ALL WOODY PLANTINGS AS SHOWN ON THE PLANTING DETAILS (DRAWING PD1) AND AS SPECIFIED IN THE SPECIAL PROVISIONS.
- 3] INSTALL MODIFIED WIRE FENCE 1 FOOT INSIDE WSDOT PROPERTY. SEE DRAWING PDZ FOR DETAILS.
- 4] INSTALL SINGLE WIRE GATE, 14 FT WIDE.

WETLAND A & B
WETLAND FOREST SHRUB PLANTINGS
WETLAND FOREST SHRUB-UNDERPLANTINGS
STREAMBANK LIVE STAKE CUTTINGS
