## **Pilchuck Creek Mitigation Site**

SR 532 Corridor Improvements-Camano Island to I-5  
(MP 0.00 to MP 9.98)  
USACE NWP (14) NWS-2008-1082, WIN # A53210G

**2015 Monitoring Report  
Wetlands Program**  
*Issued March 2016*

**Washington State  
Department of Transportation**

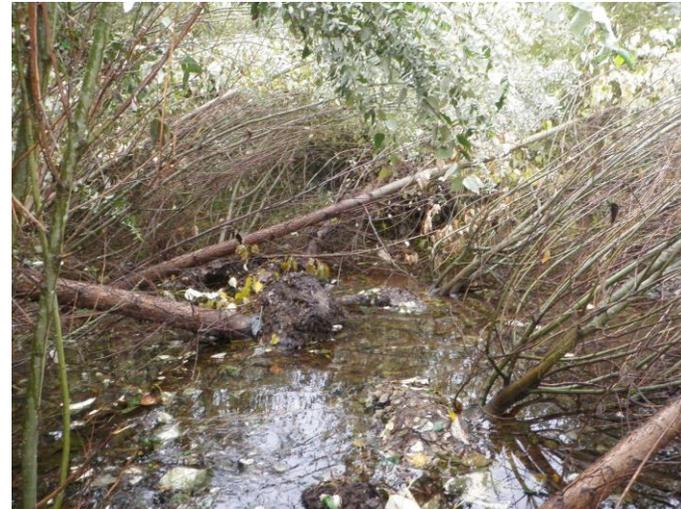
**Photo 1**  
**Black cottonwood blow down (September 2015)**

A summer storm occurred in between the two vegetation monitoring visits causing a number of the larger black cottonwood (*Populus balsamifera*) to blow down within the wet buffer (Photo 1). This may benefit the overall herbaceous cover by opening areas that are experiencing stem exclusion to colonization. Without these openings this performance standard may be difficult to meet due to the dense cover of woody species shading out the entire herbaceous layer in portions of the wet buffer.

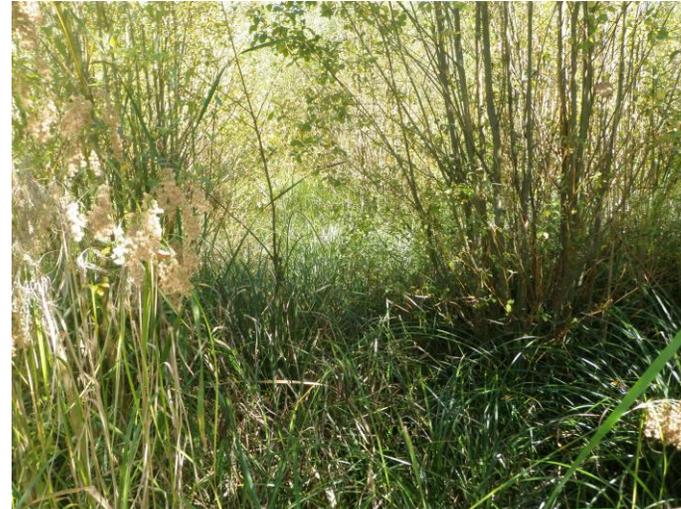
**Photo 2**  
**Herbaceous cover in the north buffer (August 2015)**

Native facultative or wetter herbaceous cover in the wet buffer is estimated at 34% cover ( $CI_{80\%} = 28-40\%$ ), with a total of thirteen species sampled. The herbaceous layer varies dramatically based on a north to south gradient of decreasing hydrology as well the degree of canopy closure throughout the wet buffer. The northern portion (Photo 2) tends to have more standing water and as a result more canopy gaps allowing for a more robust herbaceous layer. The southern portion (Photo 3) tends to be dryer with much more closed canopy resulting in a “stem exclusion” stage.

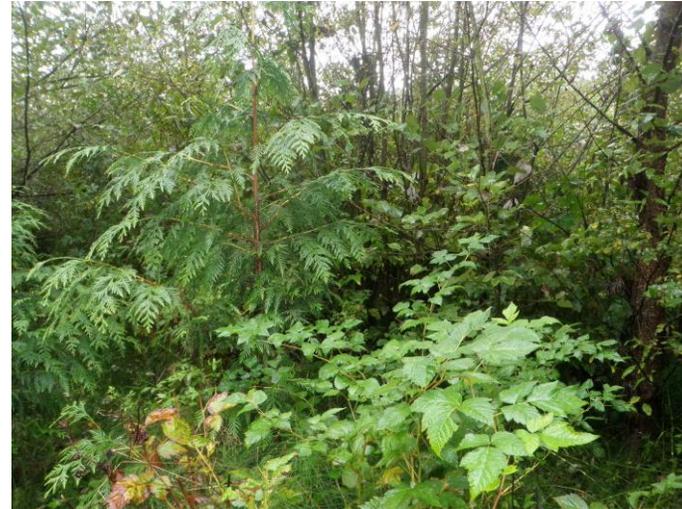
**Photo 4**  
**Native woody cover (September 2015)**

Native facultative or wetter woody species cover is estimated at 95 percent. The dominant species present in the scrub shrub wetland include Sitka willow (*Salix sitchensis*) and Pacific willow (*Salix lasiandra*) with an average height of three meters. Black cottonwoods (*Populus balsamifera*) are reaching heights up to seven meters creating the beginning of canopy differentiation (Photo 4).

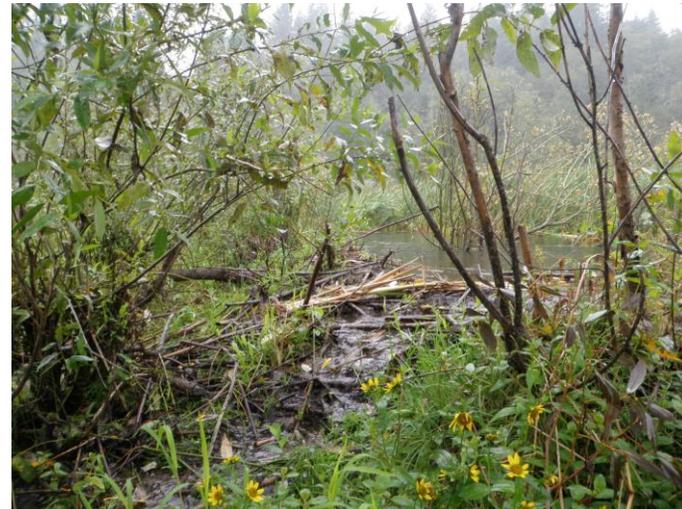
**Photo 5**  
**Beaver dam (September 2015)**

As-built documentation is complete and located in Appendix 1. Wildlife observed on site during monitoring include chorus frogs, a Pacific jumping mouse, beaver sign, coyote and deer tracks, and deer and rabbit scat, (Photo 5). A total of 37 separate species of birds have been observed on site with several species of ducks observed in the permanently inundated areas and belted kingfishers observed hunting. Passerines were observed using the habitat structures and the perch poles were white washed. Amphibian egg masses were observed in the wetland in the spring.

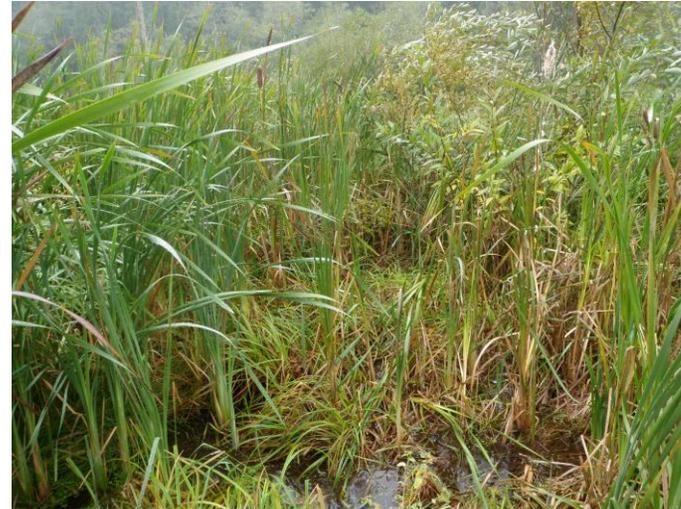
**Photo 4**  
**Herbaceous cover in the emergent zone (Sept 2015)**

The cover of native herbaceous species in the emergent wetland is estimated at 90 percent. This estimate includes all cattail species of which potentially 25 percent maybe the hybrid *x gluaca*. If the hybrid is excluded the cover is estimated at 80 percent.

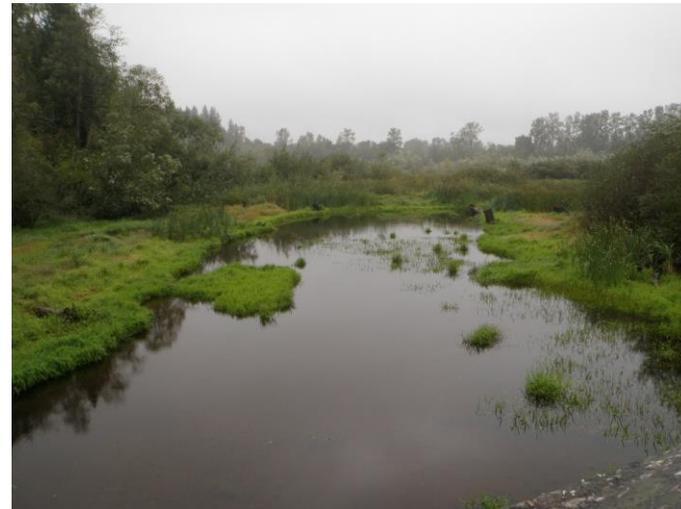
**Photo 5**  
**Herbaceous cover in the permanently ponded areas (Sept 2015)**

Native herbaceous cover within the permanently ponded areas is estimated at 50 percent cover overall. However, areas that are too deep to cross had varying degrees of cover. Some small ponds had 0% cover, others had 80% cover. The areas of permanent ponding change continually due to beaver activity on site. The water level has been observed to raise at least six inches in some areas overnight shifting the areas of ponding and making it difficult to determine what is permanent ponding or not.

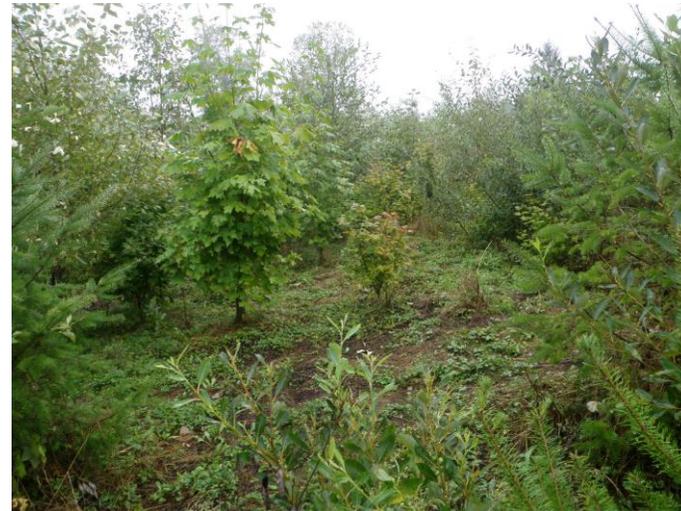
**Photo 6**  
**Woody cover in the upland buffer (September 2015)**

Native woody cover in the buffer is estimated at 85 percent. The dominant species present in the buffer include black cottonwood (*Populus balsamifera*), red alder (*Alnus rubra*), and willows (*Salix spp.*) ranging in height between three and seven meters tall (Photo 6).
