**US 101 Purdy Creek Bridge Replacement Mitigation Site
USACE NWP (23) NWS-2007-1812**

2015 MONITORING REPORT

**Washington State
Department of Transportation**

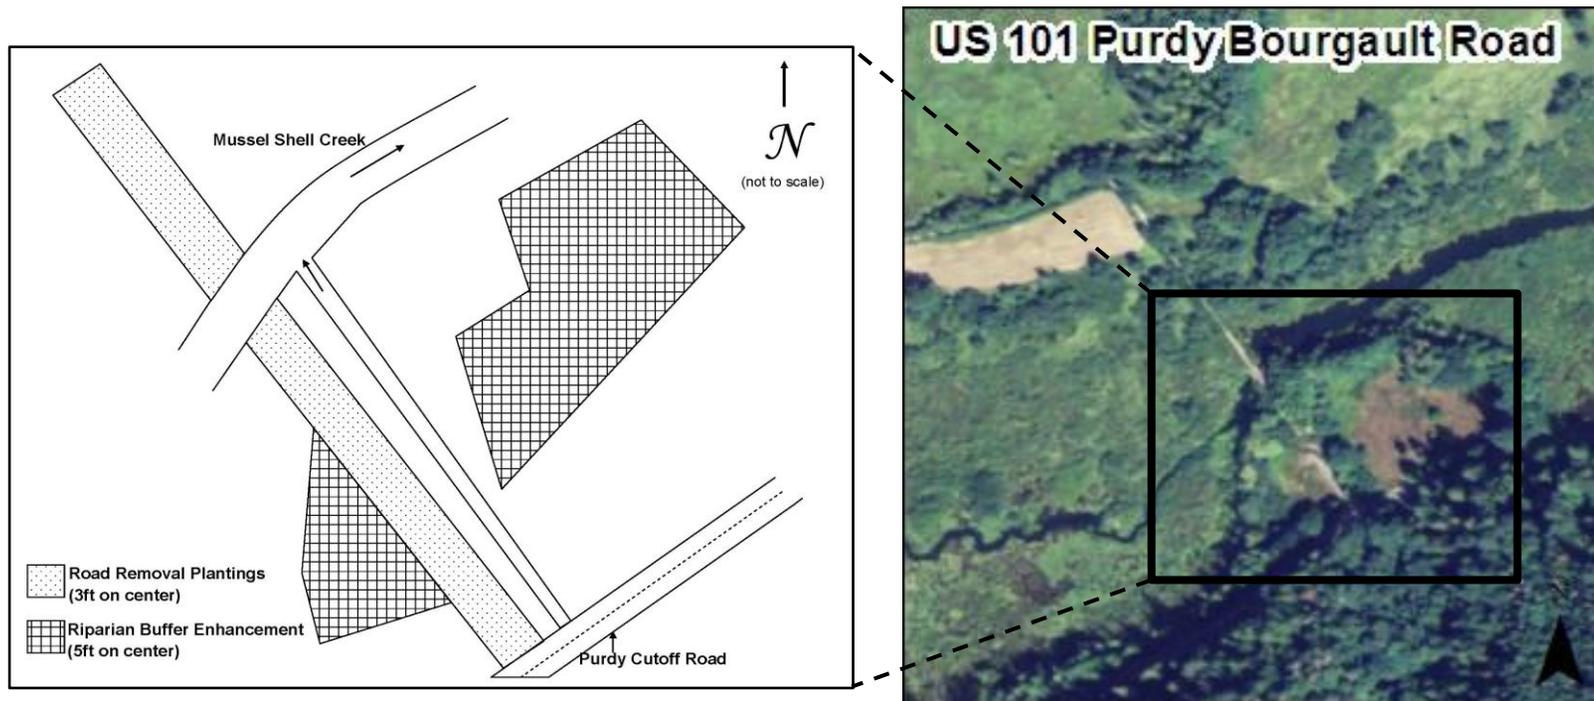
Figure 1 Site Sketch

This 0.81-acre mitigation site (Figure 1) includes 0.14 acre of wetland re-establishment and 0.67 acre of riparian/buffer enhancement. This site was created to compensate for 0.23 acre of permanent impacts due to the replacement of the bridge over Purdy Creek on United States (US) 101. The enhancement of the riparian buffer and the wetland re-establishment are intended to provide hydrologic and water quality functions, as well as wildlife habitat. The wetland re-establishment area is on the northwest side of Mussel Shell Creek within the road removal area.

The US 101 Purdy Creek Mitigation Site is out-of-kind mitigation for a bridge replacement upstream on US 101. The site consists of a section of Bourgault Road that was removed, decompacted, graded and planted; a bridge removal; and riparian buffer enhancement on the northeast and southwest sides of the site. Appendix 2 includes site directions.

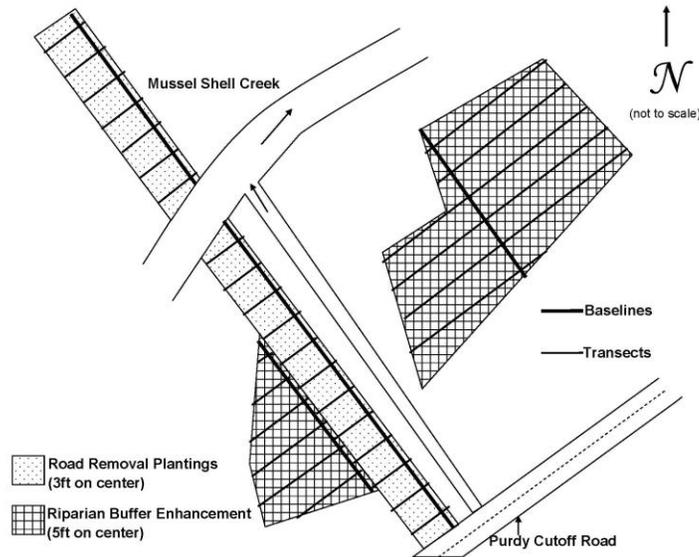
Figure 2 Site Sampling Design (2015)

Placement of Baseline: Three baselines were used for three separate pieces of the site. All baselines were placed roughly south to northwest.

Segmented Baseline: Length 128m Transects 1-14
 Length 54m Transects 15-20
 Length 37m Transects 21-24

PS 1	PS 2	PS 3
Attribute	Cover	Cover	Cover
Target pop.	Native Woody	Noxious Weeds	Invasive sp.
Zone	Entire site	Entire site	Entire site
Sample method	Line Intercept	Qualitative	Qualitative
SU length	5 meters	N/A	N/A
SU width	N/A	N/A	N/A
Points per SU	N/A	N/A	N/A
Total # of SU	32	N/A	N/A

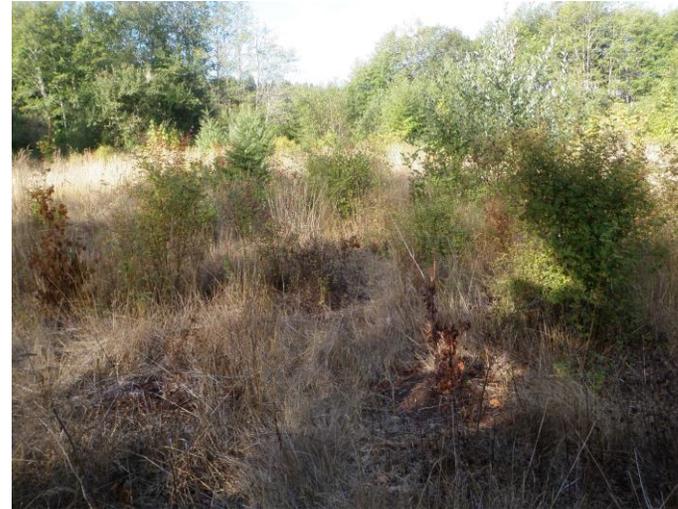
Cover in the planting areas is 41% cover (CI_{80%} = 35-47%). This result reflects only the areas in which the plantings have survived. Most of the plantings have survived the dry hot summer; however, the plantings in the southeast riparian buffer appeared the most stressed (Photo 1). The willows in the northern road removal area are thriving (Photo 2).

Photo 1
Woody cover in the southeast riparian buffer (Aug 2015)

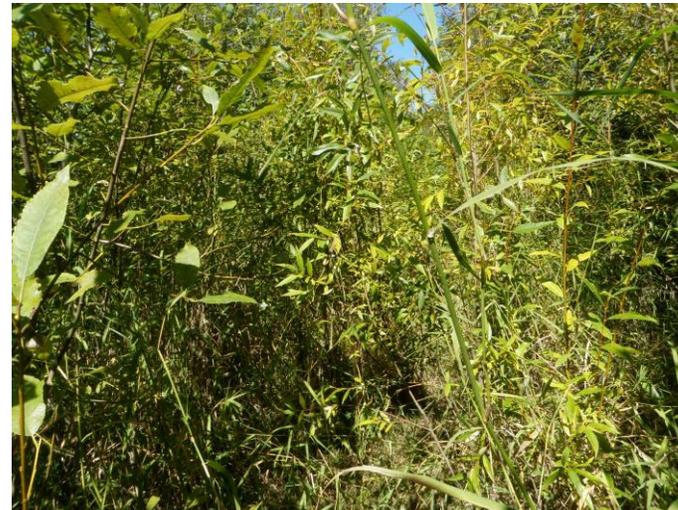
Photo 2
Woody cover in the north road removal (Aug 2015)

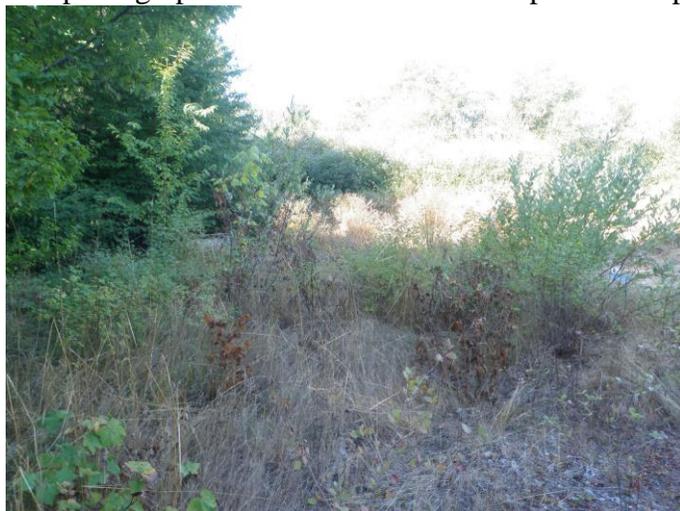
Photo Point 1a

The photographs below were taken from permanent photo-points on August 25, 2015 and document current site development.

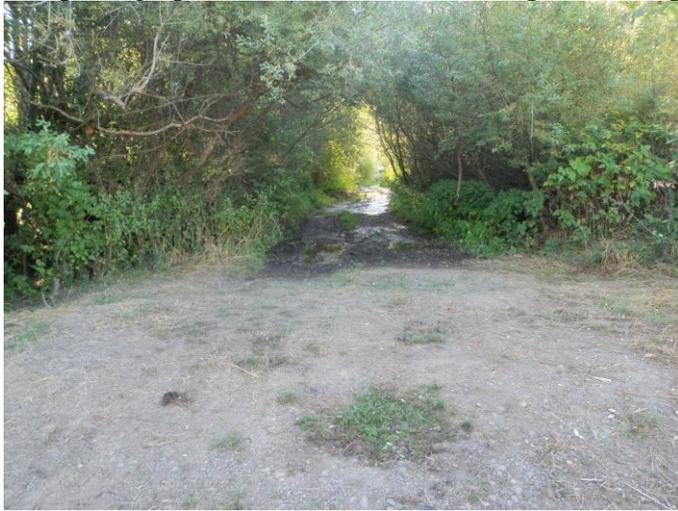
Photo Point 2b

The photographs below were taken from permanent photo-points on August 25, 2015 and document current site development.

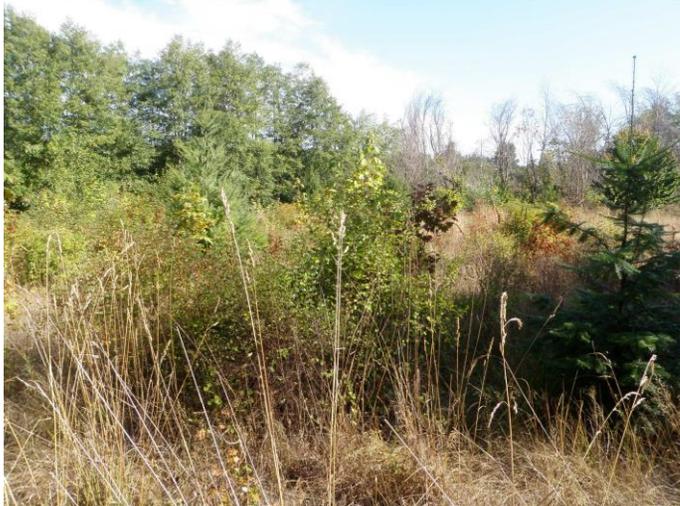
Photo Point 3d

The photographs below were taken from permanent photo-points on August 25, 2015 and document current site development.

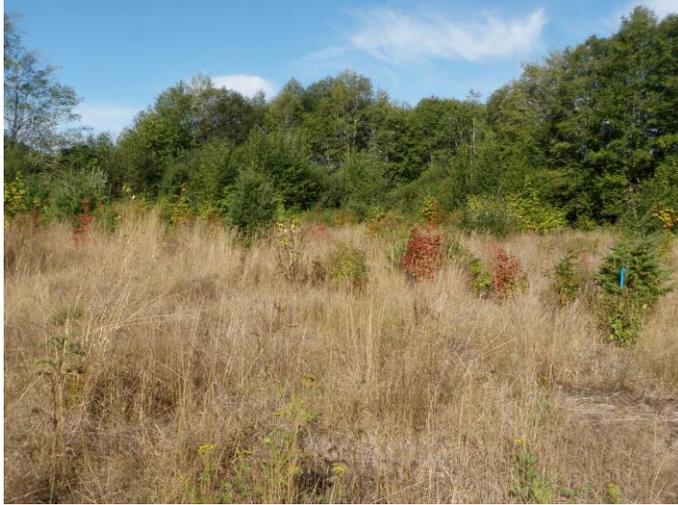
Photo Point 4b

The photographs below were taken from permanent photo-points on August 25, 2015 and document current site development.
