**US 101 Middle Nemah River Bridge Replacement MP 33.70  
to MP33.99 (Middle Nemah) Mitigation Site**

**USACE NWP (23) NWS-2012-134**

**2015 MONITORING REPORT**

**Washington State  
Department of Transportation**

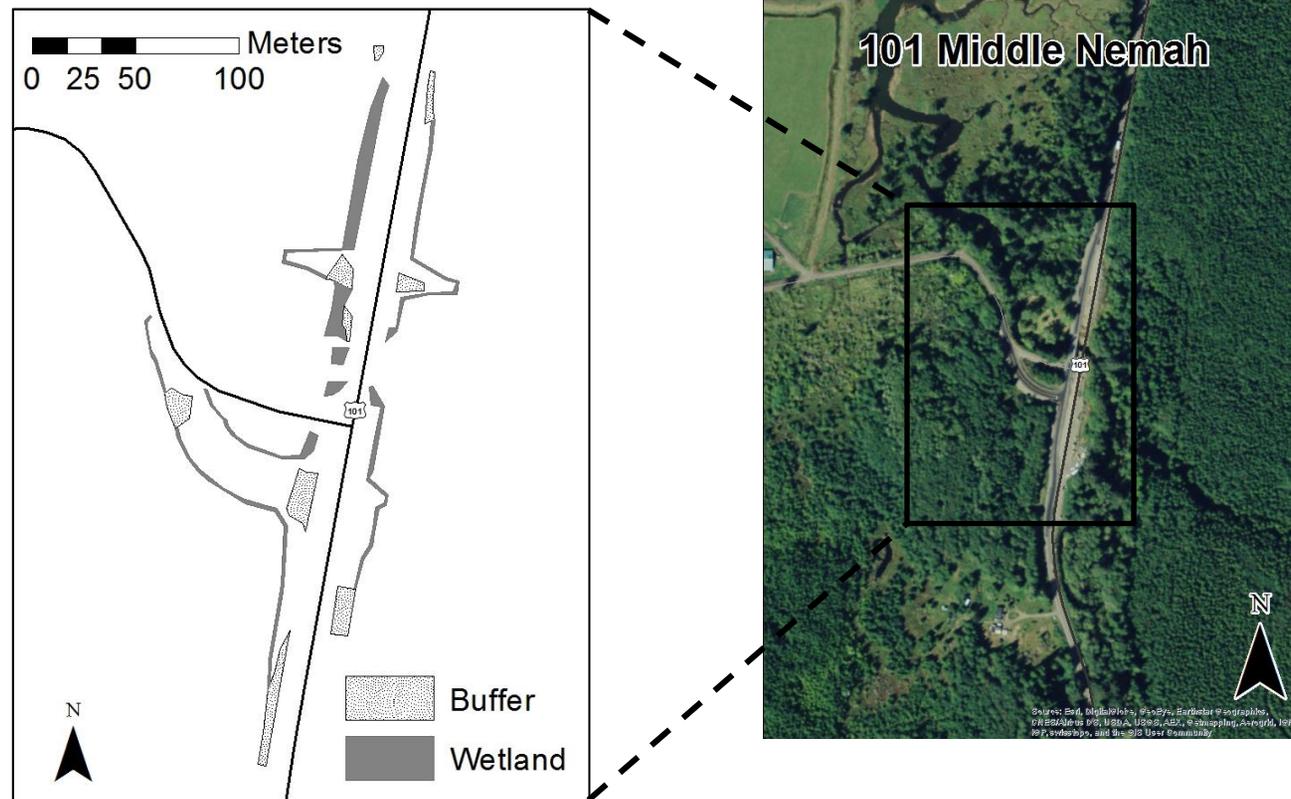
**Figure 1** Site Sketch

This mitigation site (Figure 1) is a re-established wetland and buffer, and newly established buffer area adjacent to the US 101 Middle Nemah Bridge Replacement project. This site was created to compensate for the temporary impacts to 0.37 acre of wetlands and 0.042 acre buffer, and permanent impacts to 0.25 acre buffer due to construction during the bridge replacement. The wetland and buffer areas are designed to provide mitigation for lost wetland and buffer functions including wildlife habitat, biological support, and flood flow alteration.

The US 101 Middle Nemah Mitigation Site contains several re-established wetland and buffer, and newly established buffer areas on both sides of US 101 near the Middle Nemah River Bridge. Appendix 1 includes site directions.

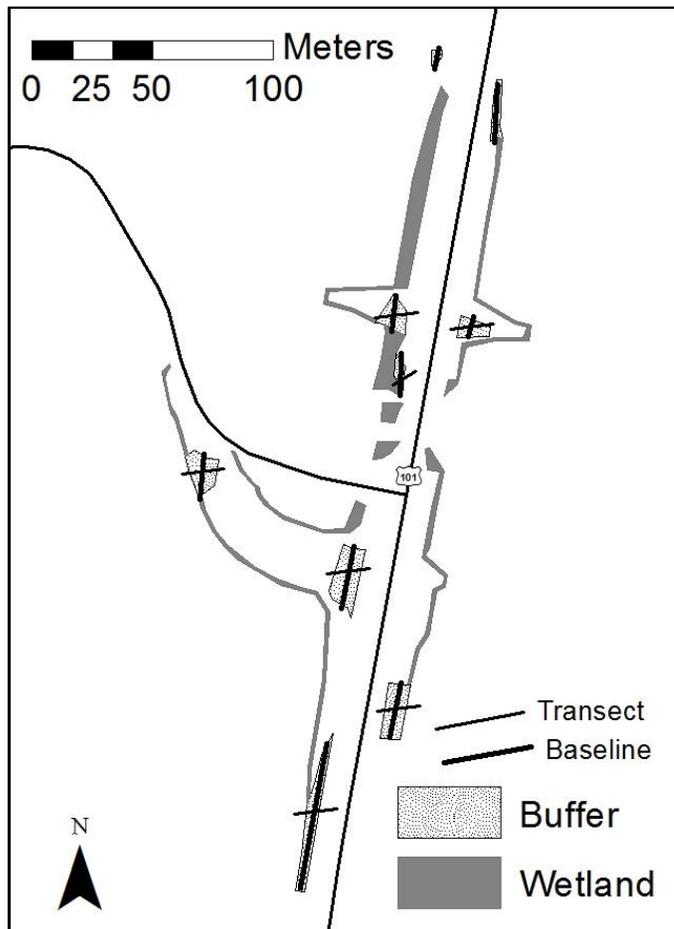
Figure 2 Site Sampling Design (2015)

**Placement of Baseline:** A segmented baseline was placed through the center of each buffer area.  
Total Length 62m, Transects 1-7

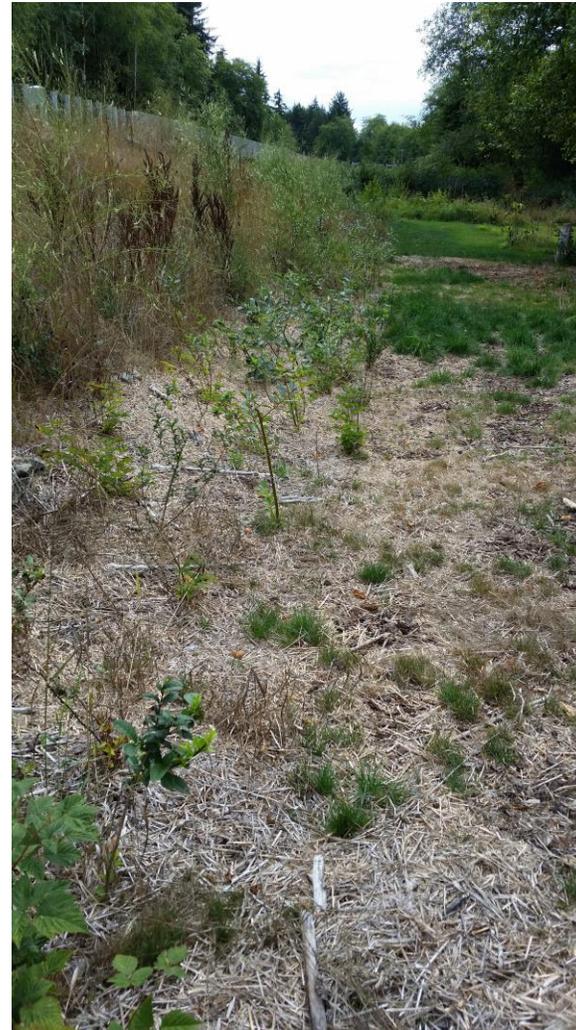
**Photo 1**  
**Survival in the restored PSS areas (August 2015)**

Survival in the restored scrub-shrub wetland areas is estimated at 91 percent. This value exceeds the performance standard target. Some areas appear to have had plants removed, and those areas were not included in this estimate. Dominant species include salmonberry (*Rubus spectabilis*), twinberry honeysuckle (*Lonicera involucrata*), and willows (*Salix* species). (Photo 1)

Routine weed control and replanting is planned for 2016. The planting that was installed to restore temporary impacts to Wetland C was removed by the property owner (Photo Points 1 and 2, Appendix 1) once the temporary construction easement was released. WSDOT has no legal control over this area or the ability to do additional replanting in Wetland C. Continued work will focus on the Buffer Mitigation Area (Appendix 1), and woody plantings in temporary impacted areas of Wetland B.

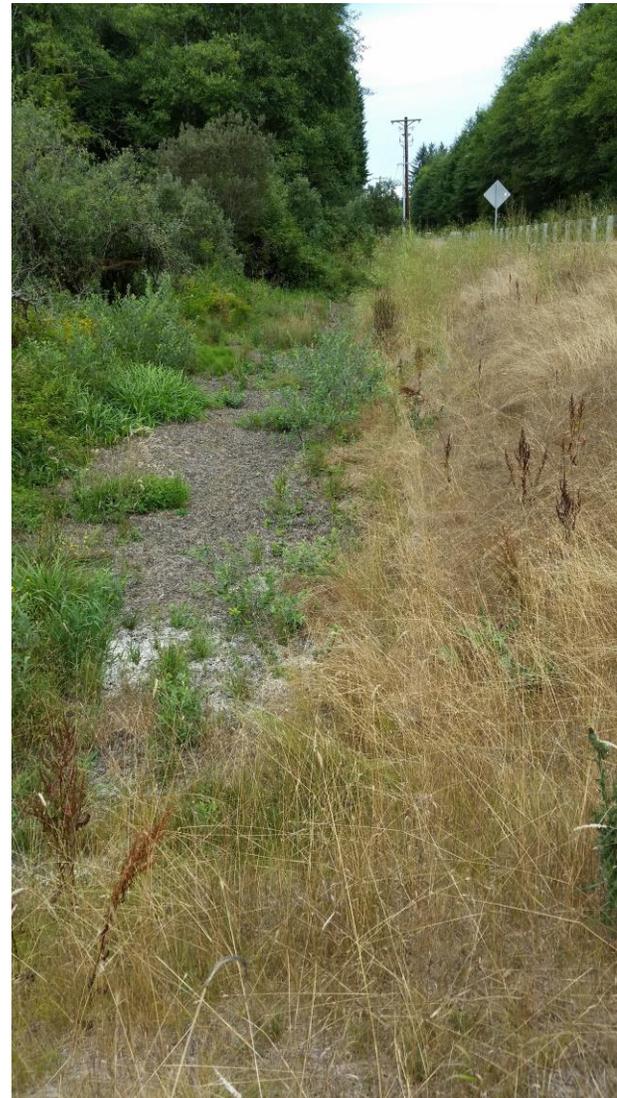
**Photo 2**  
**Survival in the buffer areas (August 2015)**

Survival in the combined buffer restoration and establishment areas is estimated at 89% (CI<sub>80%</sub> = 80-97%). This value is just below the performance standard target and does not include areas where plants appear to have been removed. Dominant species include salal (*Gaultheria shallon*) and California huckleberry (*Vaccinium ovatum*). (Photo 2)

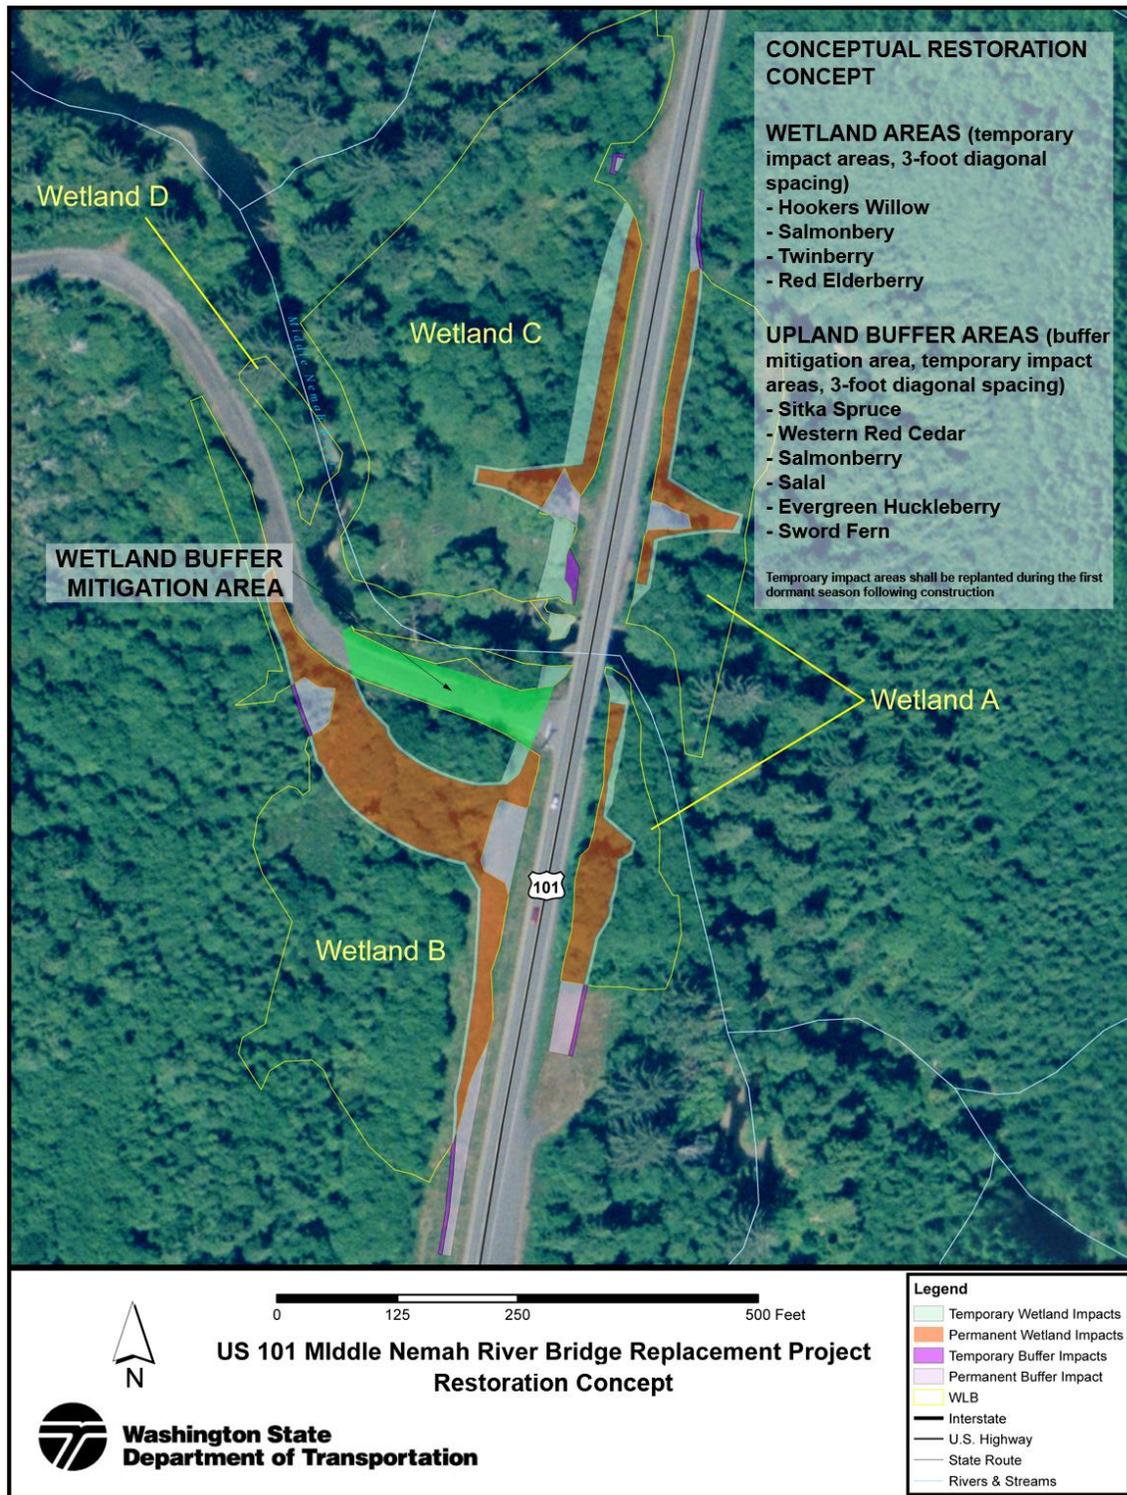
# Appendix 1 – Proposed Impact Areas

Appendix 1 shows the planting plan (WSDOT 2012).
