SR 410 Nile Valley Landslide Reconstruct Route (Nile Slide) Mitigation Site

USACE NWS-2010-511-DOT

2015 MONITORING REPORT

Issued March 2016

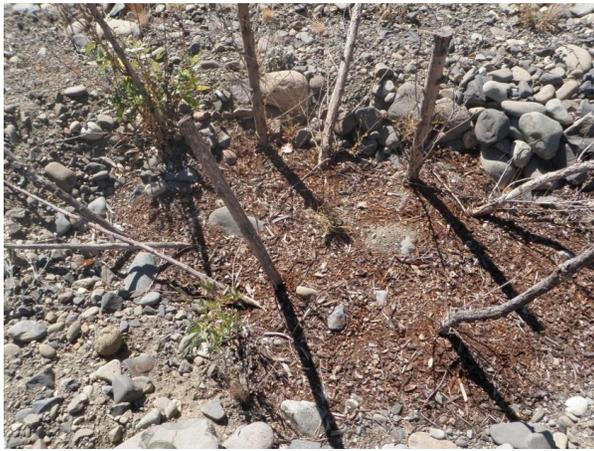
Photo 1

Black cottonwood stakes on the levee (September 2015)

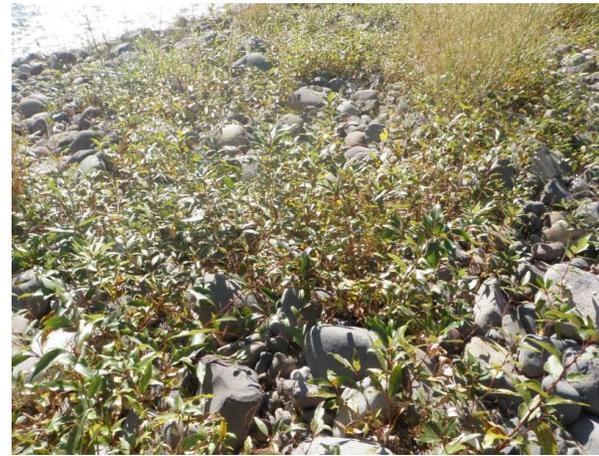
Photo 2

Now that the Naches River is closer to reaching meander equilibrium in this area, the site is beginning to establish and provide many of the intended functions across the site. Volunteer black cottonwood (*Populus balsamifera*) and sandbar willow (*Salix exigua*) have helped to increase the overall density across the site (Photo 2). The deep bore cottonwood stakes that were planted along the top of the levee have not fared well with density observed at 1 plant/100ft²(Photo 1). However, volunteer black cottonwood (*Populus balsamifera*) and sandbar willow (*Salix exigua*) are colonizing the levee from the top of the slope down to the water's edge. This area was sampled and the density, all of which are volunteers, is estimated at 22.3 plants/100ft² (CI_{80%} = 15.6-29). These volunteer plants are not included in the density estimate for the rest of the site as it was believed they will be washed away during the high waters of winter and early spring. Should it be determined that the volunteers are viable they will be counted towards the overall density of native woody species in the years to come.

Volunteer black cottonwoods (September 2015)

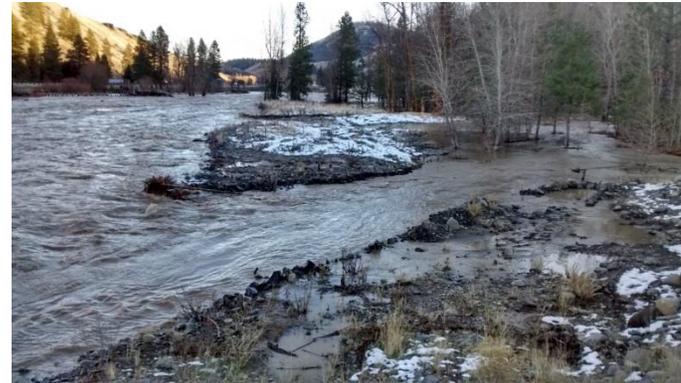
Connectivity to the floodplain has been reestablished by the breeches created in the levee (Photo 3). Invasive cover across the site is low. The backwater channel is developing wetland characteristics. Completion of the rock barbs, large woody debris structures, and flood fence was confirmed.

On December 9, 2015 the Naches River reached flows high enough to enter the breaches in the levee and access the reestablished floodplain (Photo 3) (Appendix 3).

Photo 3
Levee breach allowing flow to reconnect to the floodplain (December 2015)

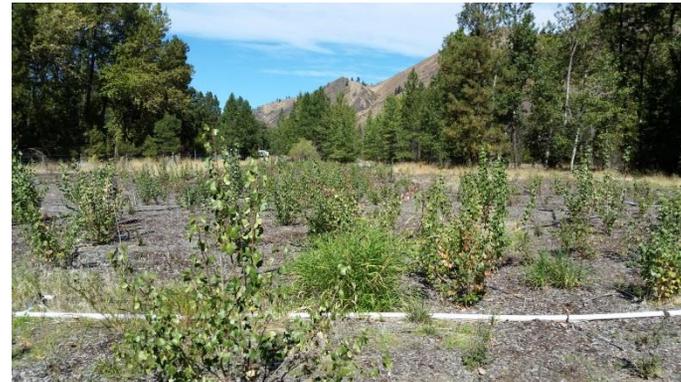
The density of native woody species across the site is estimated at 5 plants/100ft² (CI_{80%} = 4.4-5.7) (Photo 4). This does not include the levee. The dominant species include black cottonwood (*Populus balsamifera*), snowberry (*Symphoricarpos albus*), and sandbar willow (*Salix exigua*). An additional fifteen species were observed during sampling.

Photo 4
Density of woody riparian plantings (September 2015)
