**I-5 SR 432 Talley Way Interchange  
(Sandy Bend) Mitigation Site**

**USACE NWP (23) NWS-2009-444**

**2014 MONITORING REPORT**

**Wetlands Program**

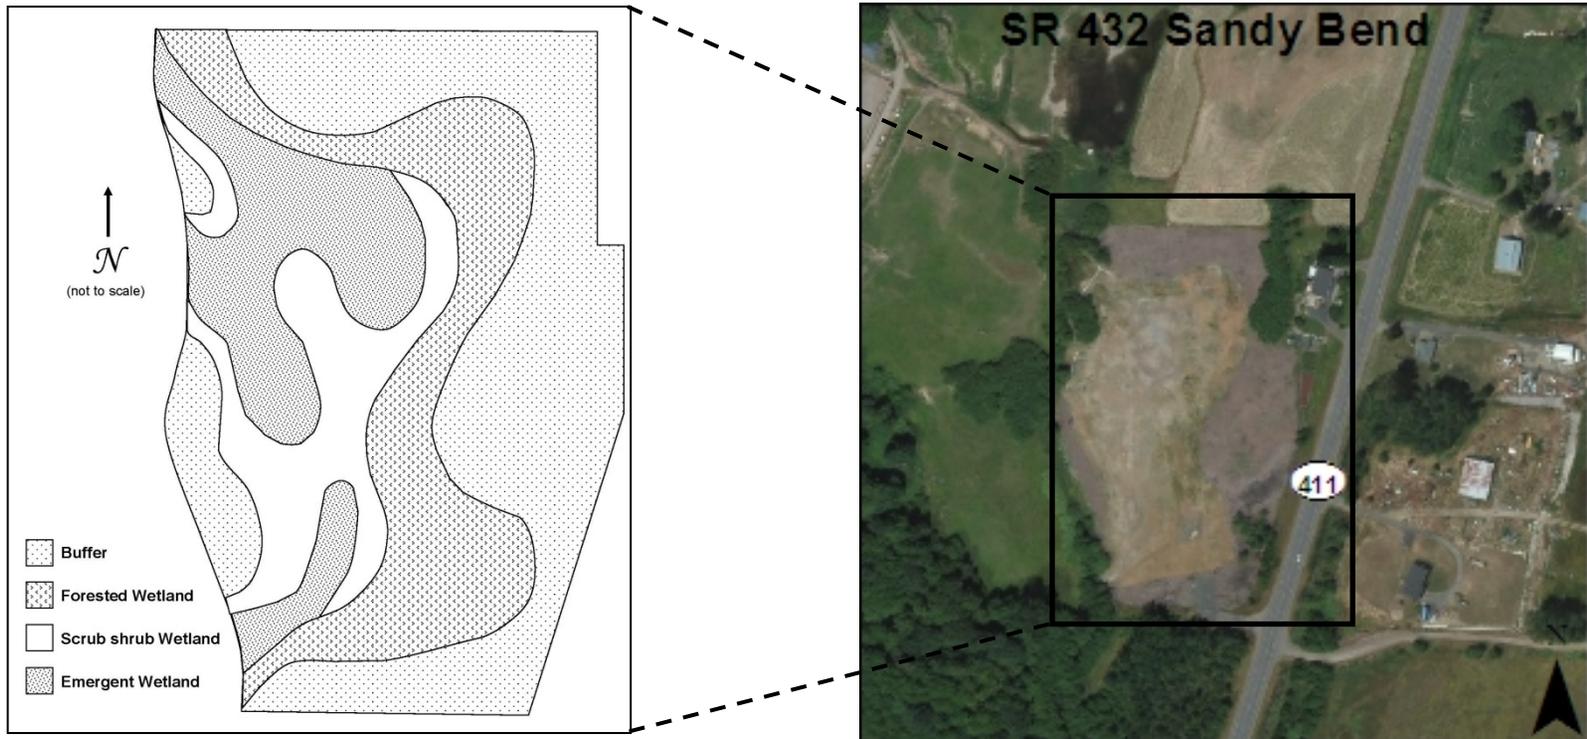
**Figure 1 Site Sketch**

The SR 432 Sandy Bend Mitigation Site connects to Sandy Bend Creek, a tributary to the Cowlitz River, on the west side of the site. Emergent, scrub-shrub, and forested wetland areas are interspersed and surrounded by an upland buffer. Appendix 2 includes site directions.

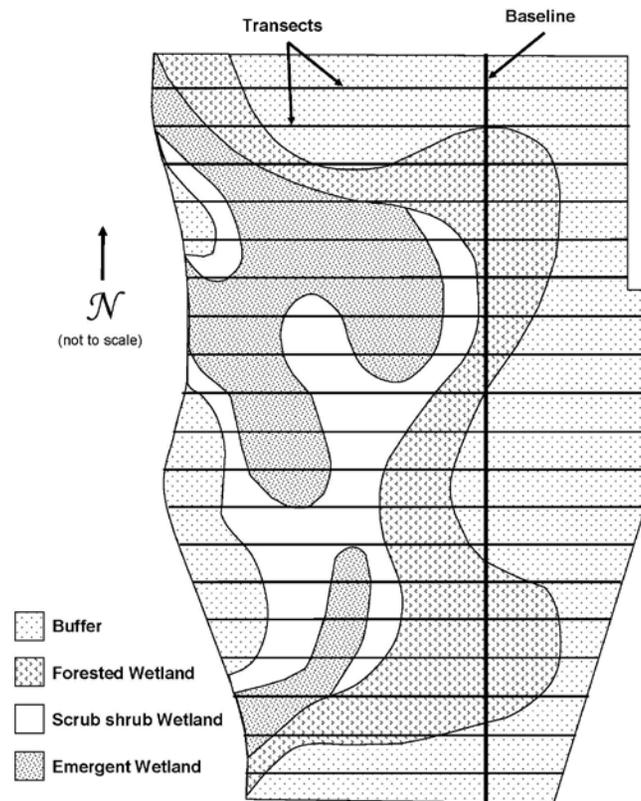
**Figure 2 Site Sampling Design (2014)**

To evaluate standards for vegetative density and cover, a 240-meter baseline was established north-south through the middle of the site (Figure 2). Twenty-four sampling transects were placed perpendicular to the baseline using a systematic random sampling method. The point-line method was used to determine the cover of noxious weeds across the site (Performance Standards 12 and 13) and the cover of herbaceous vegetation in the emergent area (Performance Standards 10 and 11). Twenty-three 50-meter-long point-line sample units (100 points each) were randomly positioned along the transects across the site to sample for noxious weeds. Twenty-five 10-meter-long point-line sample units (20 points each) were randomly positioned along the transects in the emergent area to sample for herbaceous vegetation. The unequal-area belt transect method was used to determine the density of native woody species in the forested wetland (Performance Standards 2, 3, and 4), scrub-shrub wetland (Performance Standards 5 and 6), and buffer (Performance Standards 7, 8, and 9). One-meter-wide belt transect sample units were positioned along the entire length of the transects in each of these zones.

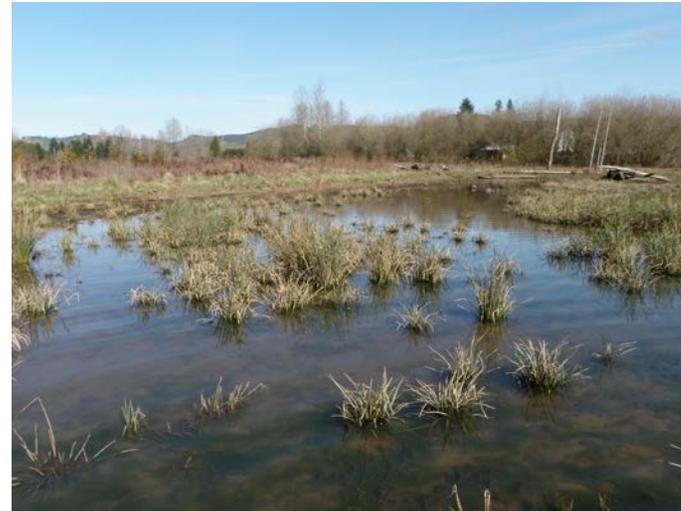
**Photo 1**  
**Inundation in the wetland (March 2014)**

Three hydrology monitoring visits were conducted in 2014 on March 11, April 2, and April 15. During each of these visits most of the emergent wetland and scrub-shrub wetland were inundated or saturated to the soil surface (Photo 1). During the first visit, four shallow groundwater monitoring wells were installed. The wells were placed in more questionable areas near the intended wetland boundary; one in the scrub-shrub wetland and three in the forested wetland (Appendix 1). During the first visit, only one well reading indicated water within 12 inches of the soil surface. These readings, however, were taken only about five to 10 minutes after well installation and are, therefore, likely not accurate due to inadequate time for equilibration of the water level within the well. During the second visit, three out of four wells registered water within 12 inches of the soil surface. During the third visit, all of the well readings were below 12 inches (Appendix 3, Table 1).

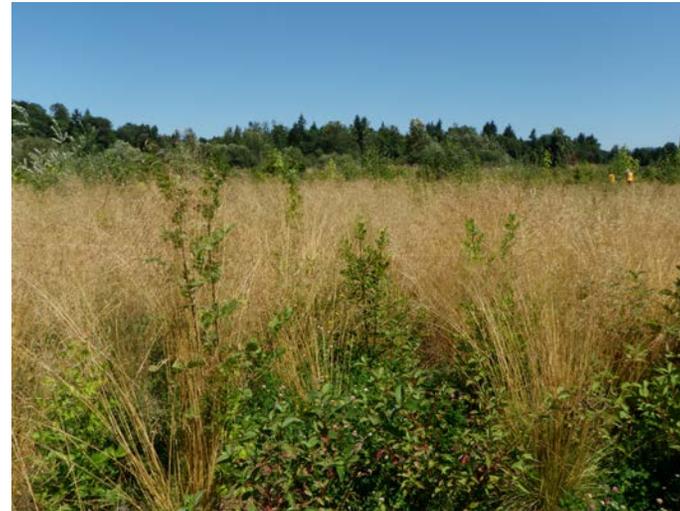
**Photo 2**  
**Woody density in the forested wetland (July 2014)**

The density of native tree species in the forested wetland (Photo 2) is estimated at 2,758 trees/acre ( $CI_{80\%} = 2,166-3,350$ ). This includes Pacific crabapple (*Malus fusca*), which is generally considered a small tree species, but can also develop as a shrub. Without Pacific crabapple, the density is estimated at 1,297 trees/acre ( $CI_{80\%} = 1,000-1,594$ ) and Oregon ash (*Fraxinus latifolia*) is easily the dominant species, with some red alder (*Alnus rubra*) mixed in.

The density of native shrubs species in the forested wetland (Photo 2) is estimated at 2,260 shrubs/acre ( $CI_{80\%} = 1,978-2,542$ ). If Pacific crabapple were included as a shrub species, the estimate would be 3,720 shrubs/acre ( $CI_{80\%} = 3,108-4,333$ ). This performance standard is not being met without Pacific crabapple and is possibly being met with it. Either way, the overall native woody density in the forested wetland is 5,018 plants/acre ( $CI_{80\%} = 4,303-5,733$ ), which means the true value is likely equal to or above the total density target of Performance Standards 1 and 2 added together.

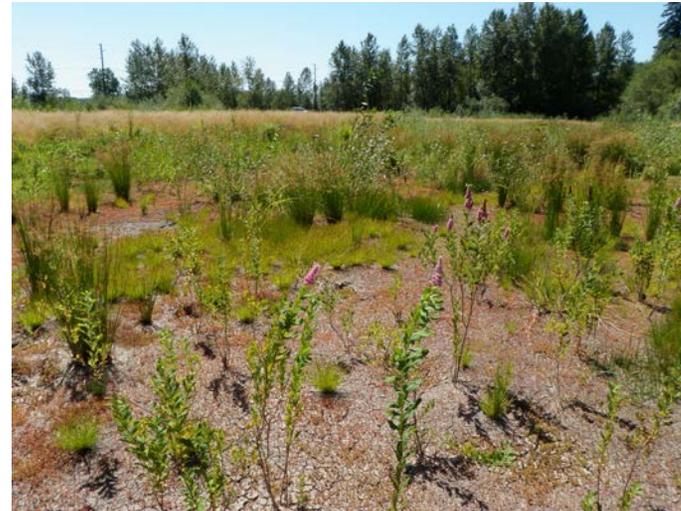
**Photo 3**  
**Woody density in the scrub-shrub wetland (July 2014)**

The density of native shrub species in the scrub-shrub wetland (Photo 3) is estimated at 4,231 shrubs/acre ( $CI_{80\%} = 3,697-4,764$ ). This about equals the performance standard target. The total native woody density in this zone, including tree species, is estimated at 4,833 plants/acre ( $CI_{80\%} = 4,086-5,581$ ).

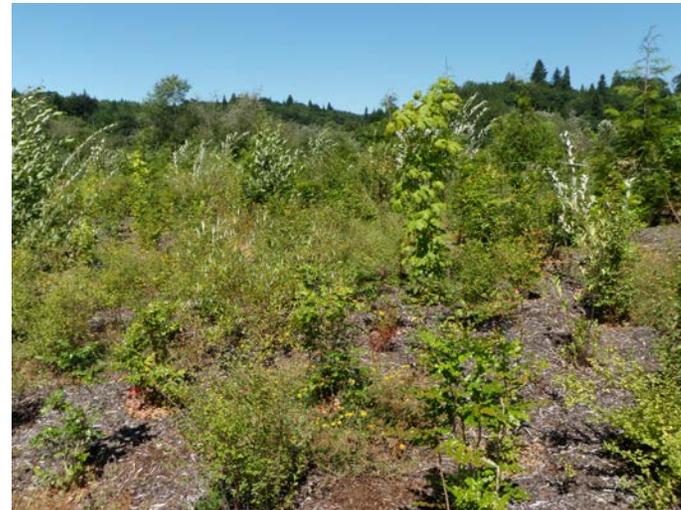
**Photo 4**  
**Woody density in the buffer (July 2014)**

The density of native tree species in the buffer (Photo 4) is estimated at 815 trees/acre ( $CI_{80\%} = 485-1,144$ ). The dominant tree species in this zone is red alder (*Alnus rubra*).

The density of native shrub species in the buffer (Photo 4) is estimated at 4,910 shrubs/acre ( $CI_{80\%} = 4,561-5,260$ ). The dominant shrub species in this zone are tall oregongrape (*Mahonia aquifolium*) and snowberry (*Symphoricarpos albus*).

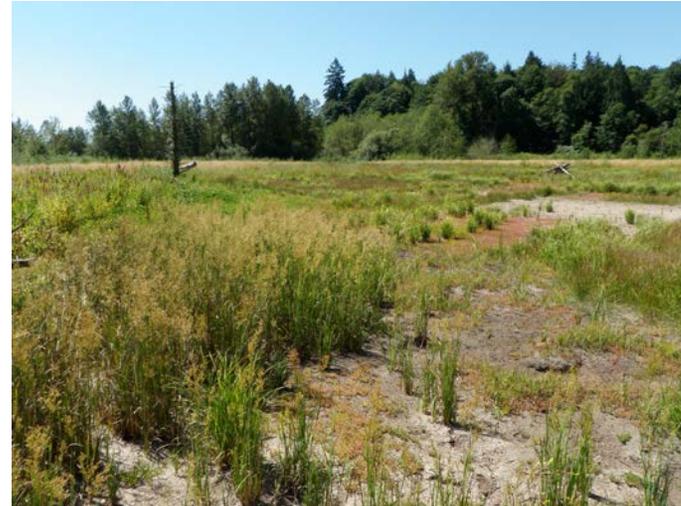
**Photo 5**  
**Herbaceous cover in the emergent wetland (July 2014)**

The cover of native herbaceous facultative wet or wetter species in the emergent wetland (Photo 5) is estimated at 49% ( $CI_{80\%} = 43-56\%$ ), about equal to the performance standard target.

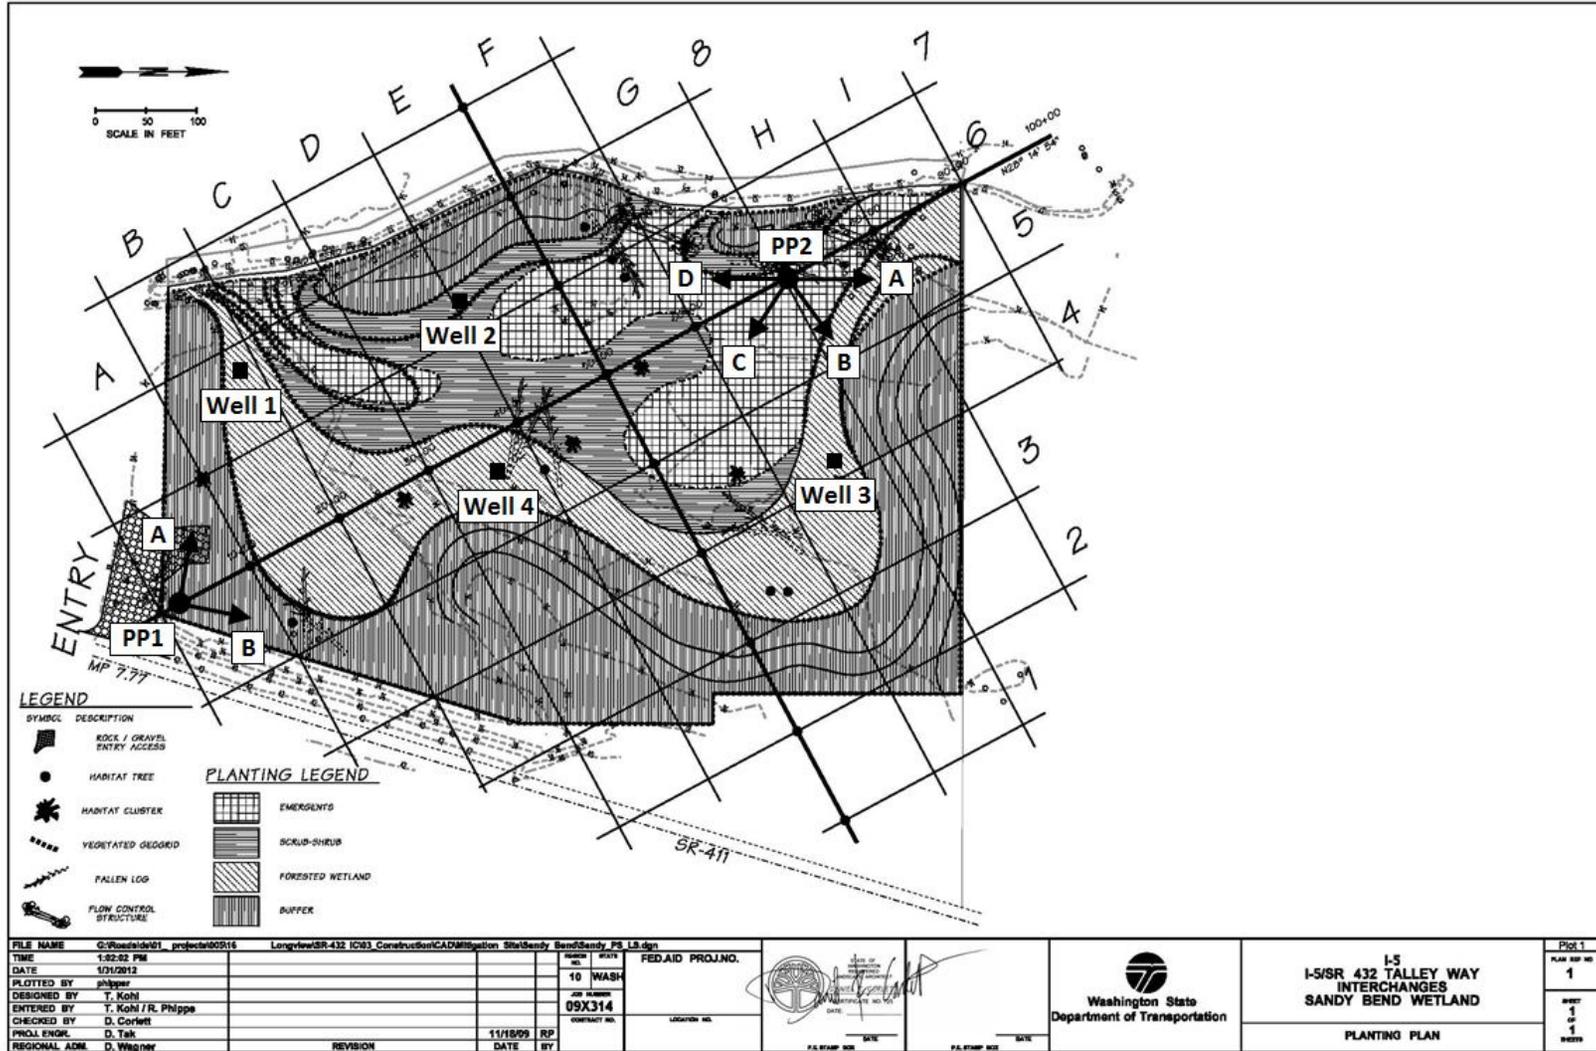
# Appendix 1 – As-built Planting Plan with Photo Point and Hydrology Well Locations

Appendix 1 shows the as-built planting plan (WSDOT 2012).
