SR 520 Program 84th On-ramp update

SR 520 84th Ave on-ramp update
Medina City Council
Medina City Hall
March 10, 2014

Dave Becher
SR 520 Floating Bridge and Landings Project,
Project Director

84th Avenue Northeast on-ramp emergency repair work

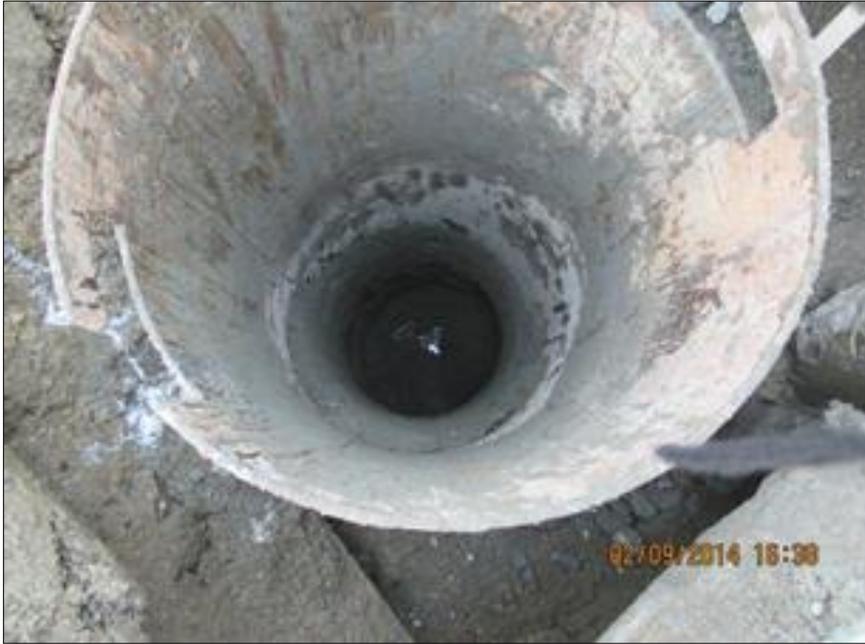
Feb. 9: Stormwater pipe damaged

View into casing at stormwater pipe location

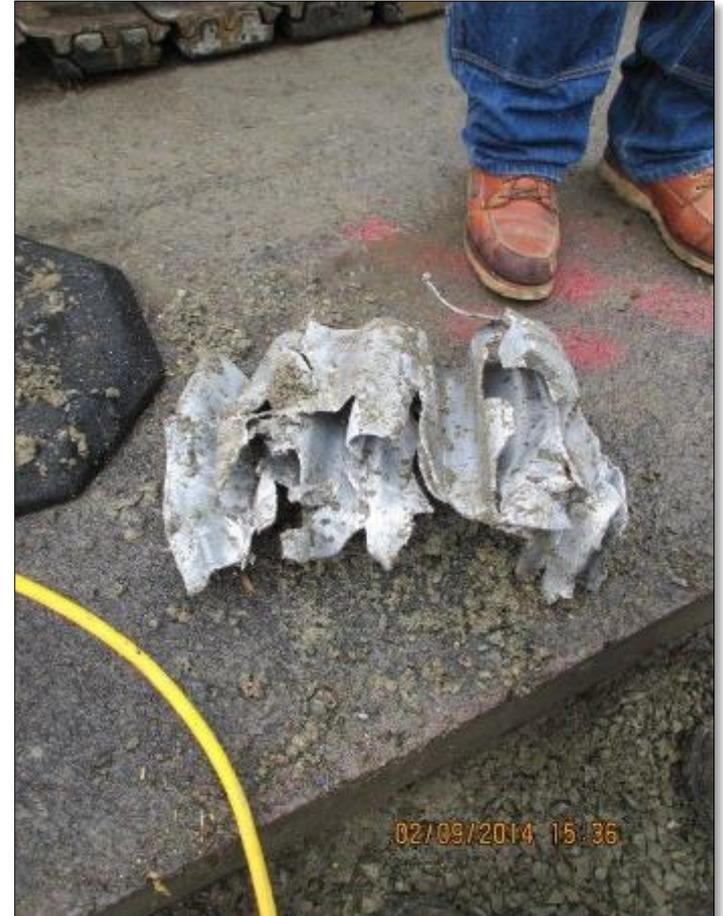
Section of stormwater pipe retrieved during drilling

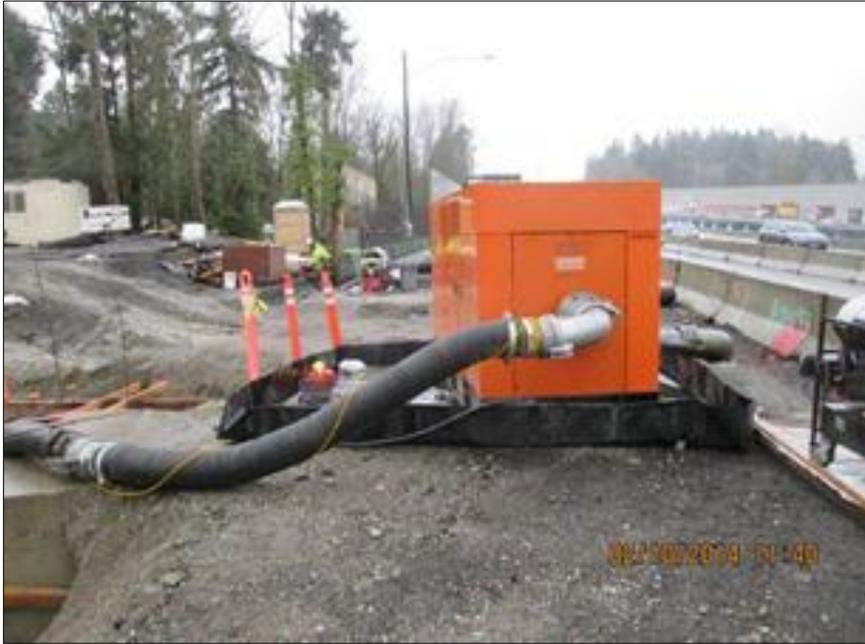
Pump unit for rerouting stormwater

Feb. 10: Pump installed to re-route stormwater

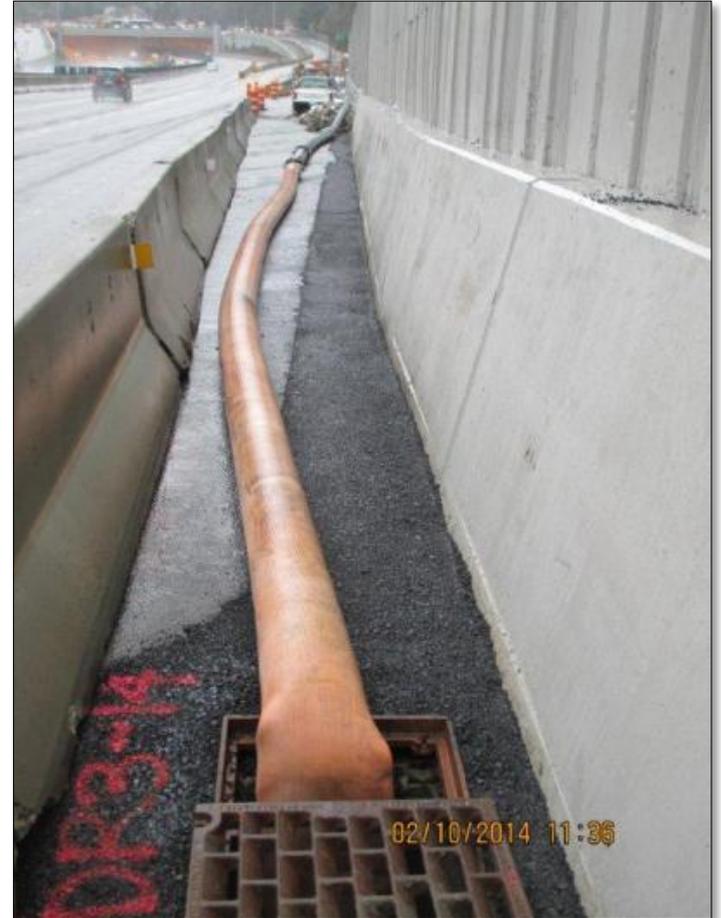
Hose conveying stormwater to separate drainage system

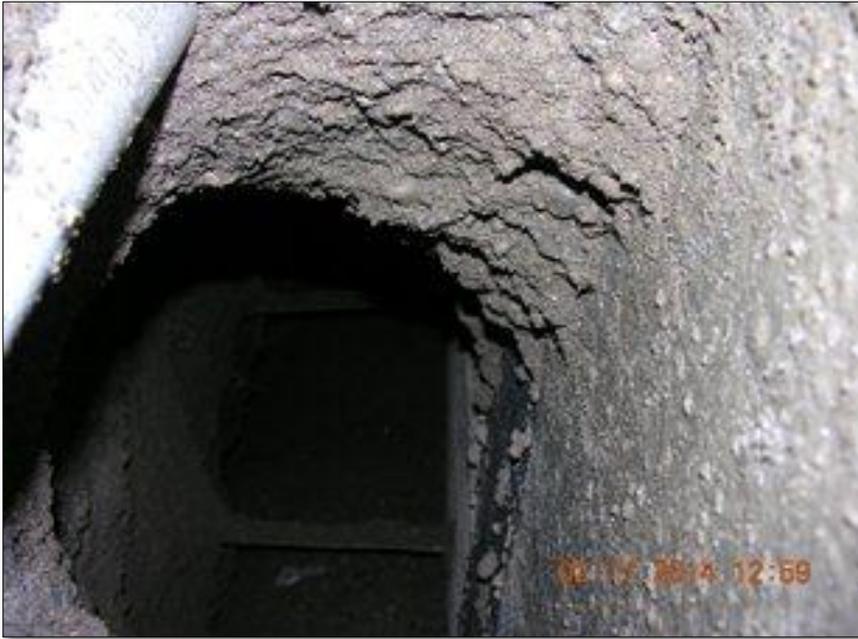
Feb. 17: Subsidence observed under ramp, left lane closed

Void under 84th Avenue NE on-ramp

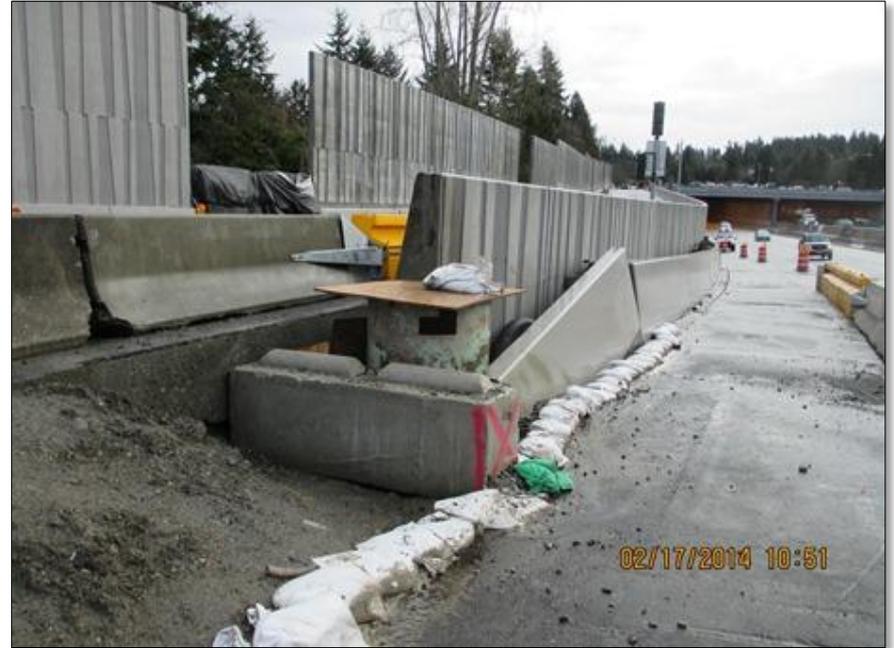
Soil subsidence under on-ramp caused a barrier to shift

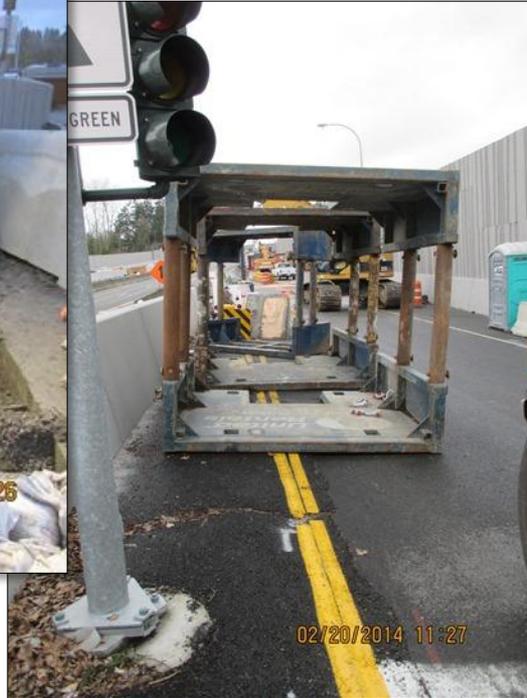
Shoring box prior to installation

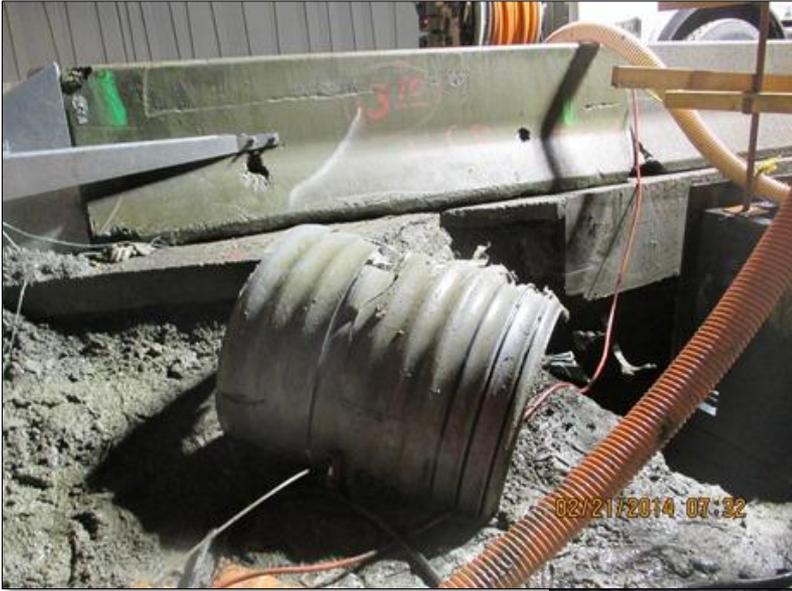
Damaged section of stormwater pipe

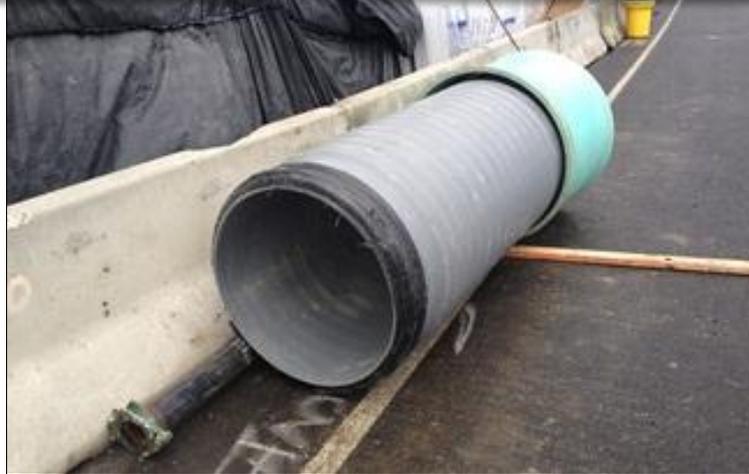
New section of pipe awaiting installation

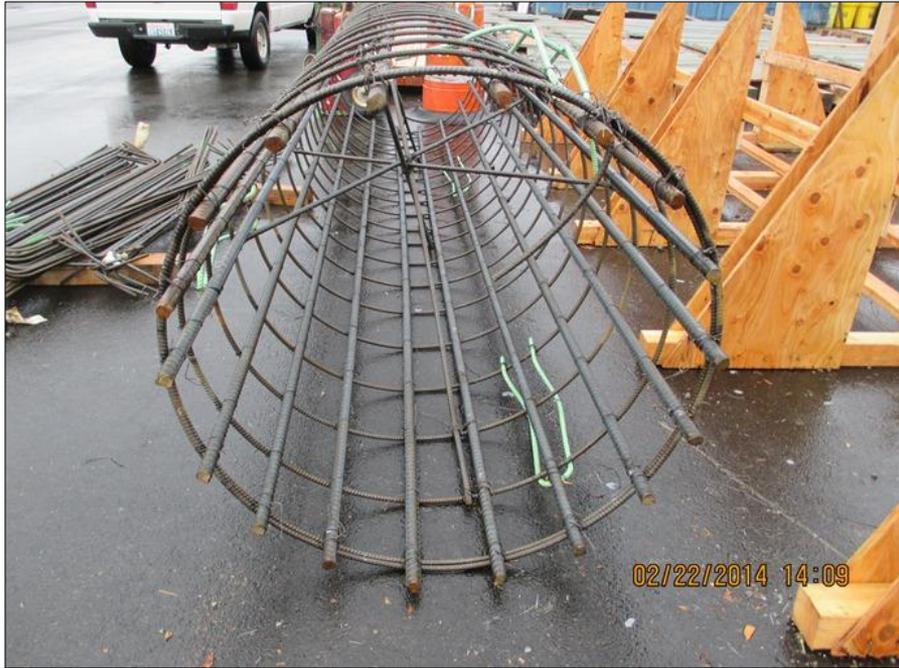
Rebar cage for foundation construction

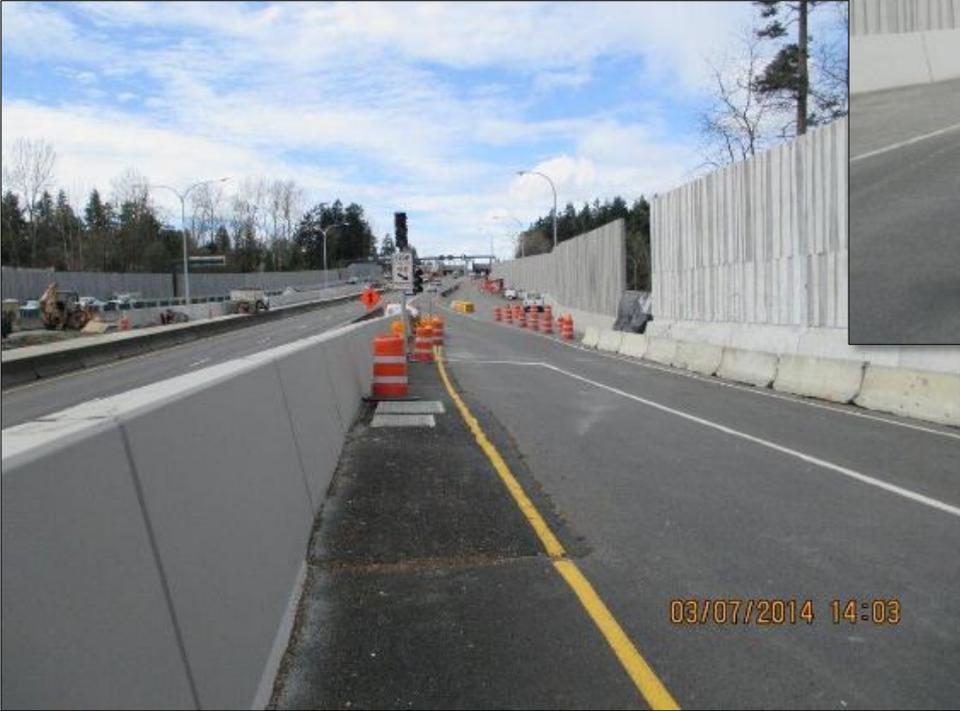
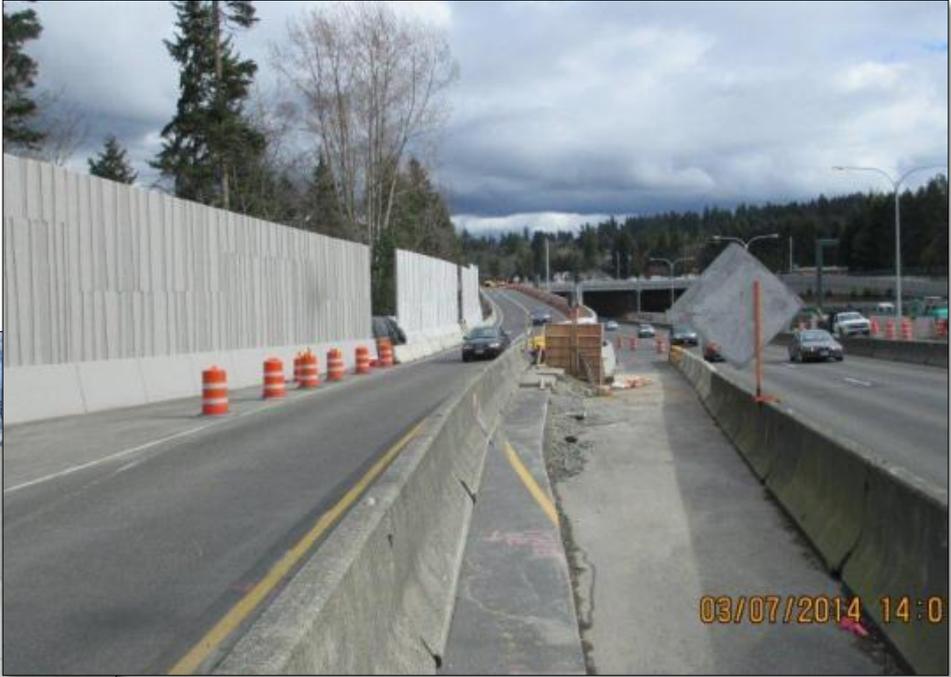
Current configuration

Both lanes are now open; final construction activities will take place during scheduled westbound SR 520 closures
