**SR 522: Snohomish River Bridge to US 2 Phase 1: SR  
522/US 2 Interchange Vicinity (Al Borlin Park & French  
Creek Tributary) Mitigation Sites**

**2014 MONITORING REPORT**

# SR 522 Al Borlin Park & French Creek Tributary Mitigation Sites

## USACE NWP (14) NWS-2010-31

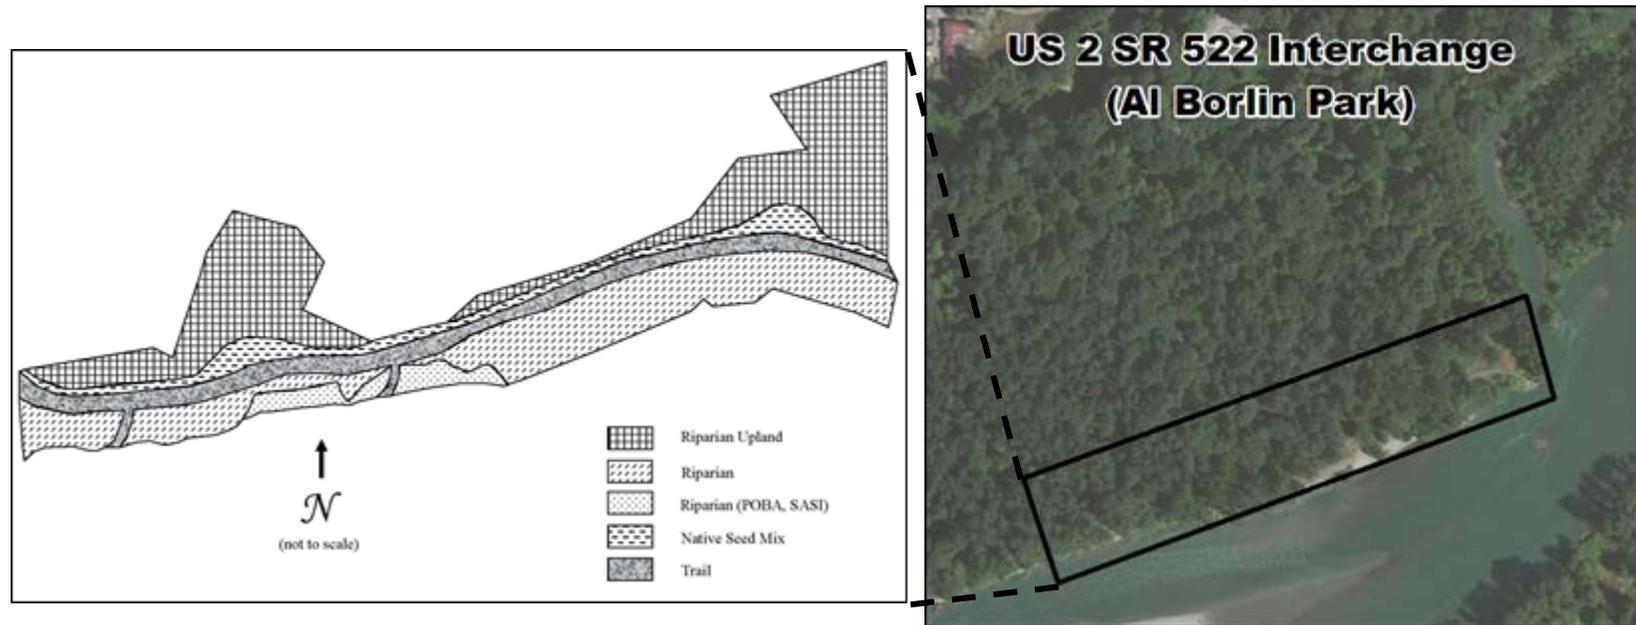
**Figure 1 Site Sketch**

Mitigation for the impacts associated with this project is provided in two locations. The 0.92 acre off-site mitigation area is located within Al Borlin Park along the Skykomish River. The 90-acre park is on a peninsula formed by the Skykomish River and Woods Creek. It is a natural park that is thickly wooded and crisscrossed with a network of trails. The portion of the park used for mitigation was primarily unvegetated or vegetated by non-native blackberries. Mitigation activities in this area included clearing non-native vegetation, soil amendments, native shrub and tree plantings along and above the bank of the Skykomish River, and stabilizing the bank using tree top revetments.

The US 2/SR 522 Interchange (Al Borlin Park) Mitigation Site consists of several types of vegetation communities. These communities include wet riparian shrub species closer to the river, upland riparian buffer areas as the topography changes as well as a native seed mix to fill in the bare ground areas. Under plantings in areas with existing vegetation also create multiple strata while inhibiting weed growth. Appendix 2 includes site directions.

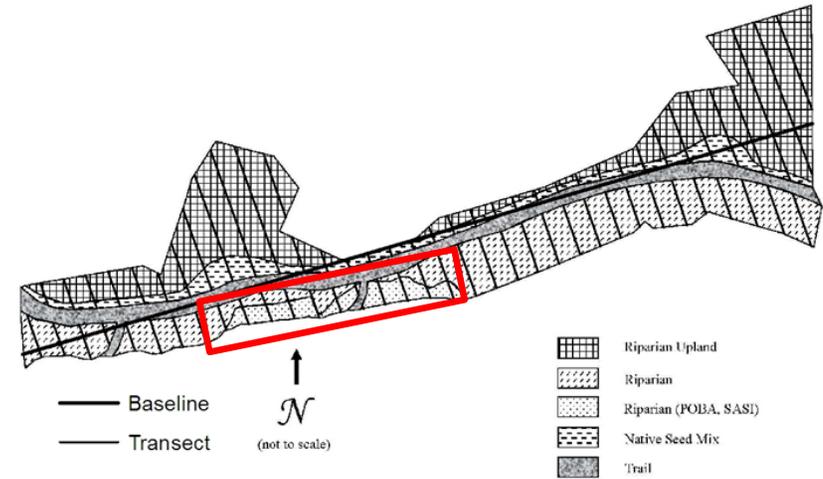
**Figure 2 Al Borlin Park Sampling Design (2014)**

To evaluate native woody density (Performance Standard 1) at the Al Borlin Park site, a 187-meter baseline was established parallel to the Skykomish River (Figure 2). Nineteen one-meter-wide unequal-area belt transects were placed perpendicular to the baseline using a systematic random sample design. The area in the red box in Figure 2 was not sampled for density due to previous vandalism and the subsequent decision not to replace the treetop revetment or replant in this area. Visual observations were used to assess the presence, and estimate the cover, of targeted non-native, invasive species (Performance Standards 2 and 3). Photos were used to document the presence and condition of the tree-top revetment (Performance Standard 4).

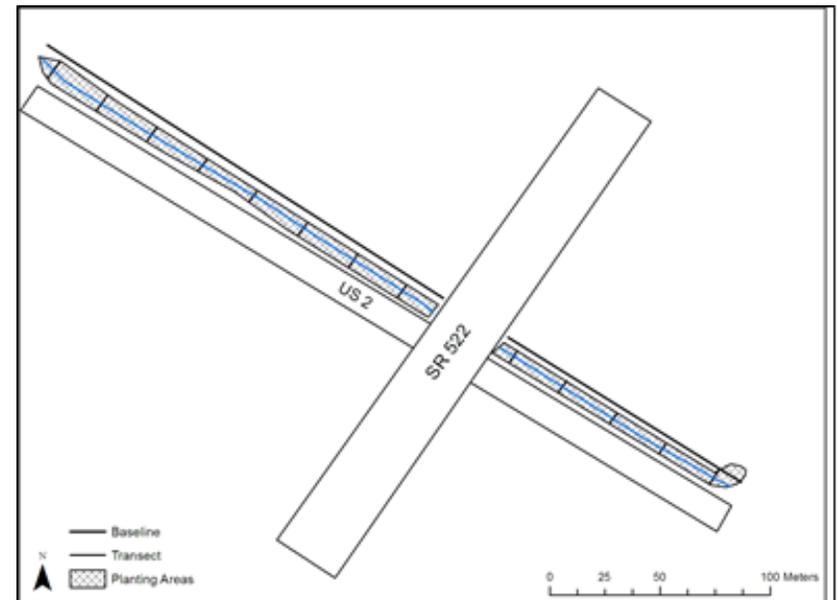
**Figure 3 French Creek Tributary Sampling Design (2014)**

To evaluate vegetative performance standards at the French Creek Tributary site, a 303-meter baseline was established parallel to French Creek Tributary (Figure 3). Twenty transects were placed perpendicular to the baseline using a systematic random sample design. One-meter-wide unequal-area belt transects were used to estimate the density of native woody species (Performance Standard 1). The point-line method was used to estimate the cover of targeted non-native, invasive species (Performance Standard 2). Twenty-three 10-meter-long point-line sample units (20 points per sample unit) were randomly positioned along the transects. Visual observations were used to assess the presence of purple loosestrife and Japanese knotweed (Performance Standard 3) and to assess the condition of the stream channel (Performance Standard 5).

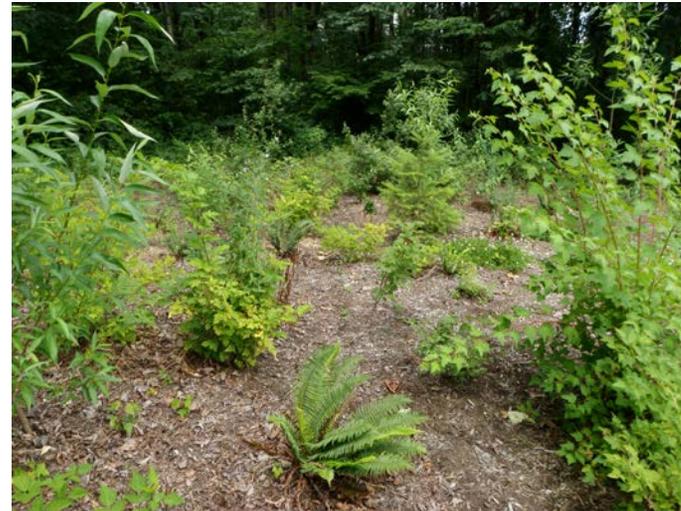
The density of native woody species in the sampled area of the Al Borlin Park site (Photo 1) is estimated at 11 plants per 100 square feet (CI<sub>80%</sub> = 10-12). The dominant woody species on this site are salmonberry (*Rubus spectabilis*), snowberry (*Symphoricarpos albus*), and cluster rose (*Rosa pisocarpa*).

**Photo 1**  
**Woody density at the Al Borlin Park site (July 2014)**

Mitigation area maintenance at Al Borlin Park will continue for 2 more years. Maintenance will focus on weed control within the newly planted areas. Blackberry and Japanese Knotweed are expected to require aggressive control. Due to the success of the planting, additional planting is not likely to be needed.

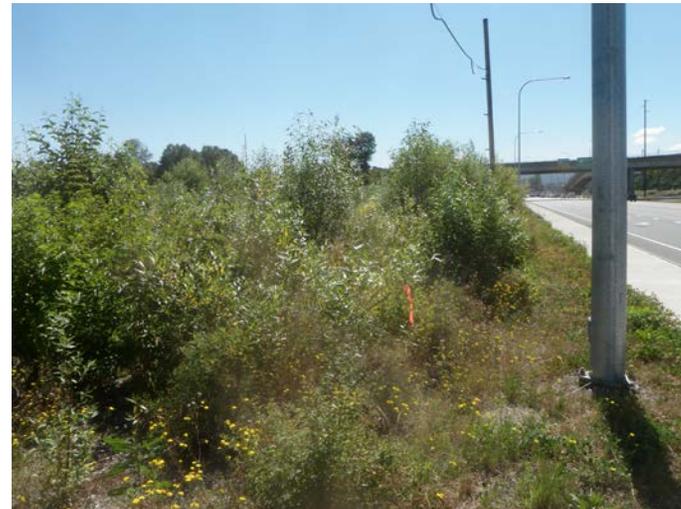
The density of native woody species at the French Creek Tributary site (Photo 2) is estimated at 5.9 plants per 100 square feet (CI<sub>80%</sub> = 5.4-6.5). The dominant woody species on this site are western serviceberry (*Amelanchier alnifolia*), snowberry (*Symphoricarpos albus*), Scouler's willow (*Salix scouleriana*), and Pacific willow (*Salix lasiandra*).

**Photo 2**  
**Woody density at the French Creek Tributary site (July 2014)**

French Creek will continue to receive weed control for 2 more years. A major focus will be to control reed canarygrass at the stream, and blackberry in the buffer areas. This control will occur during the active growing season. Additional planting is not expected due to the successful coverage of the planted areas.

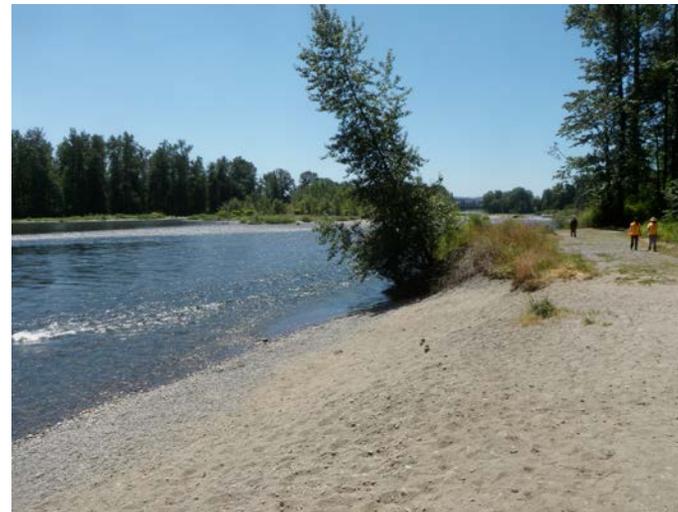
The tree top revetment is no longer present and all the willow stakes have been removed (Photo 3). WSDOT met with the City of Monroe in February 2013, and the City agreed that the revetment and live stakes are not compatible with the recreational use of the area. These features will not be replaced.

**Photo 3**  
**Tree top revetment area (July 2014)**

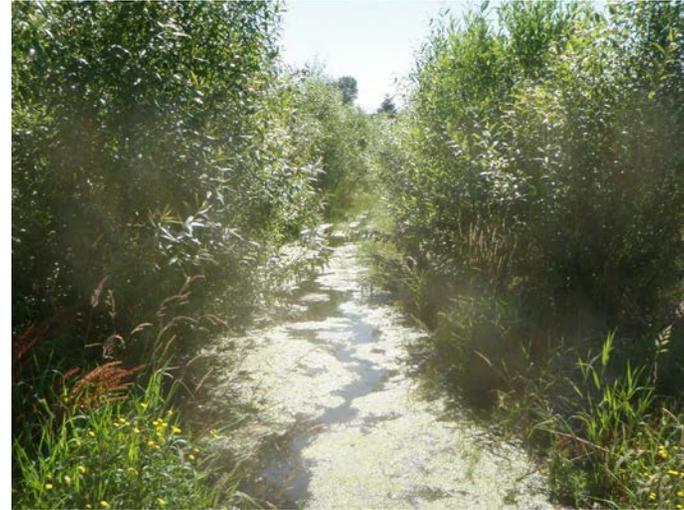
**Photo Point 6**

During monitoring, the creek channel at the French Creek Tributary site was inspected and the banks were found to be stable and densely vegetated in the planted areas of the site (Appendix 2, Photo Point 6). No signs of significant headcutting, avulsion, or subsurface seepage were observed.
