**SR 161 234th Street to 176th Street East (Graham Hill)
Mitigation Site**

Ecology Order DE 03SEAHQ-5832

2015 MONITORING REPORT

WETLAND DELINEATION REPORT

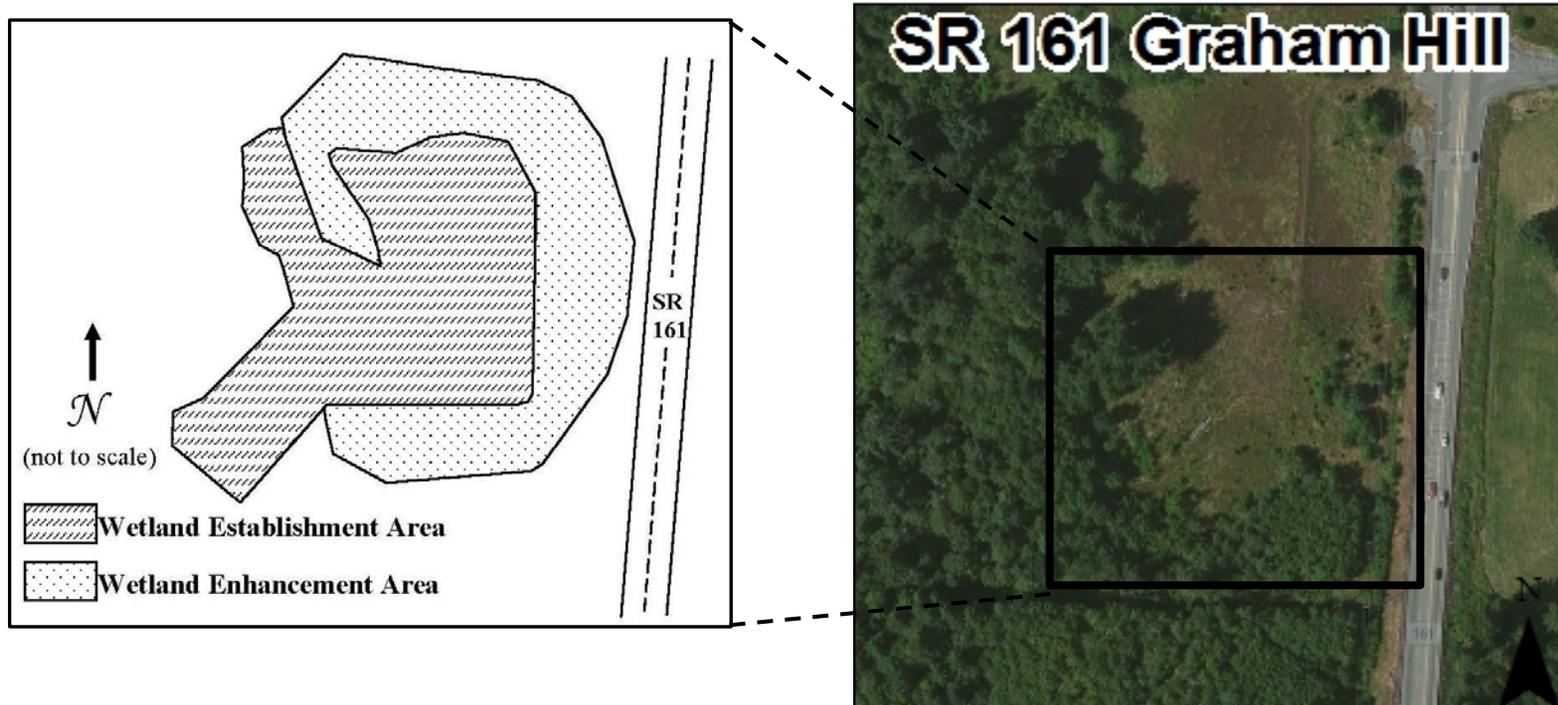
Figure 1 Site Sketch

The SR 161 Graham Hill Mitigation Site includes a sloped and forested wetland establishment area surrounded by wetland enhancement. Existing wetlands border the site to the north and west. Appendix 2 contains driving directions.

This 8.93 acre WSDOT property (Figure 1) contains 1.3 acres of mitigation to compensate for impacts to 0.55 acre of isolated wetlands due to road widening along SR 161. The mitigation site is located south of Graham, and at the southern end of the road project. Connected to a larger wetland complex and situated on a slight slope, the site combines forested wetland establishment and wetland enhancement. The site provides mitigation for lost wetland functions including wildlife habitat, groundwater recharge, and water quality.

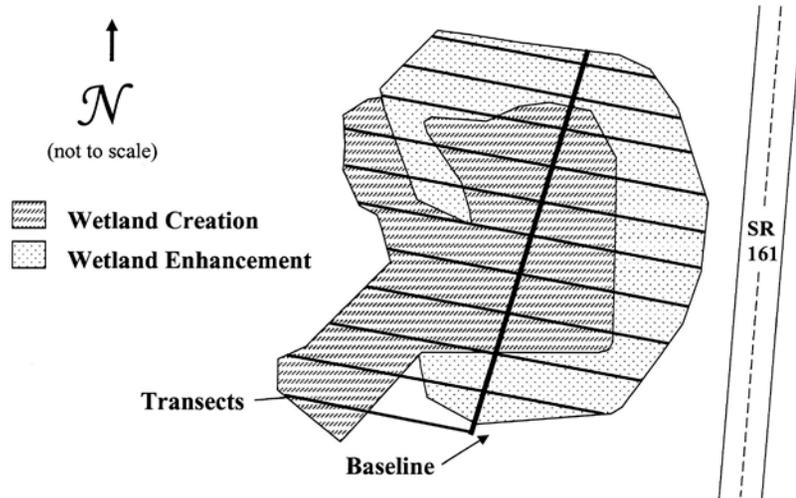
Figure 2 Site Sampling Design (2015)

Placement of Baseline: The baseline was 100 meters long and placed north to south through the middle of the site.

PS 2	PS 3
Attribute	Cover	Cover
Target pop.	Native Woody	Noxious Weeds/ Invasive sp.
Zone	Wetland	Entire site
Sample method	Line Intercept	Qualitative
SU length	15 meters	N/A
SU width	N/A	N/A
Points per SU	N/A	N/A
Total # of SU	29	N/A

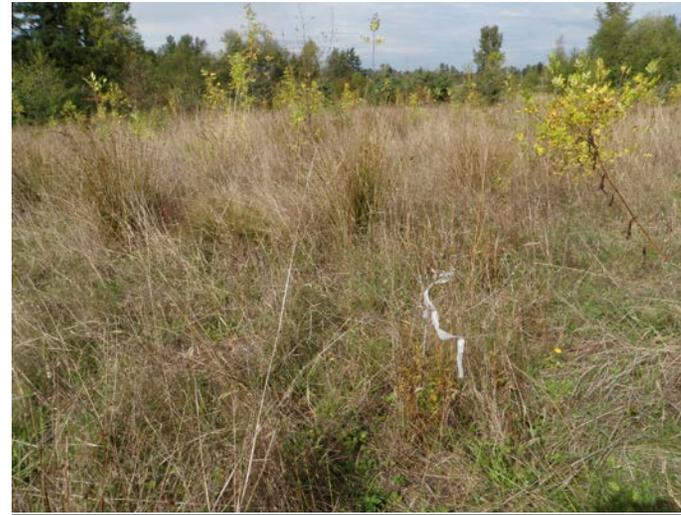
Photo 1
Woody cover in the created wetland (Sept 2015)

SR 161 Graham Hill is steadily progressing towards achieving its intended goals and objectives. The woody vegetation standard was not met this year, but it appears that many of the intended functions are being supported. Work done in previous years includes additional plantings, plant protector removal on established woody species, weed control, and control of competitive grasses around the plantings. This has helped increase cover over the past few years. Red alder (*Alnus rubra*) and black cottonwood (*Populus balsamifera*) were planted as suggested by regulatory personnel to increase cover rapidly. However, the extremely hot and dry conditions that western Washington experienced in 2015 impacted these plantings and many have died or appear stressed.

The wetland enhancement area has developed more rapidly than the wetland establishment area. The enhancement area was planted with conifers, primarily Sitka spruce (*Picea sitchensis*). The Sitka spruce dominates the area along with red alder. The spruce is approximately three to seven meters tall in this area. The wetland establishment area has less cover when compared to the enhancement area and is dominated by Oregon ash (*Fraxinus latifolia*) and red alder. Shrub species have less cover but are present in the area. Redosier dogwood (*Cornus alba*) show signs of herbivory and the salmonberry (*Rubus spectabilis*) show signs of stress most likely related to the hot and dry conditions. Although the wetland area lacks the cover to achieve the performance standard for Year 10, there is a robust herbaceous understory present that consists of soft rush (*Juncus effusus*), swordleaf rush (*Juncus ensifolius*), sawbeak sedge (*Carex stipata*), slough sedge (*Carex obnupta*), intermixed with native and nonnative pasture grasses.

The Region has plans to continue weed control.

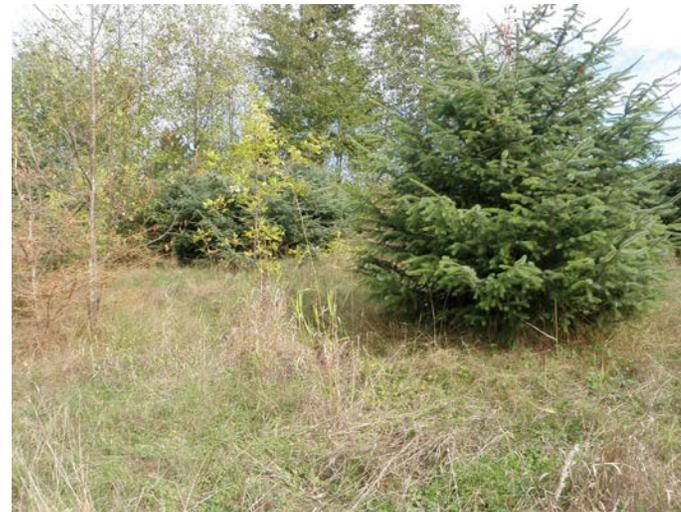
Photo 2
Woody cover in the enhanced wetland (Sep 2015)

The wetland has 33% cover ($CI_{80\%} = 28-39\%$). The species contributing the most cover include red alder, Sitka spruce, and Oregon ash. The wetland enhancement area appears to be establishing faster than the creation area (Photo 1). The enhancement area is made up of the Sitka spruce which dominates the wetland (Photo 2).

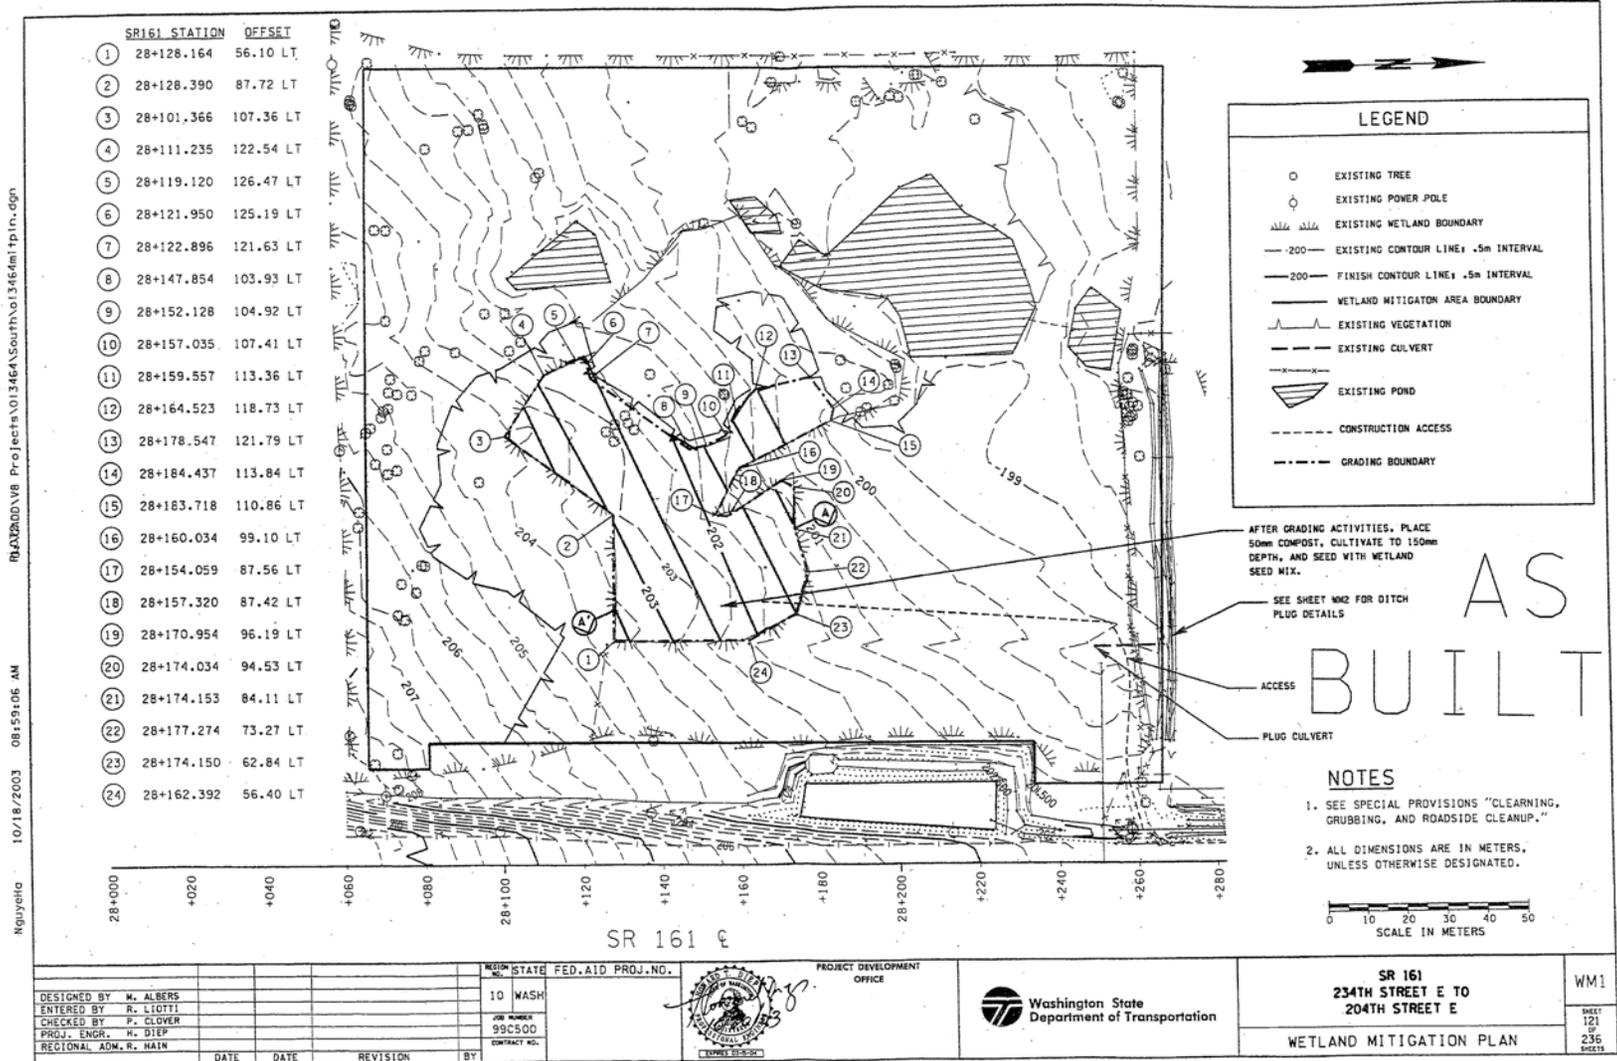
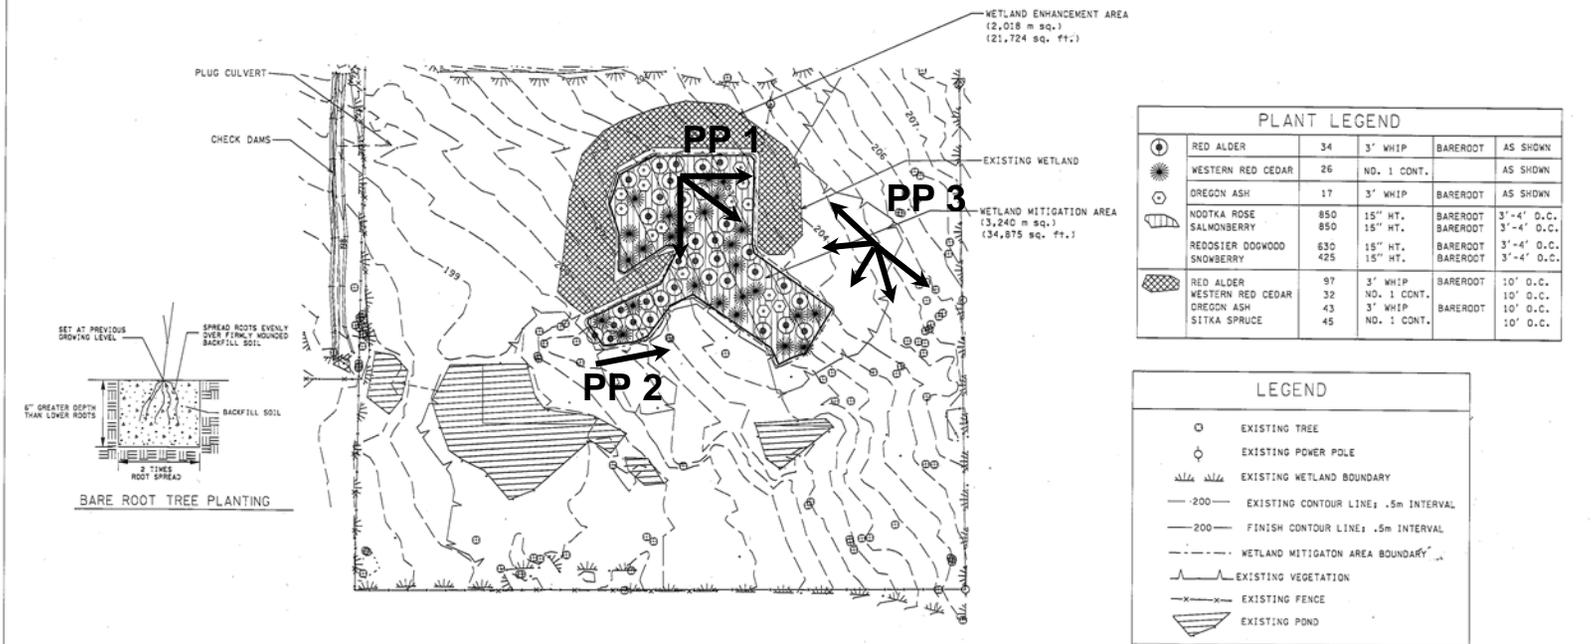
Appendix 1 – As-Built with Photo Point Locations

Appendix 1 shows the as-built planting plan (WSDOT 2005).

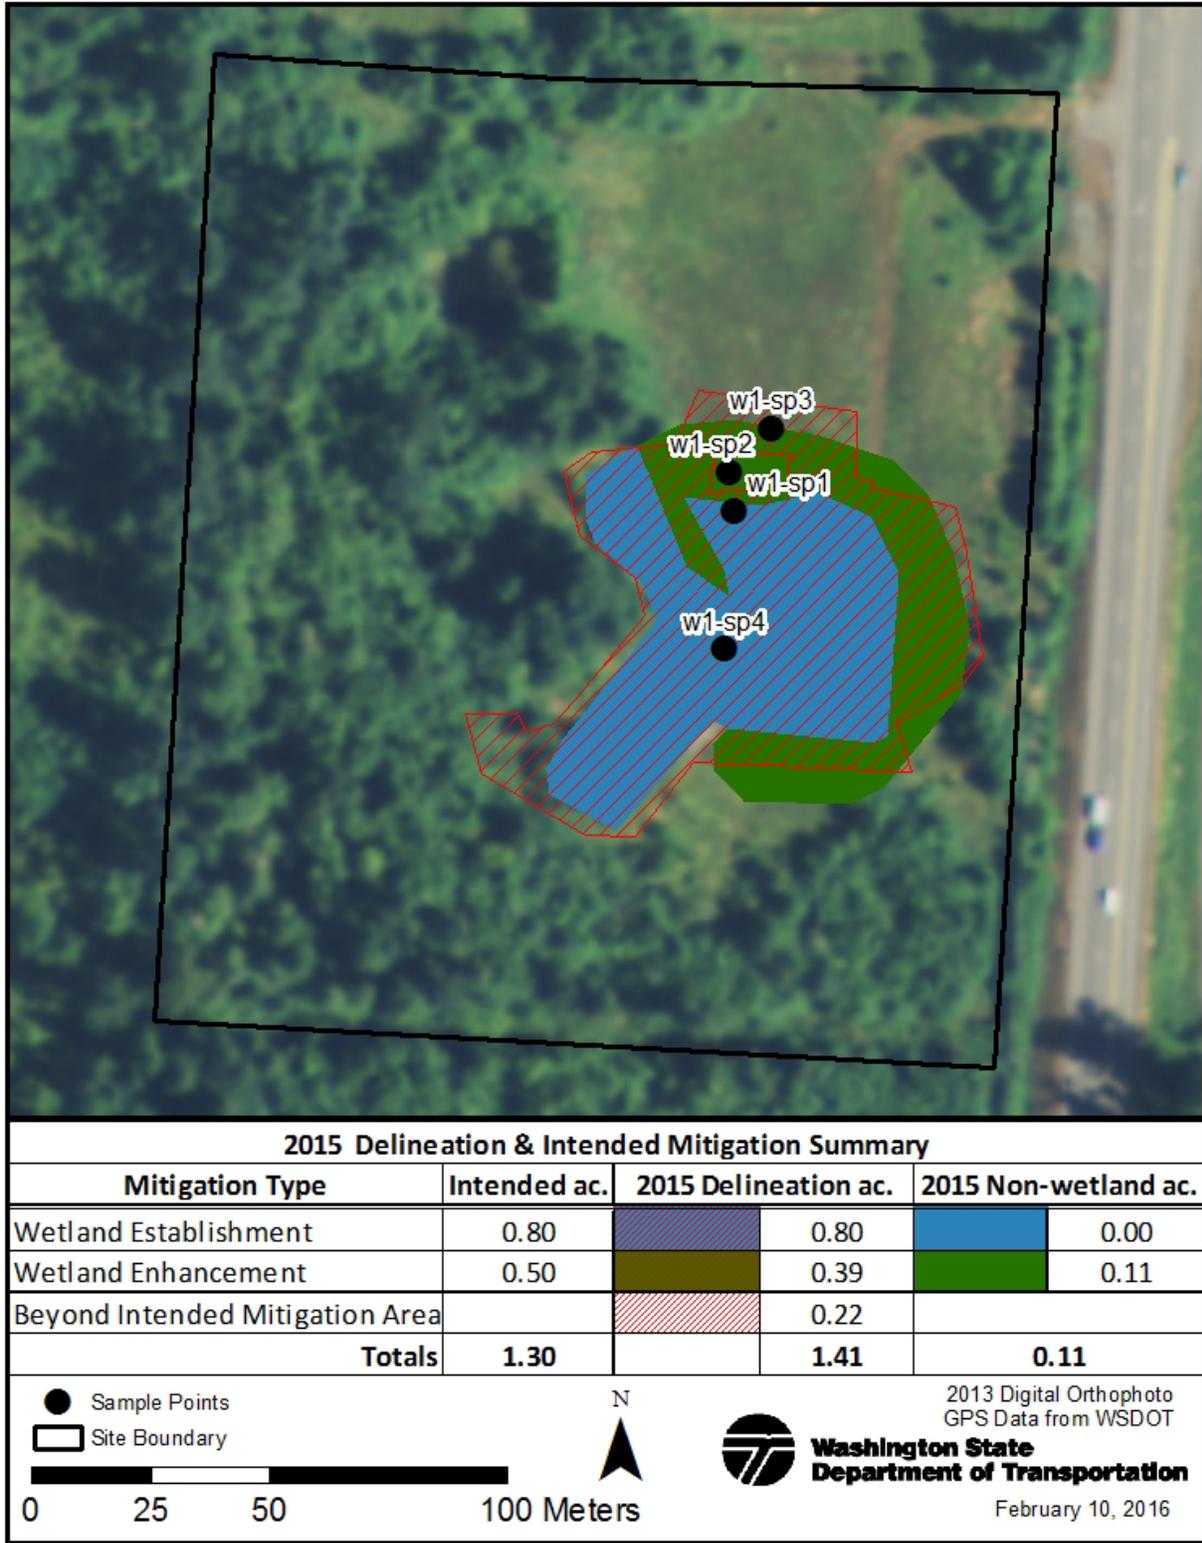
Figure 2. Wetland boundary/study area in red, sampling point locations in black.

A Global Positioning System (GPS) Trimble GeoXT mapping grade unit was used to record wetland boundaries and sampling point locations (Figure 2). Wetland boundary points were recorded at regular intervals and at any change in direction along the boundary. Wetland mitigation types (Figure 2) were georeferenced by digitizing the mitigation site as-built planting plan in ArcGIS 10.2.2. Inherent in both GPS and georeferencing are minute errors, resulting in slight inaccuracies in both boundary line placement and acreage calculations. These tools represent the best available methods at the time of the study and report preparation.

The delineation determined 1.41 acres of wetland were present within the mitigation areas at the SR 161 Graham Hill Mitigation Site. Delineation data were collected at four sampling points and recorded on wetland determination data forms (Appendix A). Paired wetland and upland sample points were used to define the wetland edge. Additional wetland sample points characterize various wetland vegetation communities. Data recorded on wetland determination data forms characterize typical wetland and upland conditions observed on site. Vegetation, soils, and hydrology were examined in many additional sampling locations to determine the wetland boundary.

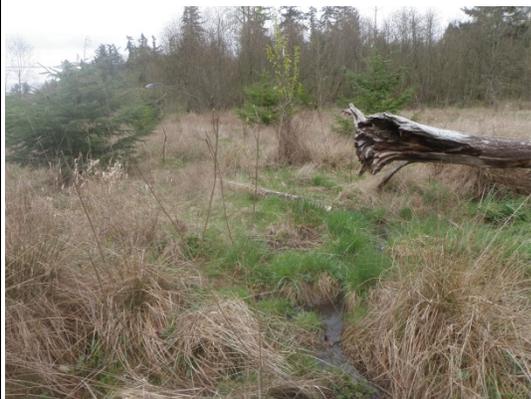
SR 161 Graham Hill Mitigation Site – Wetland Delineation Summary		
Total Delineated Wetland Area	1.41 acres

Wetland Determination Data Form(s)	Appendix A; Sampling Points W1-SP1, W1-SP3, W1-SP4
	Upland Determination Data Form(s)	Appendix A; Sampling Point W1-SP2
	Delineator(s)	Tatiana Dreisbach. Doug Littauer
	Delineation Date	March 25, 2015
Vegetation	Trees – none Shrubs – redosier dogwood (<i>Cornus alba</i>), red alder (<i>Alnus rubra</i>) saplings, Nootka rose (<i>Rosa nutkana</i>), Sitka spruce (<i>Picea sitchensis</i>) and Oregon ash (<i>Fraxinus latifolia</i>) plantings Herbs – creeping buttercup (<i>Ranunculus repens</i>), soft rush (<i>Juncus effusus</i>), colonial bentgrass (<i>Agrostis capillaris</i>), quackgrass (<i>Elymus repens</i>), orchard grass (<i>Dactylis glomerata</i>), bird's-foot trefoil (<i>Lotus corniculatus</i>), and slough sedge (<i>Carex obnupta</i>),	
Soils	Soils examined to a depth of 16 inches exhibited hydric characteristics. Matrix colors of 10YR 3/1, 10YR 3/2, 10YR 6/1, and 10 Y 5/1 were observed. Redoximorphic concentrations and depletions were observed in some layers. Indicator Depleted Below Dark Surface (A11), Depleted Matrix (F3), and Redox Dark Surface (F6) met.

Hydrology	Groundwater and sub-surface seepage from higher elevation areas to the south appear to be the main sources of hydrology. Precipitation also contributes to the hydrologic regime of this wetland. Water in the observation pits ranged from 5 inches to 10 inches below the surface. Surface water less than one-inch deep was observed in some areas.	
Rationale for Delineation	Positive indicators of all three wetland criteria are present. Placement of boundary determined by mainly by presence/absence of hydric soil and hydrology indicators.
