**SR 9 Pilchuck Creek Replace Bridge (Pilchuck Buffer)  
Mitigation Site  
WIN # A00934R**

**USACE NWP (14) NWS-2011-299**

**2015 MONITORING REPORT**

# SR 9 Pilchuck Creek Replace Bridge Mitigation Site

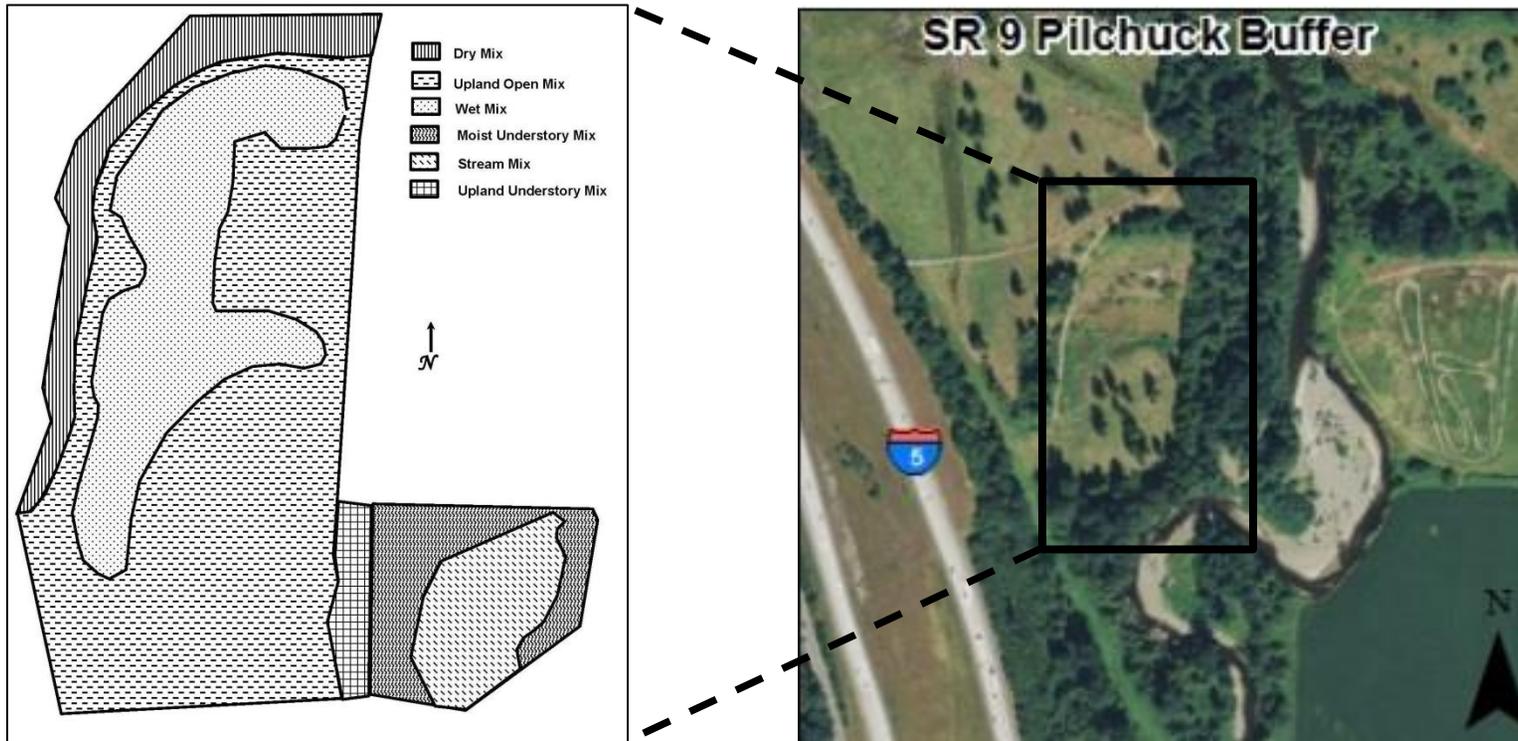
**Figure 1 Site Sketch**

The SR 9 Pilchuck Replace Bridge mitigation site contains an upper and lower terrace that contains a mix of wetland, riparian, and upland habitats. The site supports shrub and forested vegetation communities and is intended to replace stream and buffer functions. Appendix 2 includes site directions.

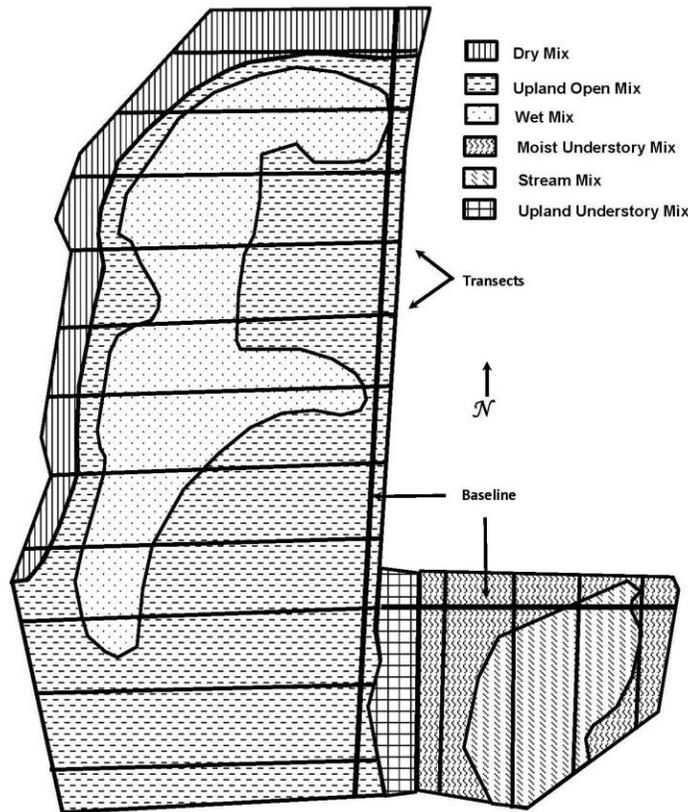
Figure 2 Site Sampling Design (2015)

**Placement of Baseline:** The top plateau section was placed roughly along the southern fence line. The riverine section was placed along the northern border of the planting zone.

**Segmented Baseline:** Length 219m Transects 2-15  
Length 54m Transects 1, 16-18

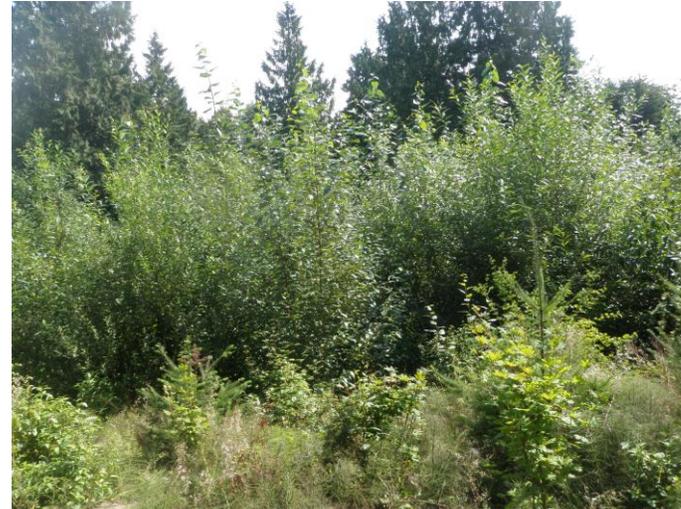
The density of planted and volunteer native woody species is 9.2 plants/100ft<sup>2</sup> (CI<sub>80%</sub> = 8.2-10.2 (Photo 1 and 2) across the site. This greatly exceeds the performance standard. Dominant species include snowberry (*Symphoricarpos albus*), cluster rose (*Rosa pisocarpa*), and salmonberry (*Rubus spectabilis*). A total of 24 native woody species were observed.

**Photo 1**  
**Woody cover in the upper terrace (July 2015)**

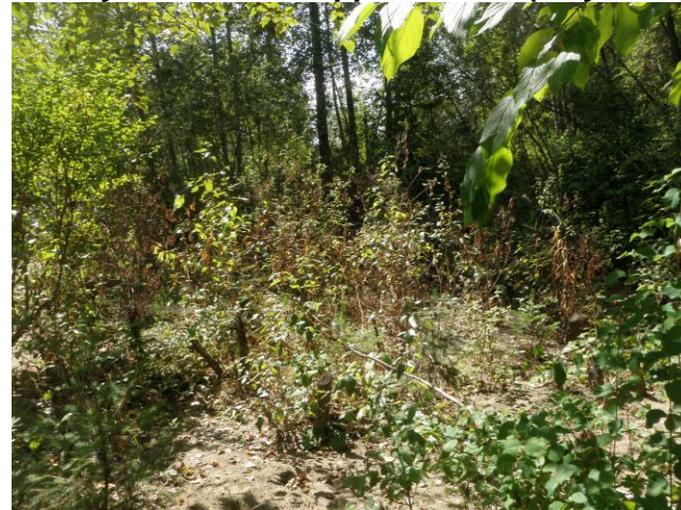
**Photo 2**  
**Woody cover in the lower flood plain terrace (July 2015)**

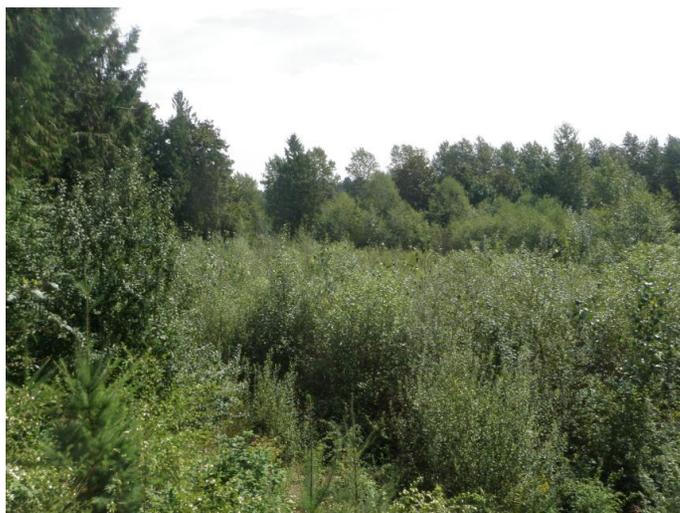
**Photo Point 1a**

The photographs below were taken from permanent photo-points on August 25, 2015 and document current site development.

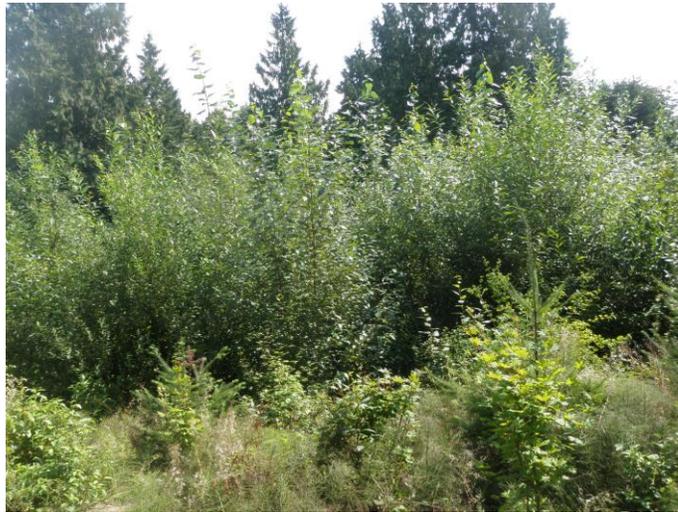
**Photo Point 2b**

The photographs below were taken from permanent photo-points on August 25, 2015 and document current site development.
