**US 97/North of Goldendale – Wildlife Habitat  
Connectivity/Fish Passage at Butler Creek Mitigation Site**

**USACE NWP (23, 27) NWS-2011-944**

**2015 MONITORING REPORT**

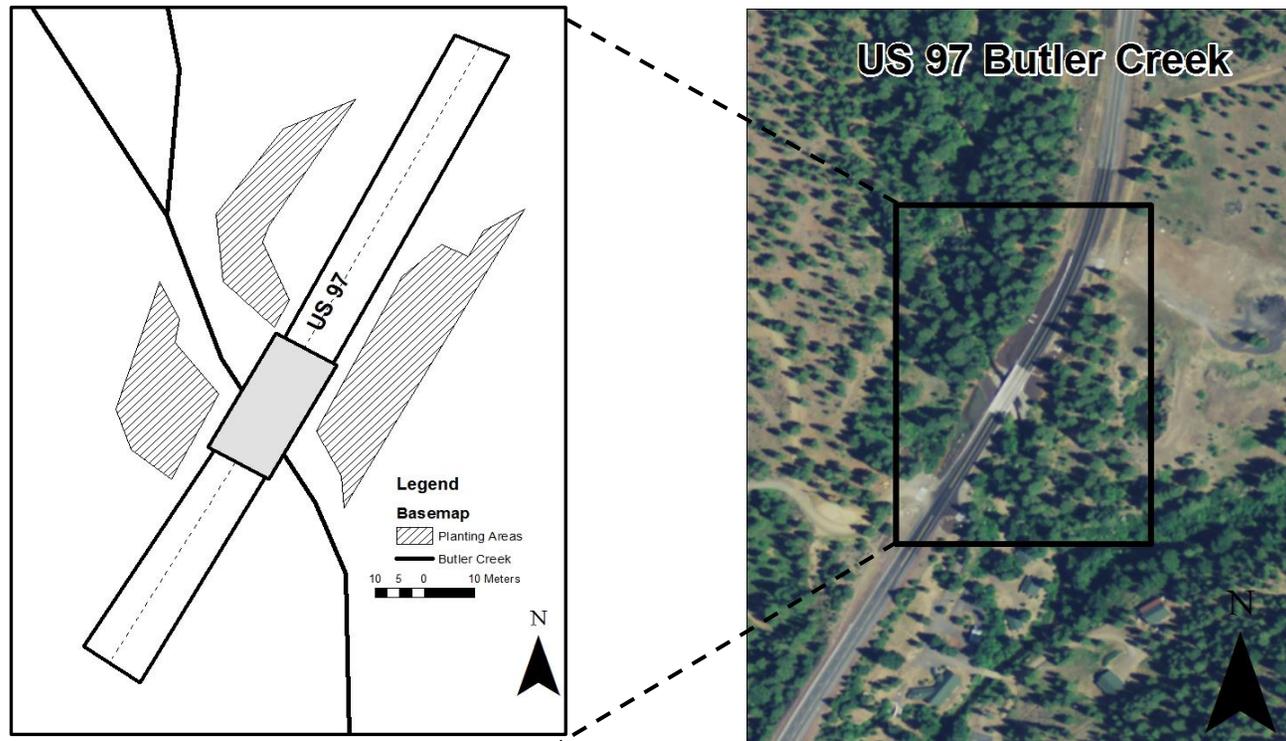
Figure 1 Site Sketch

This mitigation site (Figure 1) is a channel reconstruction and buffer planting area created north of Goldendale where Butler Creek passes under US 97. The existing culvert was replaced with a bridge to eliminate a documented fish barrier and improve wildlife connectivity. Impacts include temporary wetland buffer and permanent wetland impacts. The buffer was replanted with native woody species and the wetland impacts were mitigated on-site, out of kind by re-grading 200 feet of the Butler Creek channel associated with the culvert removal. This has provided a fish-passable stream profile and approximately 0.06 acres of floodplain bench.

The US 97 Butler Creek wildlife habitat connectivity and fish passage project planting area includes planting areas on three corners where the road and the creek intersect. Appendix 2 includes site directions.

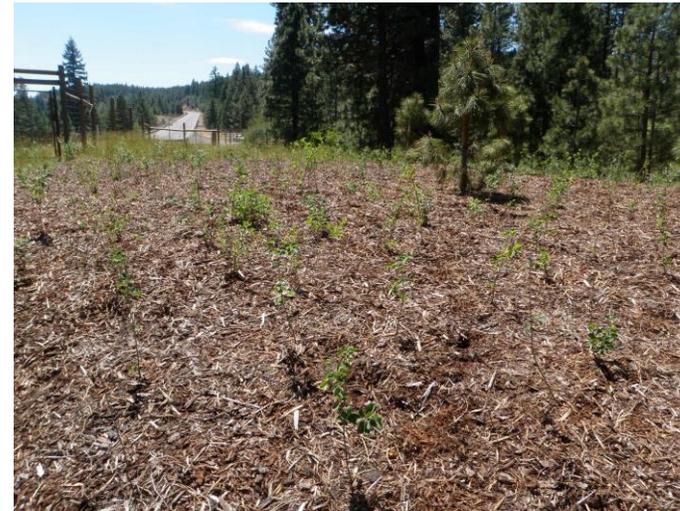
**Photo 1**  
**Woody cover in the scrub-shrub wetland (July 2015)**

This site was planted according to plan and appears to be on track for Year 1. Some of the plantings struggled through the summer and suffered high mortality. This is most likely due to the dry and hot summer experienced in 2015. The grand fir (*Abies grandis*) and redosier dogwood (*Cornus alba*) did not survive or survived in low numbers. The ponderosa pine (*Pinus ponderosa*) and snowberry (*Symphoricarpos albus*) were thriving even in the extreme conditions. During the winter of 2015-2016, the southeast planting area eroded to the point that the plantings that were counted during the summer are no longer present.

Survival of planted woody species is 46 percent. A total count of living plants was completed and compared to the planting totals. Dominant species include snowberry (*Symphoricarpos albus*), western serviceberry (*Amelanchier alnifolia*), and Lewis' mock orange (*Philadelphus lewisii*). Conifers were suffering except the ponderosa pine (*Pinus ponderosa*).

The region has plans to continue routine weed control throughout the 2016 growing season. Intensive replanting is scheduled for the winter of 2016 as well.

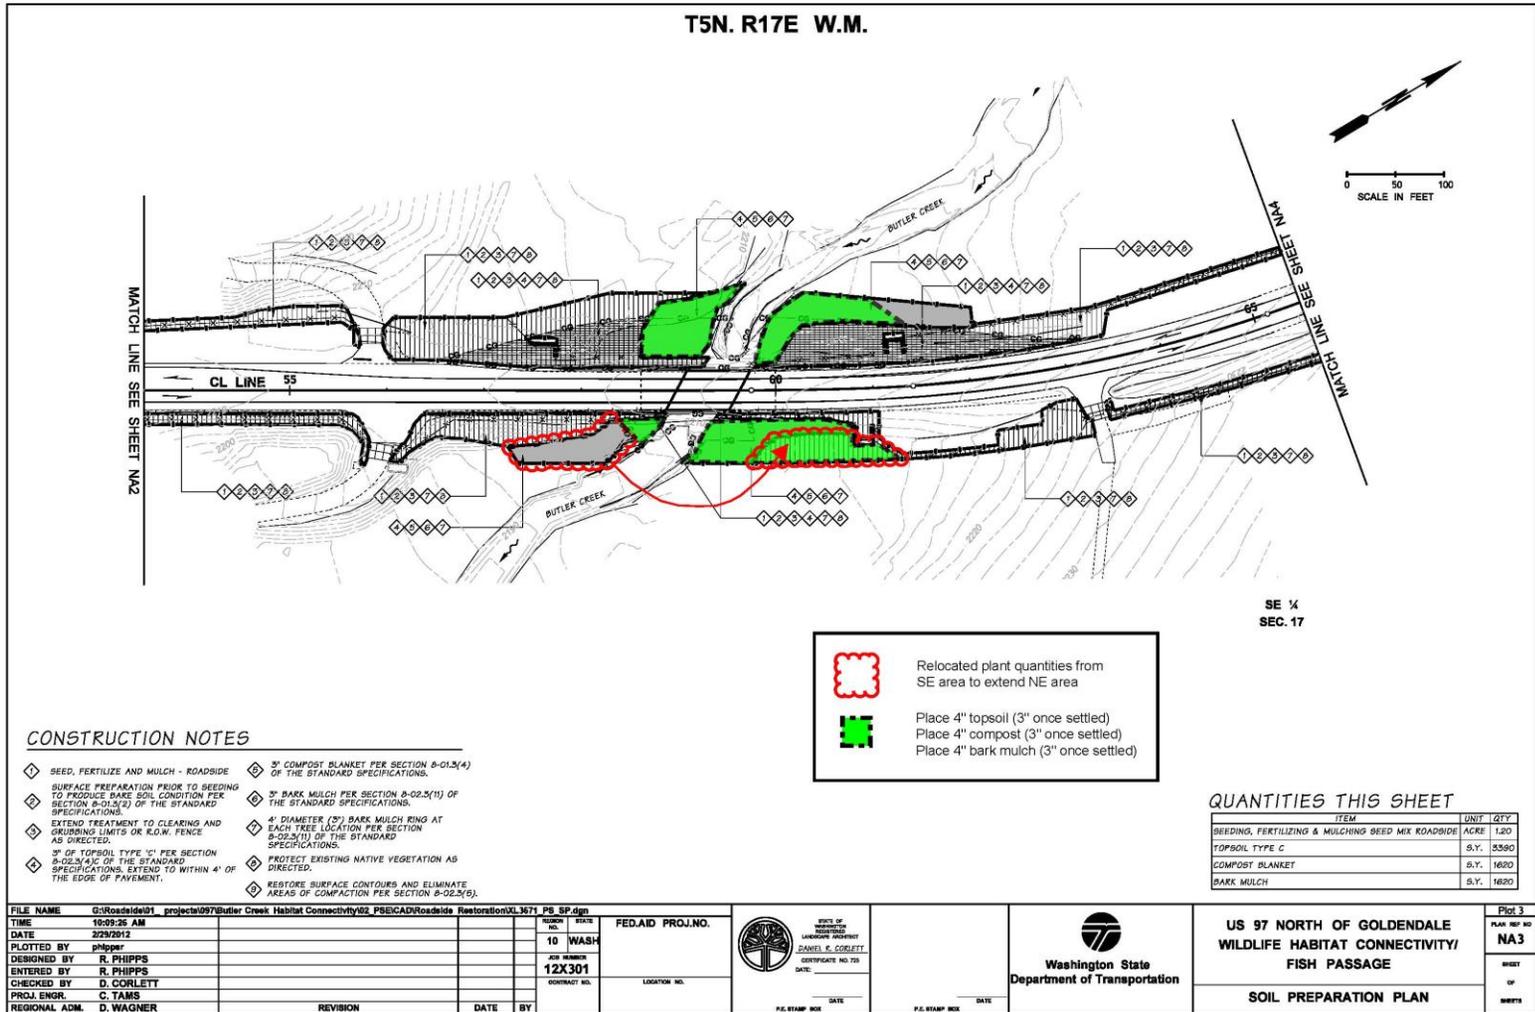
# Appendix 1 – As-Built

Appendix 1 shows the planting plan (WSDOT 2012).

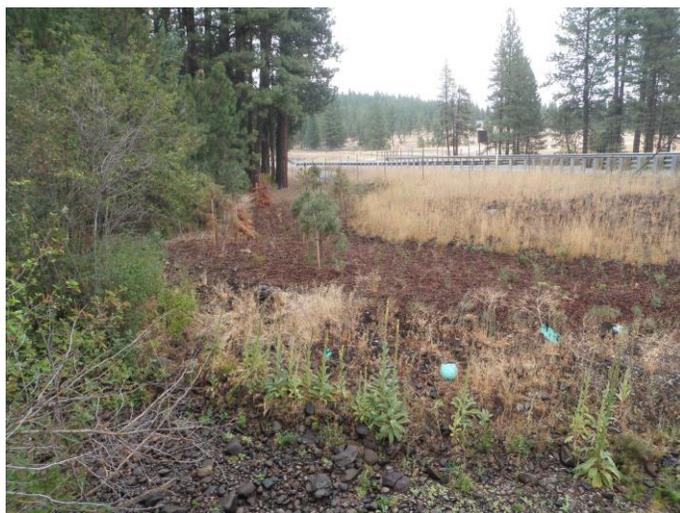
**Photo Point 1**

The photographs below were taken from permanent photo-points on August 10, 2015 and document current site development.
