SR 270 Pullman to Idaho State Line (Sunshine Road) Mitigation Site

USACE IP 200500225

2015 MONITORING REPORT

**Washington State
Department of Transportation**

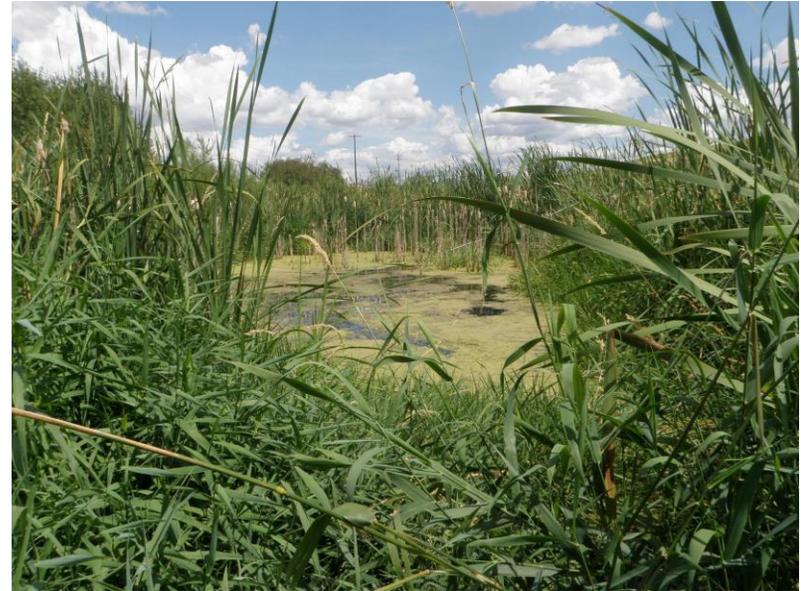
Photo 1
Inundation in the Emergent Wetland (July 2015)

On February 26, 2015, a request to discontinue hydrology monitoring was sent to USACE and the Department of Ecology. This request was accepted on April 2, 2015. During our monitoring visit, the site was inundated in the ponds and through the middle of the site (Photo 1).

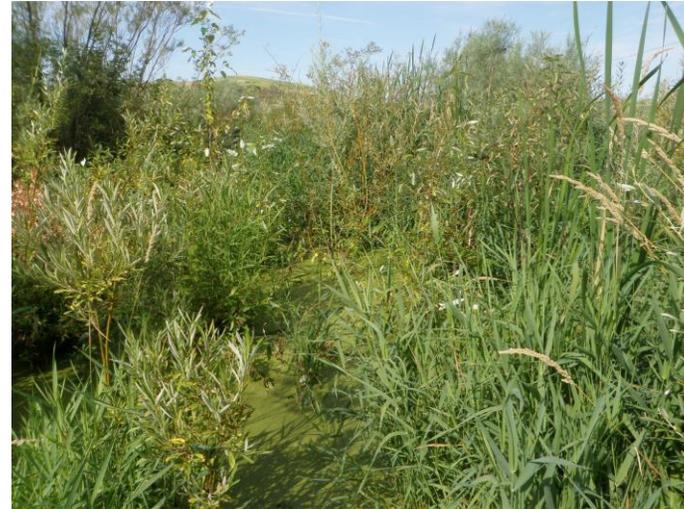
Photo 2
Woody cover in the Wetland (July 2015)

Native woody species cover in the scrub-shrub and forested wetland areas is 53% (CI_{90%} = 43-63%). This is a slight increase from 2013. The planted woody species are still completing with the reed canarygrass monoculture (Photo 2). The areas that were mowed seemed to be helping the newly installed willow stakes become established.

Several species in the forested and scrub-shrub wetland exceed this five percent relative cover standard. These species include Nootka rose (*Rosa nutkana*), willows, redosier dogwood (*Cornus alba*), and black cottonwood (*Populus balsamifera*) (Photo 2).

The region has plans for continued mowing and weed control and additional willow and cottonwood staking to shade reed canarygrass.

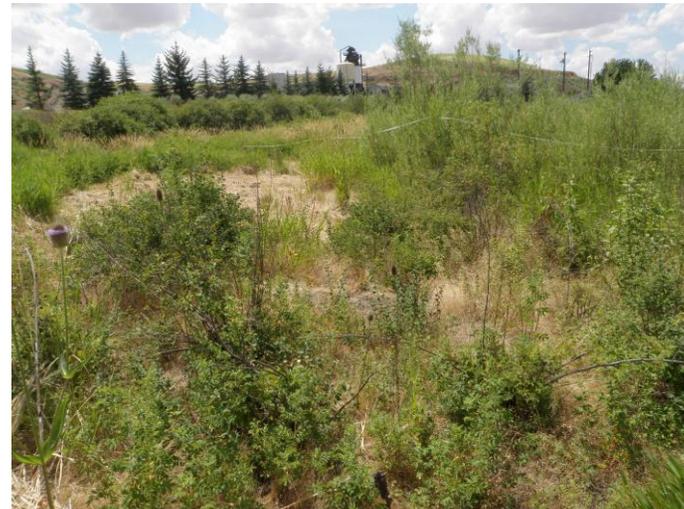
Photo 3
Woody cover in the Buffer (July 2015)

The cover of native woody species in the buffer area is 44% (CI_{90%} = 37-51%). The buffer appears to be developing slowly. Many of the golden currant (*Ribes aureum*) appeared to be dead or dying. It is most likely due to the very dry and hot summer experienced in 2015. Mowing reed canarygrass in the buffer area is helping upland vegetation become established (Photo 3).
